## BURNHAM MARKET PARISH COUNCIL ANNUAL GENERAL MEETING Minutes

Date: Wednesday 6<sup>th</sup> May 2026 at 6.30pm |

## Burnham Market Play Area

# Safety Inspection Report

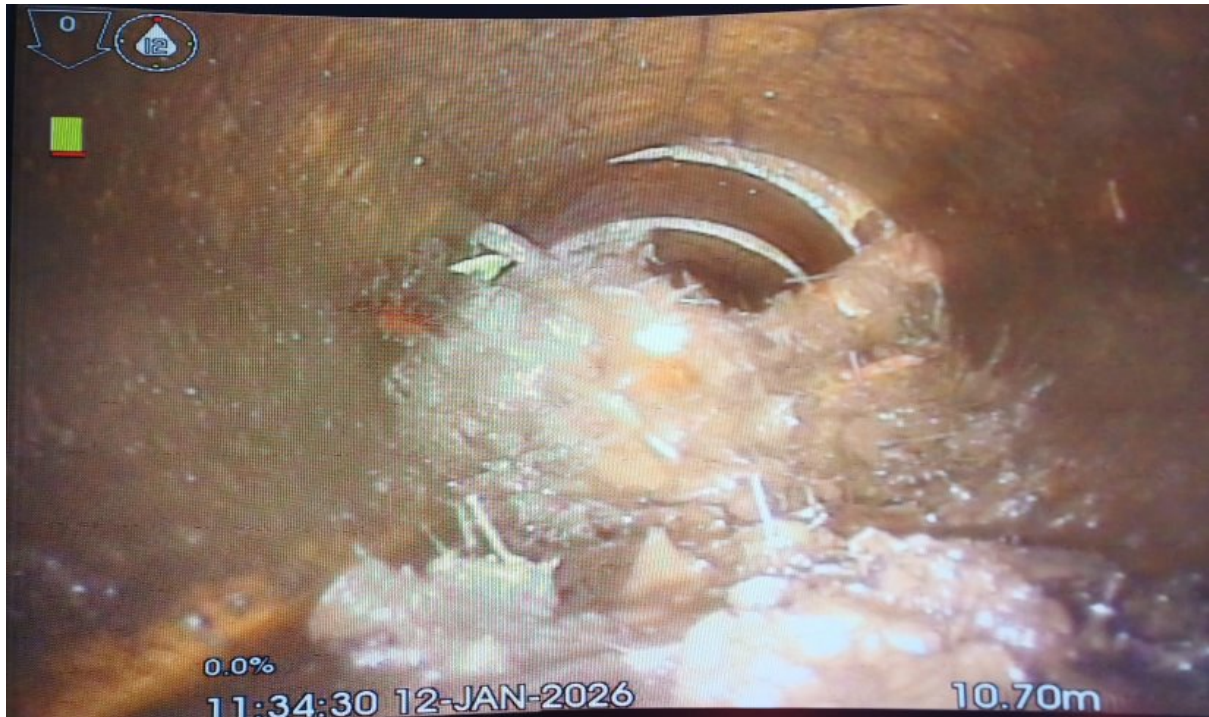
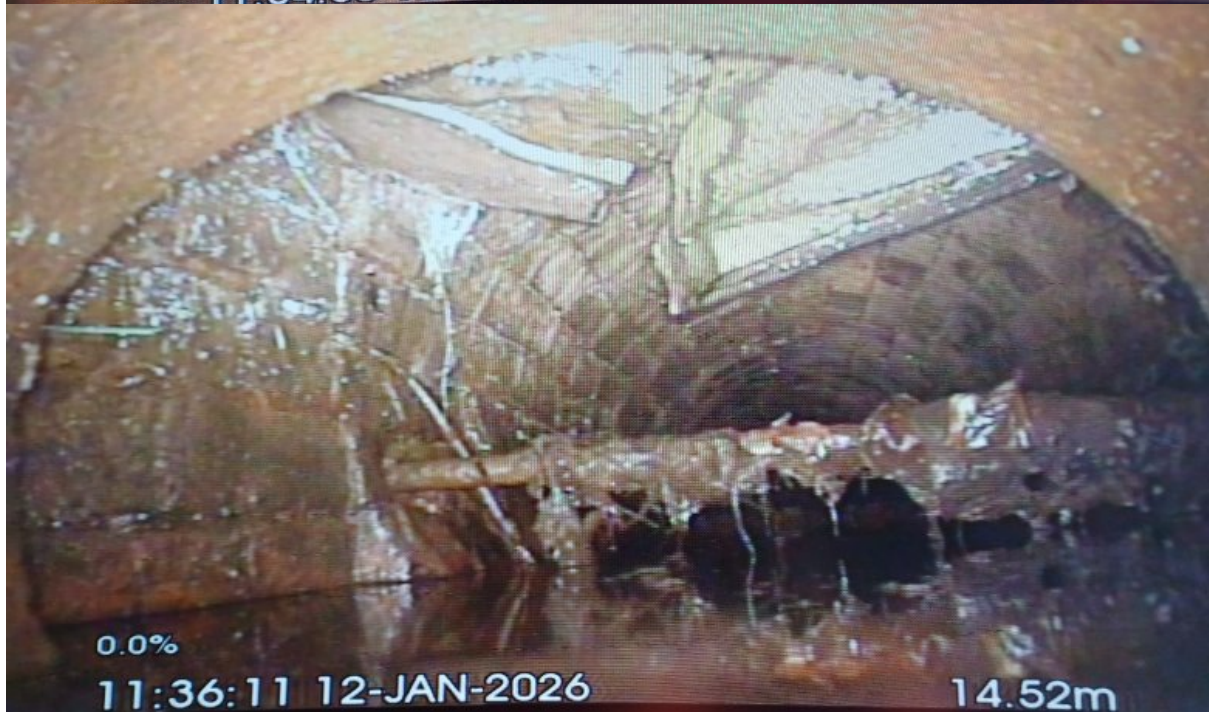
There was not an extensive amount of CCTV surveying carried out in this catchment due to the time of year and the unusually dry winter. It is noted that extensive CCTV work was completed in 2022, during which little of concern was identified.

As part of this investigation, CCTV was used to survey the route away from the Goose Beck, where restrictions were found in the existing pipework.

It is also noted that the downstream ditch system requires **maintenance and reprofiling** to an appropriate level to ensure effective flow and prevent further capacity issues.

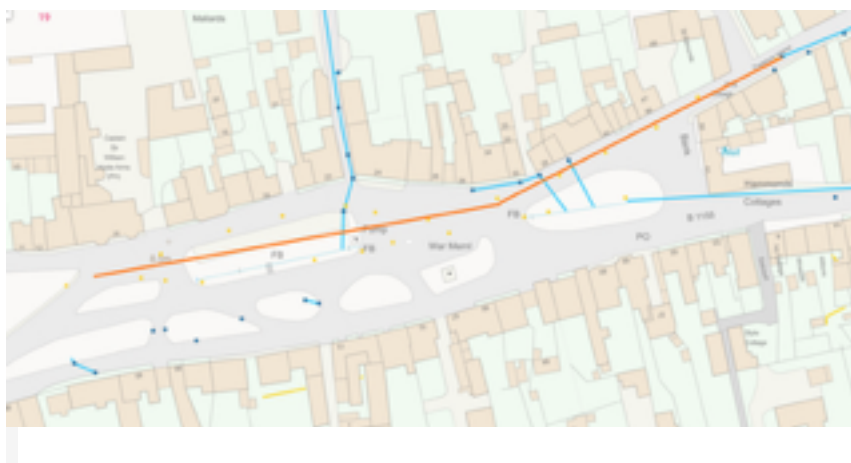
We also examined the highways drainage system throughout the catchment and identified a potential opportunity to reduce flooding during the wettest periods. A highways system was noted on North Street which appears relatively modern, as the installation scars in the tarmac are still visible. This system begins at Treasure Island and runs down North Street before connecting into the Goose Beck at Ulph Place.

It is suggested that an area worth exploring is the extension of this system into the central zone that experiences flooding during the heaviest rainfall events. Extending the network may help to alleviate or reduce the severity of flooding in this location.

A plan has been included with the proposed extension highlighted in **orange**. Please note that this is for **illustrative purposes only** and does not represent any confirmed alignment or commitment to installation. This is purely a proposal, and any future delivery would fall outside of Anglian Water's responsibilities. Progression would therefore need to be pursued through appropriate partnership routes.

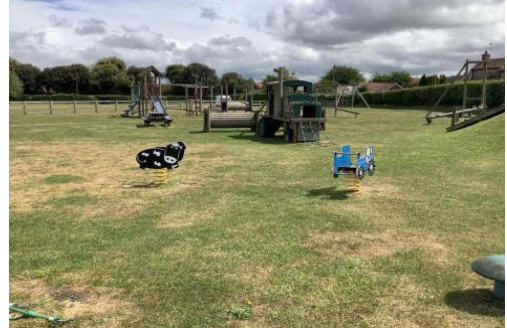
**Item:** Site General  
**Manufacturer:** N/A  
**Surface Type:** N/A  
**Item Quantity:** 1

There are trip hazards present - Remove trip hazard

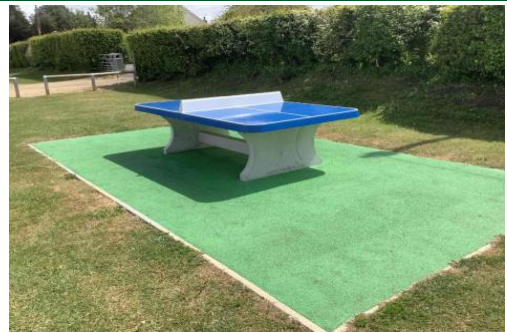
**Item:** Table Tennis  
**Manufacturer:** HeBlad  
**Surface Type:** Wet Pour  
**Item Quantity:** 1

There are trip hazards at the edges of the surface - Remove trip hazard

The item has been damaged - Monitor for any further deterioration and replace as required

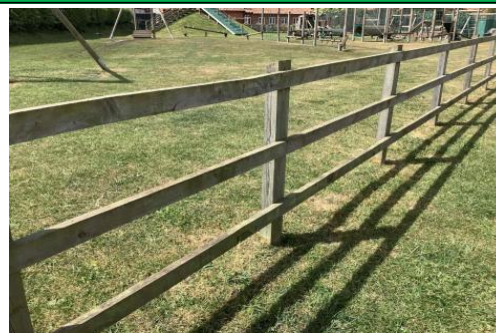
**Item:** Fencing - Post & Rail  
**Manufacturer:** N/A  
**Surface Type:** Grass  
**Item Quantity:** 1

There are a number of loose posts around the fence - Monitor for any further deterioration and reset as required

The timber has a number of splits/shakes or air cracks and this may affect the stability or allow water ingress which will accelerate the rotting process. Timber splits may also create rough / splintering edges. - Monitor, sand down any rough edges and ensure the splits do not cross through fixing points of the structure and/or cause any instability

There is some strimmer / machinery damage apparent on the posts, this can penetrate the preservative applied to the timber and accelerate the rotting process - Monitor for any deterioration (rot) and replace as required

There is some evidence of rot in the timber - Monitor for any further deterioration and replace as required

The item has been damaged - Monitor for any further deterioration and replace as required

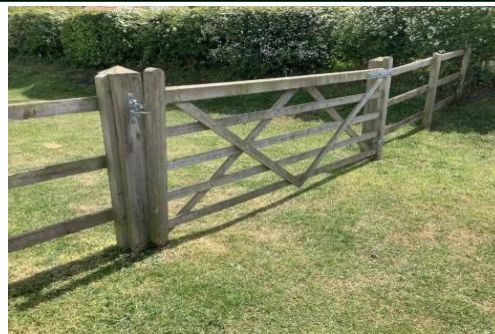
**Item:** Gate - Maintenance  
**Manufacturer:** N/A  
**Surface Type:** Grass  
**Item Quantity:** 1

There is no padlock on the maintenance gate - Provide a padlock to secure the gate

The timber has a number of splits/shakes or air cracks and this may affect the stability or allow water ingress which will accelerate the rotting process. Timber splits may also create rough / splintering edges. - Monitor, sand down any rough edges and ensure the splits do not cross through fixing points of the structure and/or cause any instability

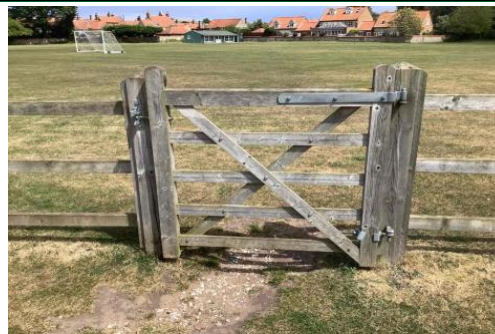
**Item:** Gate  
**Manufacturer:** N/A  
**Surface Type:** Grass  
**Item Quantity:** 1

A number of fixing(s) have worked loose - Secure all loose fixings

The timber has a number of splits/shakes or air cracks and this may affect the stability or allow water ingress which will accelerate the rotting process. Timber splits may also create rough / splintering edges. - Monitor, sand down any rough edges and ensure the splits do not cross through fixing points of the structure and/or cause any instability

The surface has eroded in some areas and may be slippery in wet conditions - Reinststate the surface

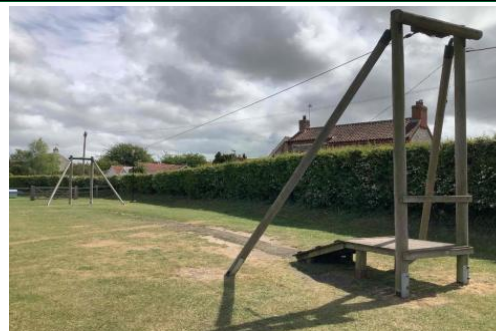
**Item:** Cable Runway  
**Manufacturer:** Action Play and Leisure  
**Surface Type:** Grass Matrix Tiles  
**Item Quantity:** 1

The item has been damaged - Monitor for any further deterioration and replace as required

There are gaps opening between the surfacing and the edging surround or between the joints in the surfacing - Monitor for any further deterioration and repair as required

The seat connection cannot be inspected without dismantling the seat - Dismantle the seat to inspect the seat connection for wear

There are projecting fixings present - Tighten / replace as required

There are post protectors around the timber posts that are preventing the inspector from thoroughly testing for signs of decay and we are unable to verify the condition of the posts in these locations. NOTE - timber rot / decay is possible even with the post protectors in place - Refer to manufacturer inspection / maintenance recommendations

There is some notable evidence of chain wear - Monitor for any further deterioration and replace when 40% worn

Bolt cap cover/s missing or damaged - Replace

The timber has a number of splits/shakes or air cracks and this may affect the stability or allow water ingress which will accelerate the rotting process. Timber splits may also create rough / splintering edges. - Monitor, sand down any rough edges and ensure the splits do not cross through fixing points of the structure and/or cause any instability

We have completed a visual inspection of the suspension links, cable and fixing points from ground level, however it is not possible to fully inspect these areas without either hiring equipment to gain access or removing the cable and suspension and inspecting at ground level. We recommend that the main cable and fixing security is thoroughly inspected at least in accordance with the manufacturers recommendations to check for wear, damage, security or internal rusting; this will help to ensure the continued safe use of the equipment - Inspect in accordance with the manufacturers recommendations

The surface has eroded in some areas and may be slippery in wet conditions - Reinstate the surface

The paintwork on this item has been damaged or worn exposing the metal underneath which is rusting / corroding - Treat affected areas and repaint

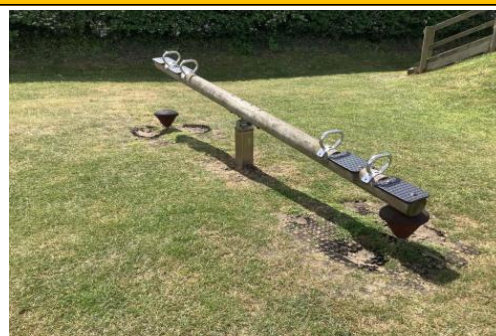
**Item:** See Saw  
**Manufacturer:** Not Identified  
**Surface Type:** Grass Matrix Tiles  
**Item Quantity:** 1

There are redundant holes on the item - Fill or provide cap / insert

There is wear apparent to the central pivot resulting in excessive sideways movement - Inspect pivot / bearings for internal wear and replace as required

The dampeners are loose and can be lifted from the posts - Secure dampeners to posts

The surface has eroded in some areas and may be slippery in wet conditions - Reinstate the surface

A number of fixing(s) have worked loose - Secure all loose fixings

Bolt cap cover/s missing or damaged - Replace

The timber has a number of splits/shakes or air cracks and this may affect the stability or allow water ingress which will accelerate the rotting process. Timber splits may also create rough / splintering edges. - Monitor, sand down any rough edges and ensure the splits do not cross through fixing points of the structure and/or cause any instability

There are trip hazards present - Remove trip hazard

The surfacing is severely damaged - Repair damaged areas of surfacing

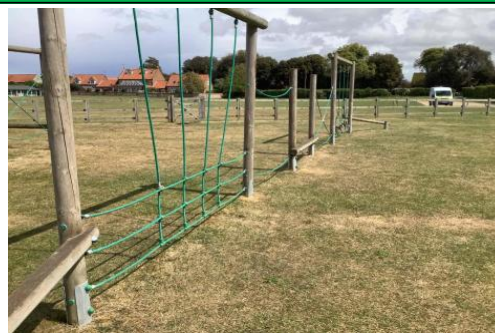
**Item:** Trim Trail  
**Manufacturer:** Action Play and Leisure  
**Surface Type:** Grass  
**Item Quantity:** 1

The ropes/nets are worn/damaged in places - Monitor for any further deterioration and repair or replace as required

The timber has a number of splits/shakes or air cracks and this may affect the stability or allow water ingress which will accelerate the rotting process. Timber splits may also create rough / splintering edges. - Monitor, sand down any rough edges and ensure the splits do not cross through fixing points of the structure and/or cause any instability

There is some evidence of fire damage to the item - Monitor for any further deterioration and repair as required

There is some wear to the suspension lugs - Monitor and replace when 40% worn

The item has been damaged - Monitor for any further deterioration and replace as required

The ropes on this item have been taped and we are unable to fully assess the condition of the rope, ensure no wire strands are broken beneath the tape - Repair or replace as required

There is some wear to the shackles - Monitor for any further deterioration and replace when 40% worn

A number of fixing(s) have worked loose - Secure all loose fixings

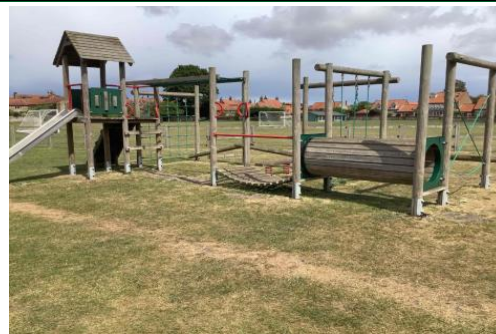
**Item:** Multi Play (Junior)  
**Manufacturer:** Action Play and Leisure  
**Surface Type:** Grass Matrix Tiles  
**Item Quantity:** 1

A number of fixing(s) have worked loose - Secure all loose fixings

There is some evidence of rot in the timber - Monitor for any further deterioration and replace as required

Bolt cap cover/s missing or damaged - Replace

The timber has a number of splits/shakes or air cracks and this may affect the stability or allow water ingress which will accelerate the rotting process. Timber splits may also create rough / splintering edges. - Monitor, sand down any rough edges and ensure the splits do not cross through fixing points of the structure and/or cause any instability

There is some wear to the shackles - Monitor for any further deterioration and replace when 40% worn

The surface has eroded in some areas and may be slippery in wet conditions - Reinstate the surface

There is some wear to the suspension lugs - Monitor and replace when 40% worn

There are a number of dents in the slide surface - Monitor for any further deterioration and repair as required

The ropes on this item have been taped and we are unable to fully assess the condition of the rope, ensure no wire strands are broken beneath the tape - Repair or replace as required

The paintwork on this item has been damaged or worn exposing the metal underneath which is rusting / corroding - Treat affected areas and repaint

The ropes/nets are worn/damaged in places - Monitor for any further deterioration and repair or replace as required

There is some minor damage to the surface - Monitor for  
any further deterioration and repair as required

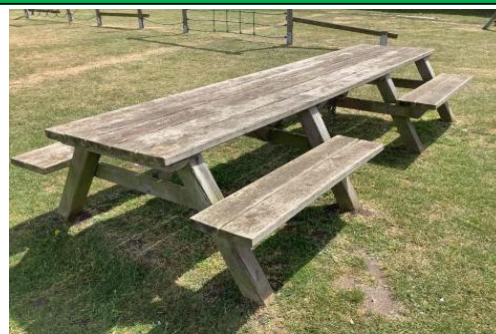
**Item:** Picnic Table  
**Manufacturer:** Action Play and Leisure  
**Surface Type:** Grass  
**Item Quantity:** 1

The timber has a number of splits/shakes or air cracks and this may affect the stability or allow water ingress which will accelerate the rotting process. Timber splits may also create rough / splintering edges. - Monitor, sand down any rough edges and ensure the splits do not cross through fixing points of the structure and/or cause any instability

There is some strimmer / machinery damage apparent on the legs, this can penetrate the preservative applied to the timber and accelerate the rotting process - Monitor for any deterioration (rot) and replace as required

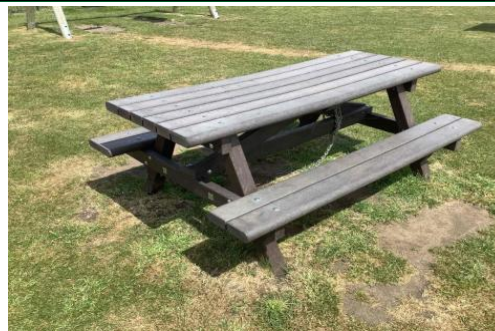
**Item:** Picnic Table  
**Manufacturer:** Glasdon  
**Surface Type:** Grass  
**Item Quantity:** 1

The surface has eroded in some areas and may be slippery in wet conditions - Reinstate the surface

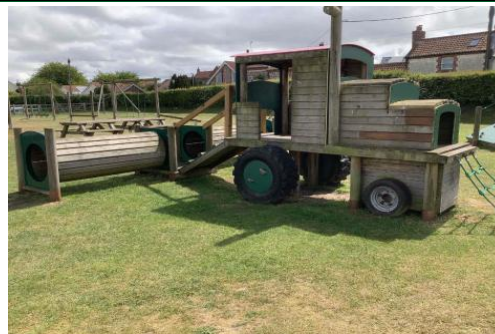
**Item:** Tractor  
**Manufacturer:** Not Identified  
**Surface Type:** Grass Matrix Tiles  
**Item Quantity:** 1

There are sharp protruding staples on the item - Remove staples

There is or are fixings missing on the roof - Replace all missing fixings

Bolt cap cover/s missing or damaged - Replace

There are post protectors around the timber posts that are preventing the inspector from thoroughly testing for signs of decay and we are unable to verify the condition of the posts in these locations. NOTE - timber rot / decay is possible even with the post protectors in place - Refer to manufacturer inspection / maintenance recommendations

The timber has a number of splits/shakes or air cracks and this may affect the stability or allow water ingress which will accelerate the rotting process. Timber splits may also create rough / splintering edges. - Monitor, sand down any rough edges and ensure the splits do not cross through fixing points of the structure and/or cause any instability

The ropes/nets are worn/damaged in places - Monitor for any further deterioration and repair or replace as required

The item has been damaged - Monitor for any further deterioration and replace as required

The surface has eroded in some areas and may be slippery in wet conditions - Reinstate the surface

A number of fixing(s) have worked loose - Secure all loose fixings

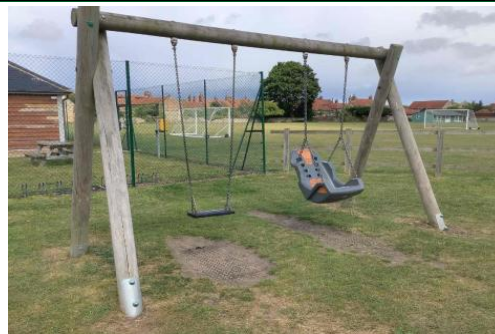
**Item:** 1 Bay 1 Inclusive 1 Flat Swing  
**Manufacturer:** Action Play and Leisure  
**Surface Type:** Grass Matrix Tiles  
**Item Quantity:** 1

There is some graffiti present - Remove the graffiti

There is some minor damage to the surface - Monitor for any further deterioration and repair as required

The surface has eroded in some areas and may be slippery in wet conditions - Reinstate the surface

The timber has a number of splits/shakes or air cracks and this may affect the stability or allow water ingress which will accelerate the rotting process. Timber splits may also create rough / splintering edges. - Monitor, sand down any rough edges and ensure the splits do not cross through fixing points of the structure and/or cause any instability

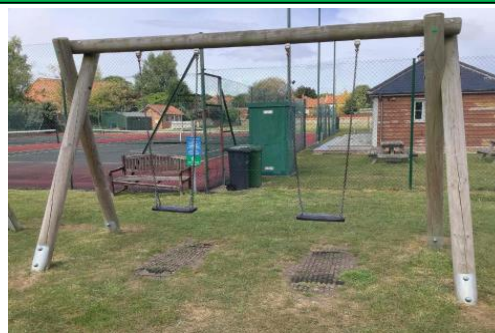
**Item:** 1 Bay 2 Seat (Flat)  
**Manufacturer:** Action Play and Leisure  
**Surface Type:** Grass Matrix Tiles  
**Item Quantity:** 1

The surface has eroded in some areas and may be slippery in wet conditions - Reinstate the surface

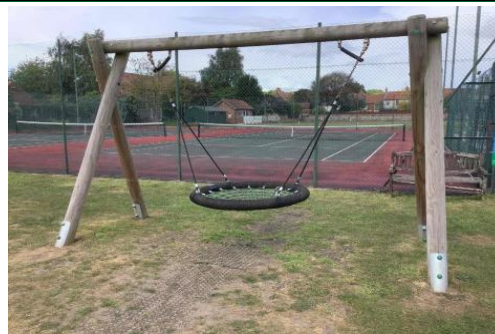
**Item:** Basket Swing - Type 1  
**Manufacturer:** Action Play and Leisure  
**Surface Type:** Grass Matrix Tiles  
**Item Quantity:** 1

A number of fixing(s) have worked loose where the suspensions pass through the cross bar - Secure all loose fixings

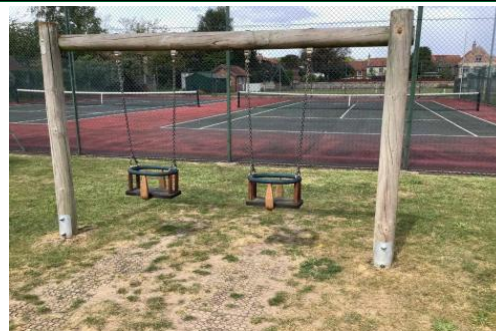
**Item:** 1 Bay 2 Seat (Cradle)  
**Manufacturer:** Adventure Playgrounds  
**Surface Type:** Grass Matrix Tiles  
**Item Quantity:** 1

There is some wear to the shackles. - Monitor for any further deterioration and replace when 40% worn

Bolt cap cover/s missing or damaged - Replace

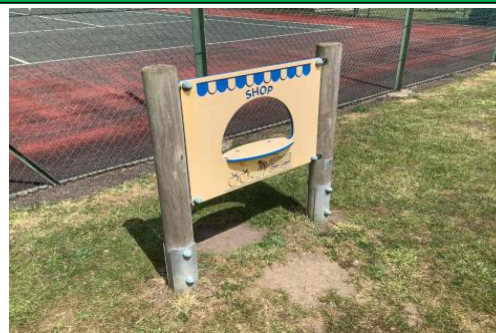
**Item:** Play Panel  
**Manufacturer:** Action Play and Leisure  
**Surface Type:** Grass  
**Item Quantity:** 1

The timber has a number of splits/shakes or air cracks and this may affect the stability or allow water ingress which will accelerate the rotting process. Timber splits may also create rough / splintering edges. - Monitor, sand down any rough edges and ensure the splits do not cross through fixing points of the structure and/or cause any instability

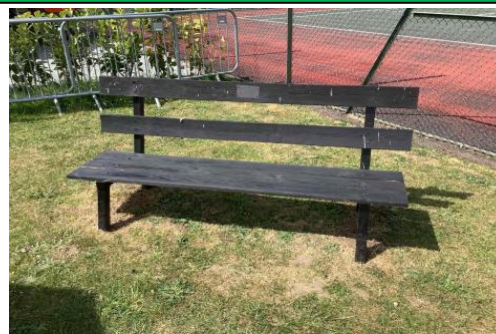
**Item:** Bench  
**Manufacturer:** Not Identified  
**Surface Type:** Grass  
**Item Quantity:** 1

There are projecting bolt thread(s) present - Remove excess thread length and deburr or provide cap

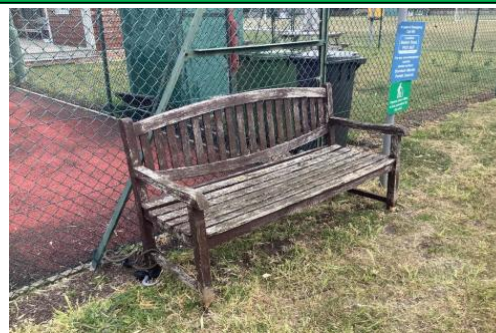
**Item:** Bench  
**Manufacturer:** Not Identified  
**Surface Type:** Grass  
**Item Quantity:** 1

The item has been damaged - Repair or replace the item / affected part

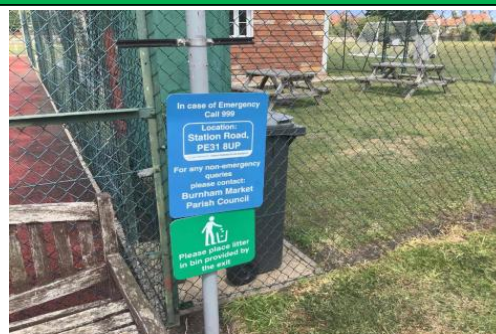
**Item:** Playground Sign  
**Manufacturer:** Not Identified  
**Surface Type:** Grass  
**Item Quantity:** 1

There is algae or moss on the surface of the equipment - Clean and treat appropriately

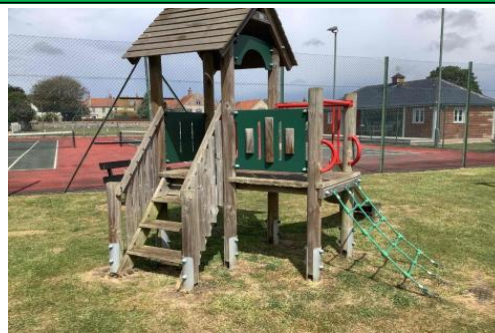
**Item:** Multi Play (Junior)  
**Manufacturer:** Action Play and Leisure  
**Surface Type:** Grass Matrix Tiles  
**Item Quantity:** 1

The timber has a number of splits/shakes or air cracks and this may affect the stability or allow water ingress which will accelerate the rotting process. Timber splits may also create rough / splintering edges. - Monitor, sand down any rough edges and ensure the splits do not cross through fixing points of the structure and/or cause any instability

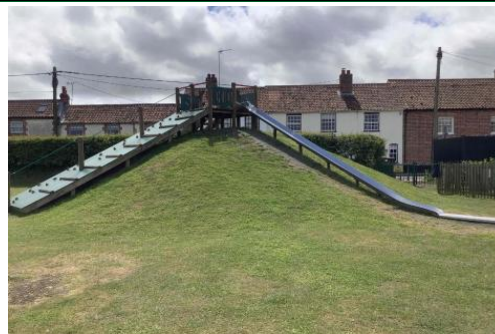
**Item:** Embankment Slide  
**Manufacturer:** Adventure Playgrounds  
**Surface Type:** Grass Matrix Tiles  
**Item Quantity:** 1

There are a number of dents in the slide surface - Monitor for any further deterioration and repair as required

| <b>Finding 21</b><br>There is some strimmer / machinery damage apparent on the posts, this can penetrate the preservative applied to the timber and accelerate the rotting process - Monitor for any deterioration (rot) and replace as required | |

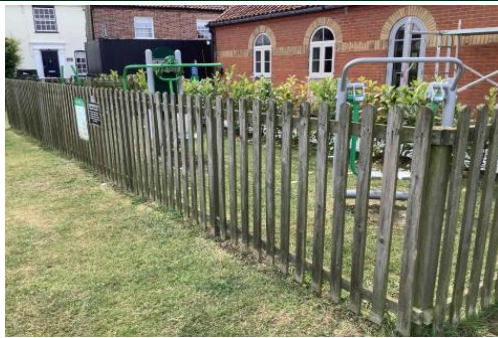
| <b>Finding 1</b><br>The timber has a number of splits/shakes or air cracks and this may affect the stability or allow water ingress which will accelerate the rotting process. Timber splits may also create rough / splintering edges. - Monitor, sand down any rough edges and ensure the splits do not cross through fixing points of the structure and/or cause any instability | <b>Finding 2</b><br>There are a number of loose posts around the fence - Monitor for any further deterioration and reset as required |

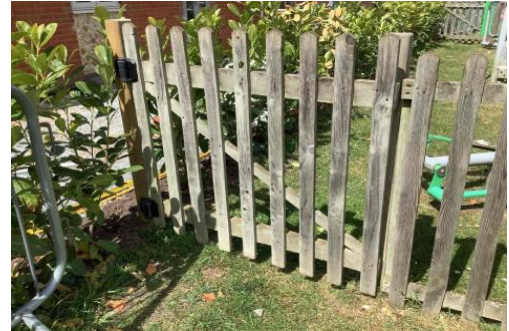
**Item:** Gate - Self Closing  
**Manufacturer:** Not Identified  
**Surface Type:** Grass  
**Item Quantity:** 1

The gate is snagging on the surrounding surface preventing it from opening fully - Carry out remedial works to ensure the gate operates correctly

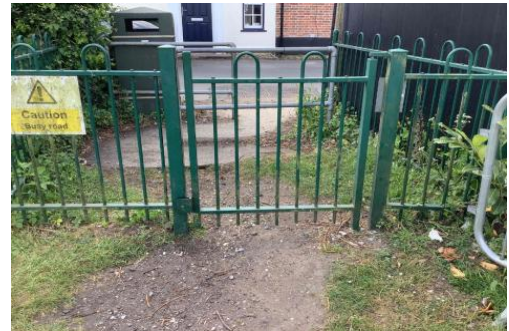
**Item:** Gate - Pedestrian  
**Manufacturer:** Not Identified  
**Surface Type:** Grass  
**Item Quantity:** 1

The surface has eroded in some areas and may be slippery in wet conditions - Reinststate the surface

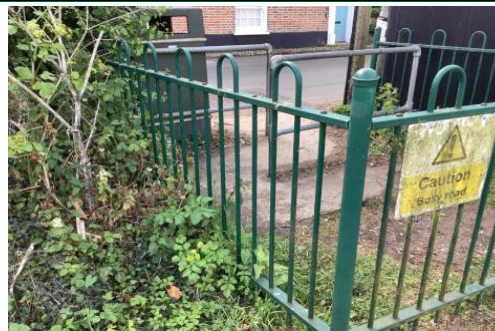
**Item:** Fence - Bow Top  
**Manufacturer:** Not Identified  
**Surface Type:** Grass  
**Item Quantity:** 1

There is algae or moss on the surface of the equipment - Clean and treat appropriately

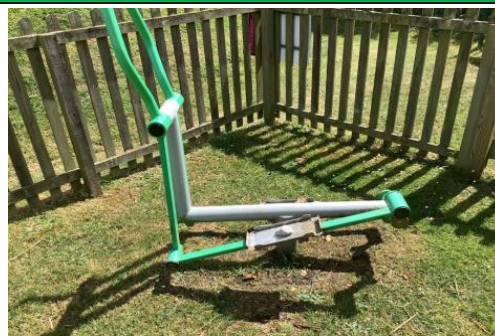
**Item:** Cross Trainer  
**Manufacturer:** Action Play and Leisure  
**Surface Type:** Grass Matrix Tiles  
**Item Quantity:** 1

There is algae or moss on the surface of the equipment - Clean and treat appropriately

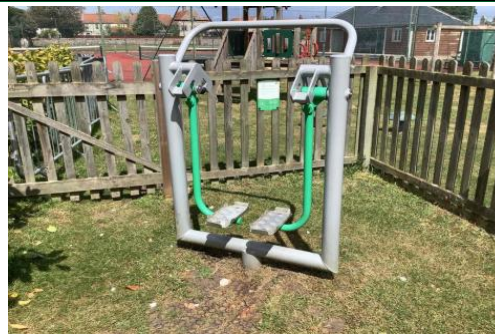
**Item:** Air Walker  
**Manufacturer:** Action Play and Leisure  
**Surface Type:** Grass Matrix Tiles  
**Item Quantity:** 1

There is algae or moss on the surface of the equipment -  
Clean and treat appropriately

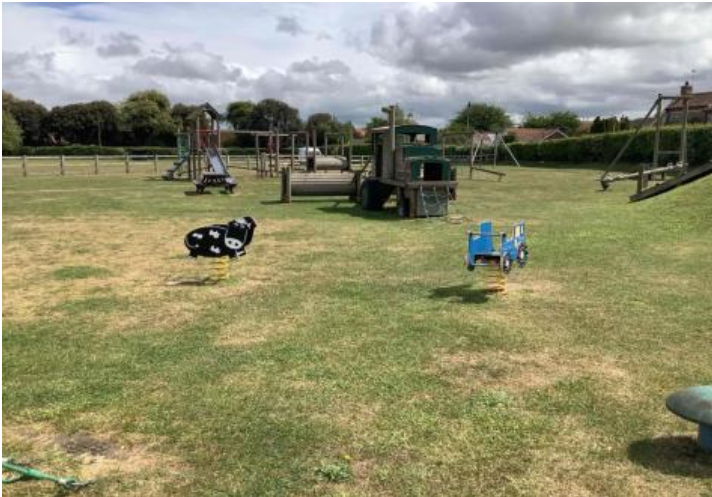
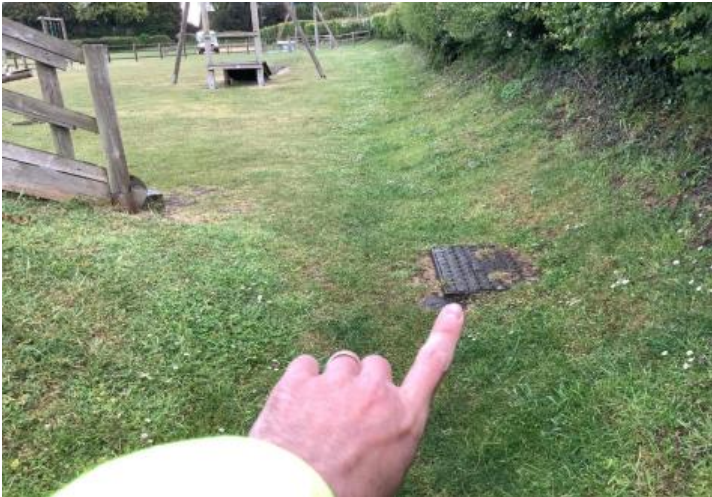
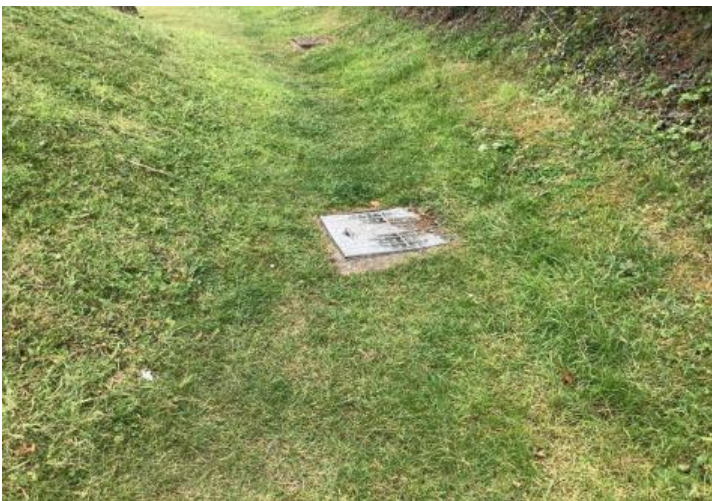
| <b>Item:</b> Ancillary Items - Site General | | <b>Risk Level:</b> L - Low Risk | |

| <b>Finding:</b> There are trip hazards present | | <b>Action:</b> Remove trip hazard | |

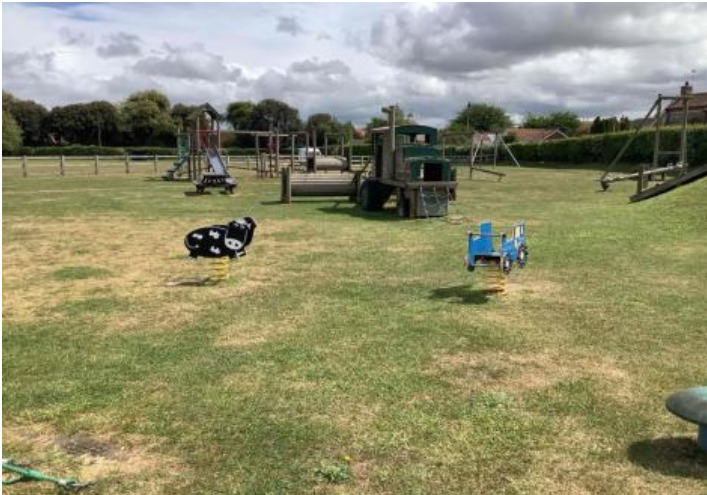
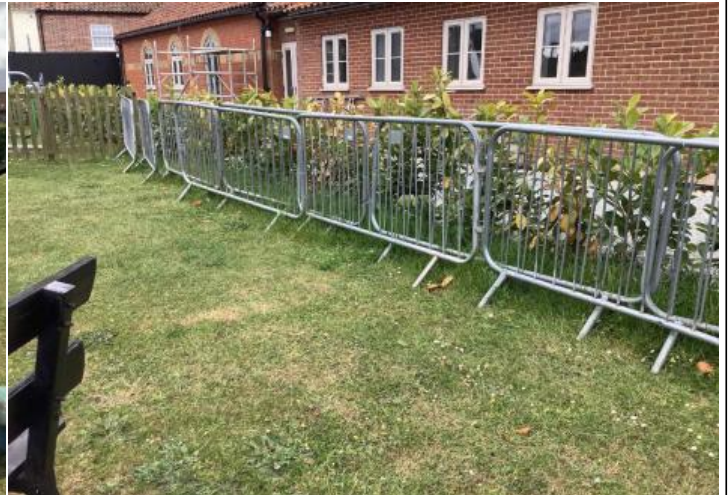
**Item:** Ancillary Items - Site General  
**Manufacturer:** N/A

**Finding:** There is crowd barrier fencing present on site

**Action:** Monitor and remove asap

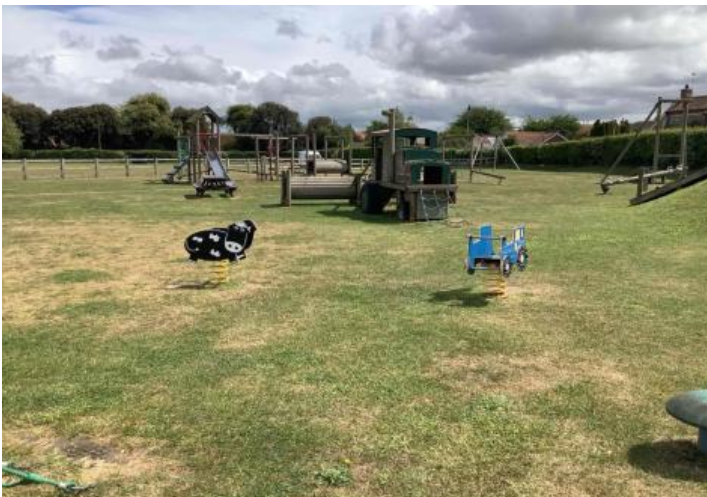
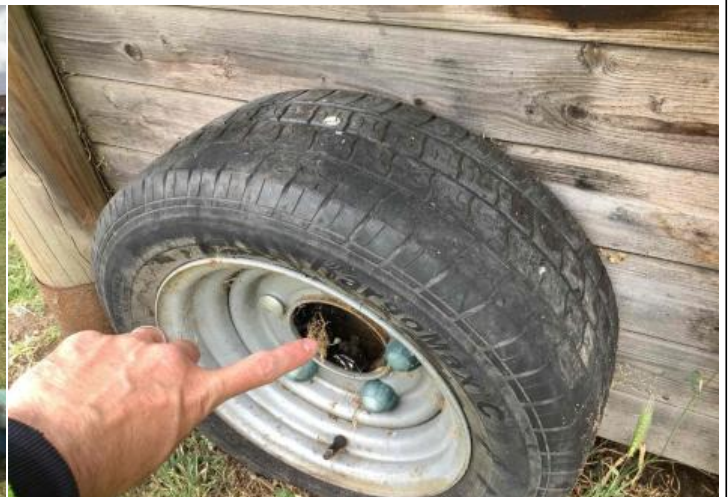
**Finding:** There is litter/debris in the area

**Action:** Remove litter/debris from the area and maintain

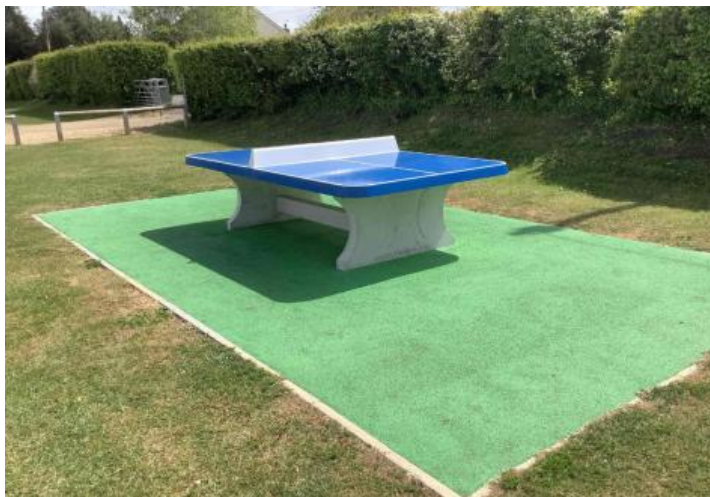
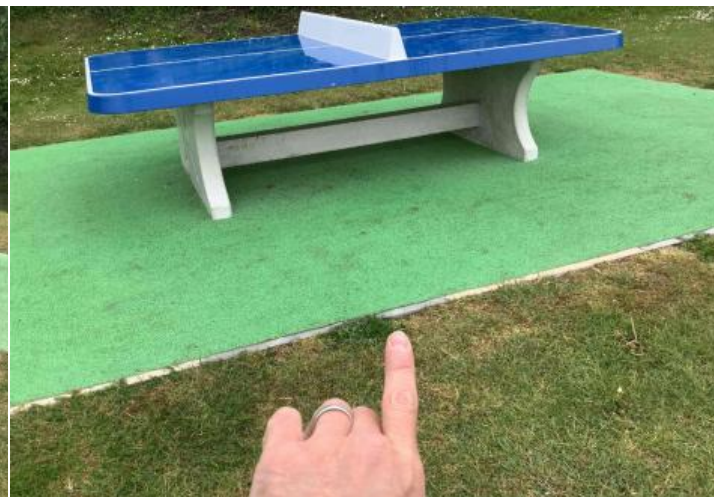
**Finding:** There are trip hazards at the edges of the surface **Action:** Remove trip hazard

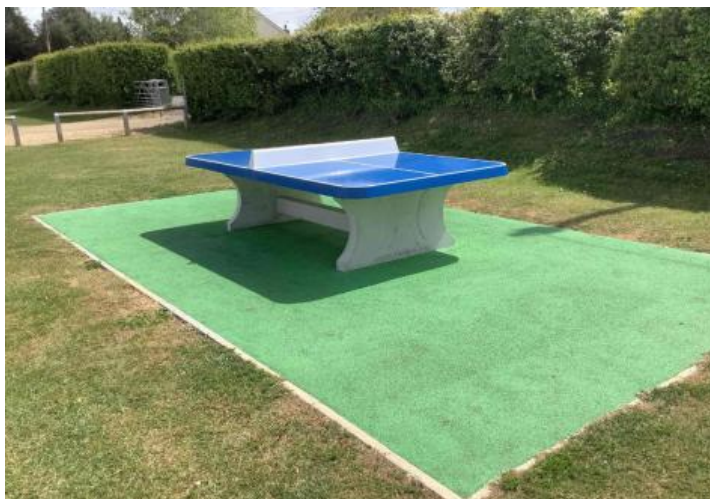
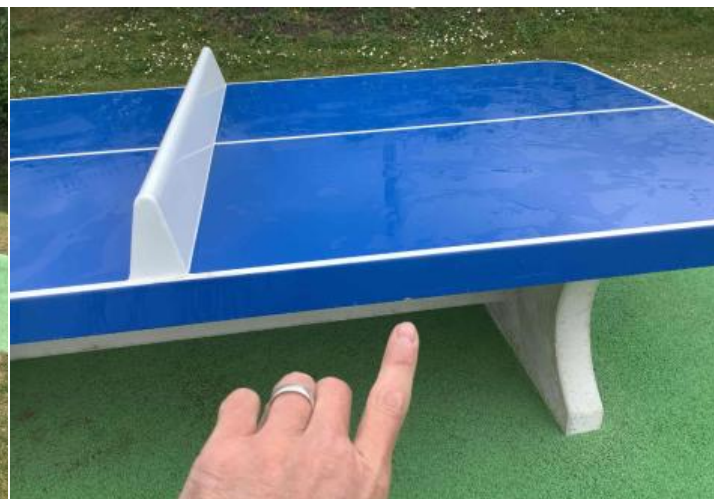
**Finding:** The item has been damaged **Action:** Monitor for any further deterioration and replace as required

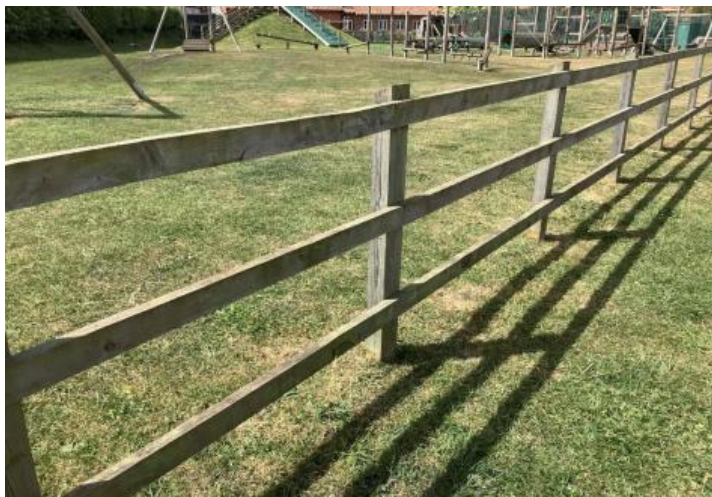
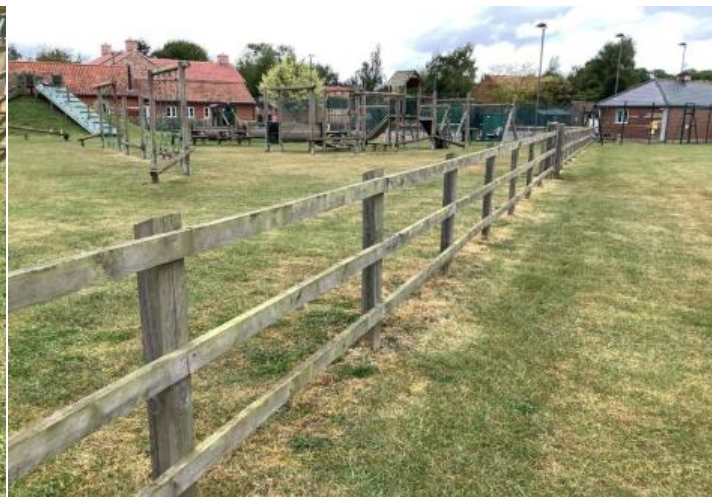
**Finding:** There are a number of loose posts around the fence

**Action:** Monitor for any further deterioration and reset as required

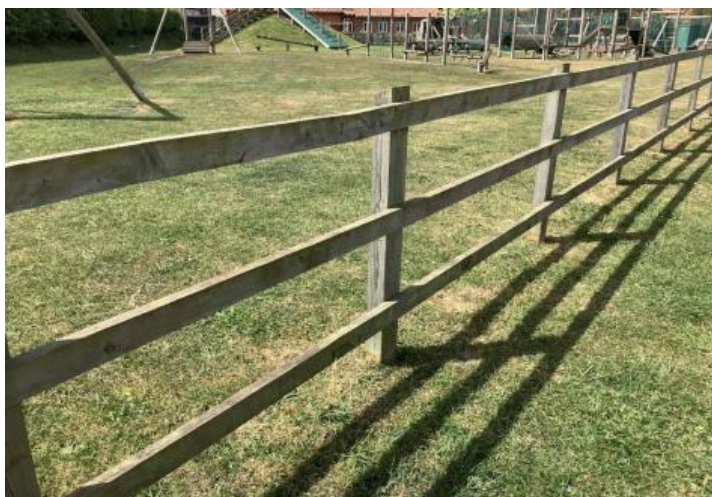
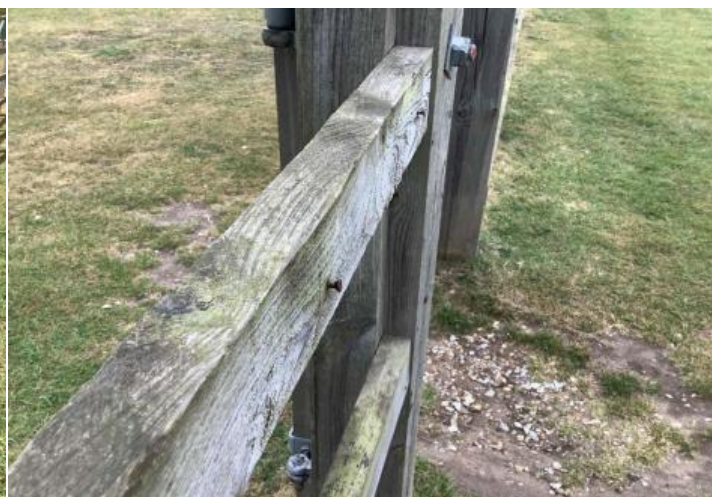
**Finding:** There are projecting nail ends present

**Action:** Remove and provide more appropriate fixings if required

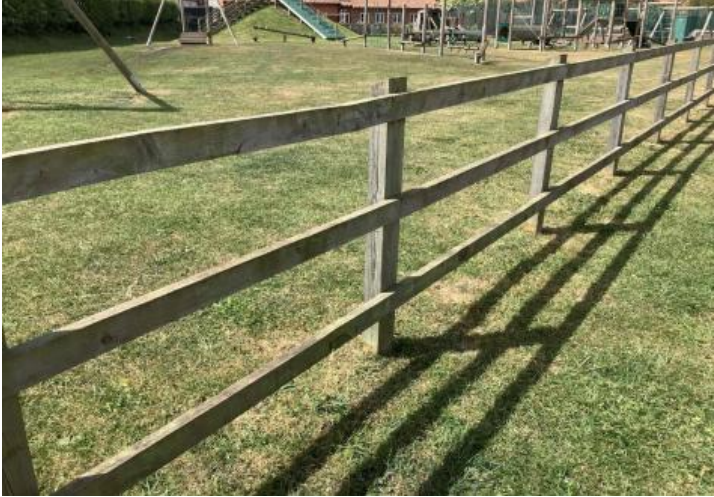
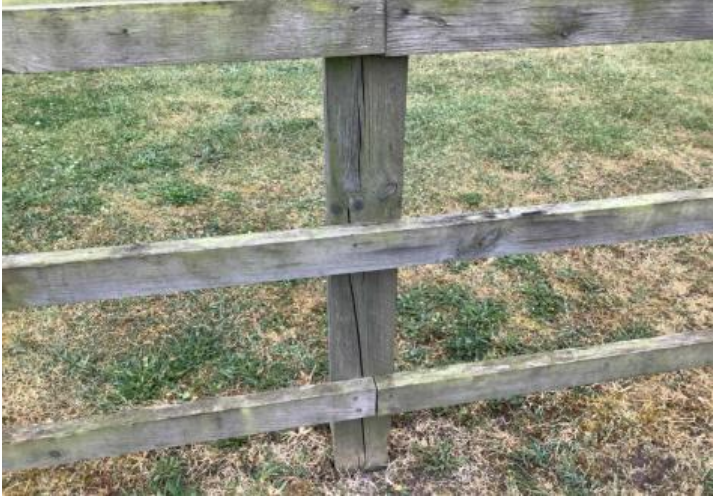
| <b>Finding:</b> The timber has a number of splits/shakes or air cracks and this may affect the stability or allow water ingress which will accelerate the rotting process. Timber splits may also create rough / splintering edges. | | <b>Action:</b> Monitor, sand down any rough edges and ensure the splits do not cross through fixing points of the structure and/or cause any instability | |

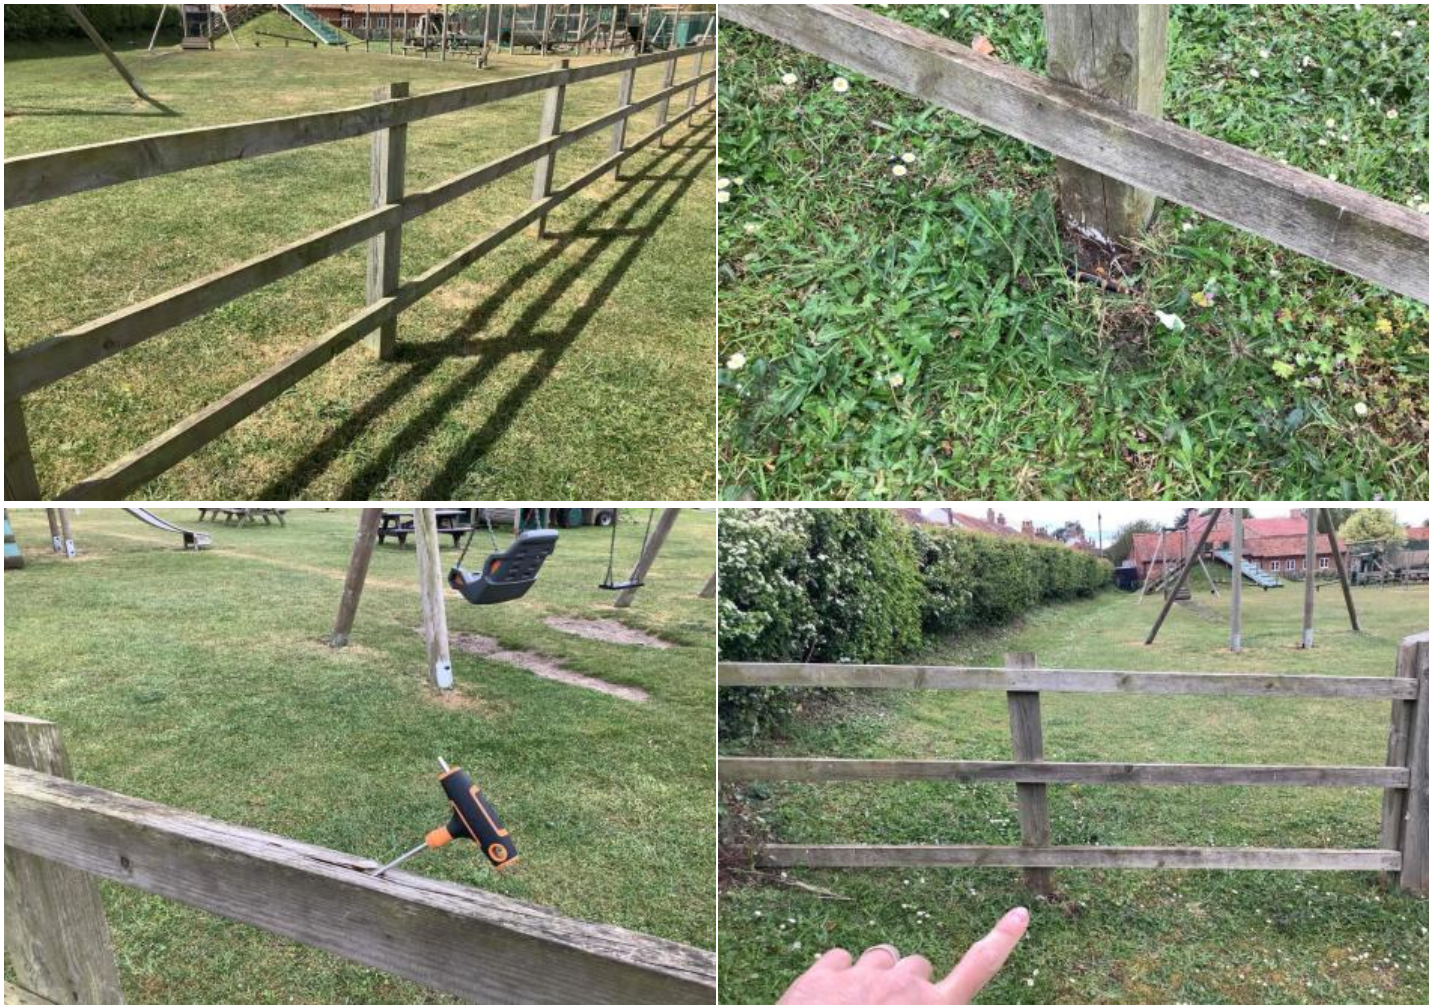
**Finding:** There is some evidence of rot in the timber

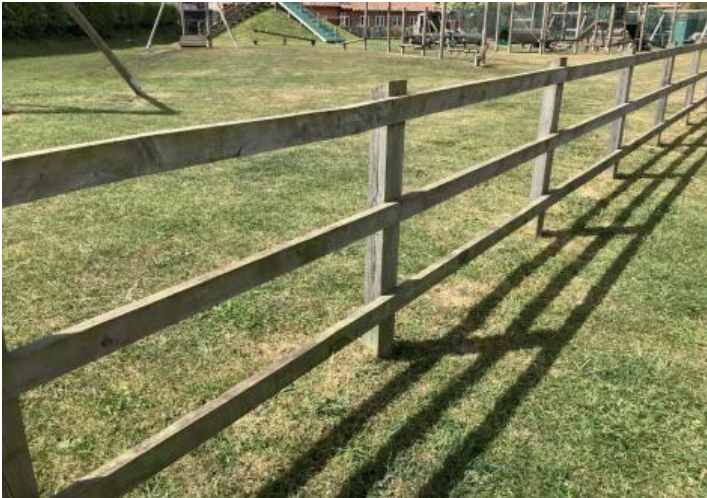
**Finding:** There is some strimmer / machinery damage apparent on the posts, this can penetrate the preservative applied to the timber and accelerate the rotting process

**Action:** Monitor for any deterioration (rot) and replace as required

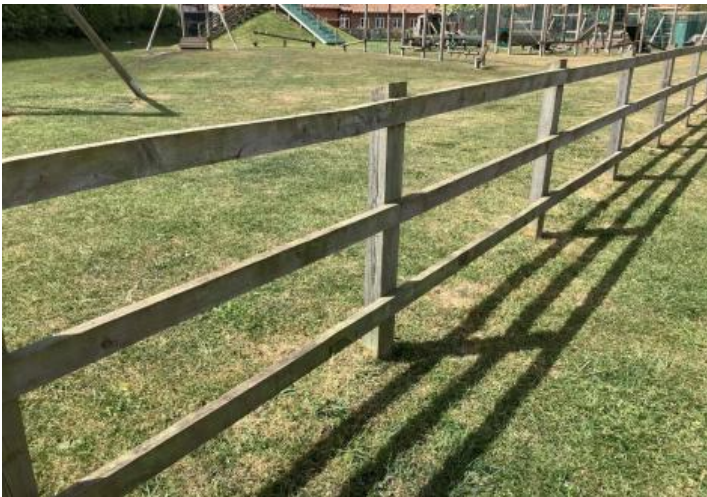
**Finding:** The item has been damaged

**Action:** Monitor for any further deterioration and replace as required

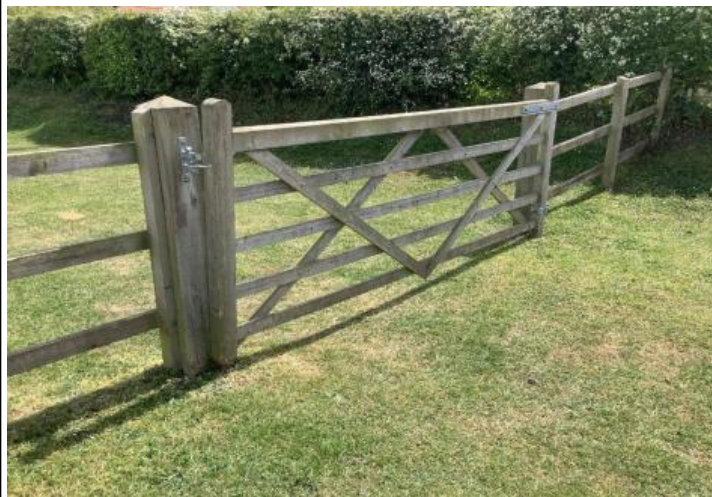
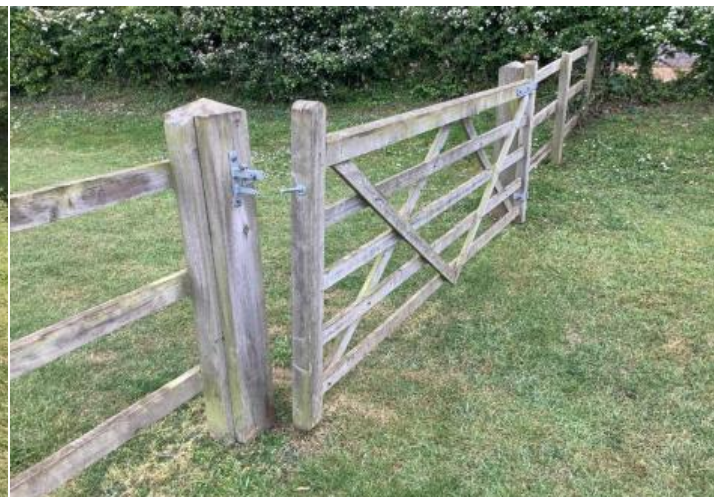
**Finding:** There is no padlock on the maintenance gate

**Action:** Provide a padlock to secure the gate

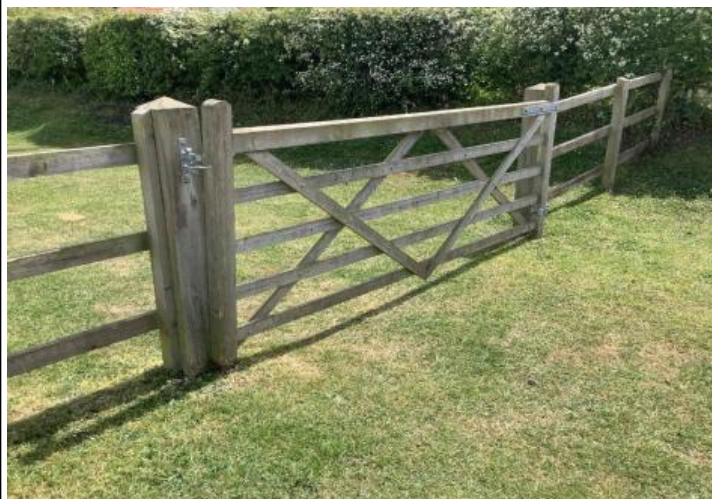
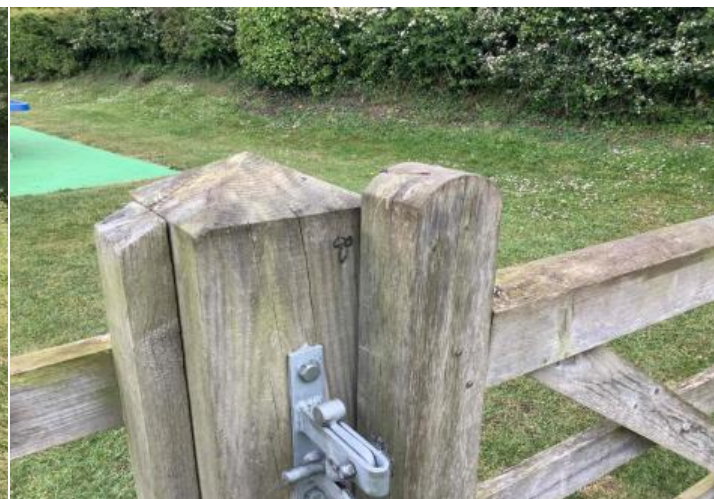
**Finding:** There is offensive graffiti present

**Action:** Remove as soon as practicable
