## BURNHAM MARKET PARISH COUNCIL ANNUAL GENERAL MEETING Minutes

Date: Wednesday 6<sup>th</sup> May 2026 at 6.30pm |

## Burnham Market Play Area

# Safety Inspection Report

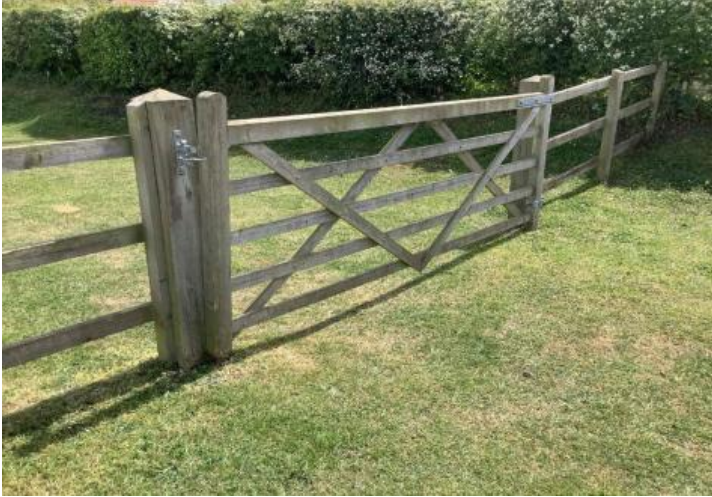
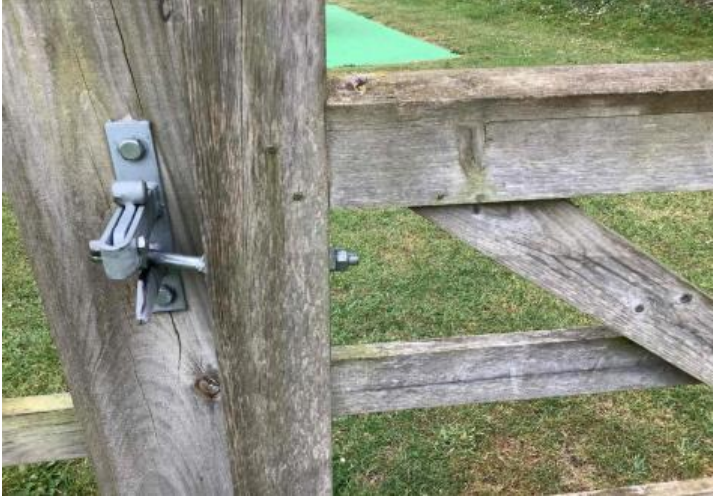
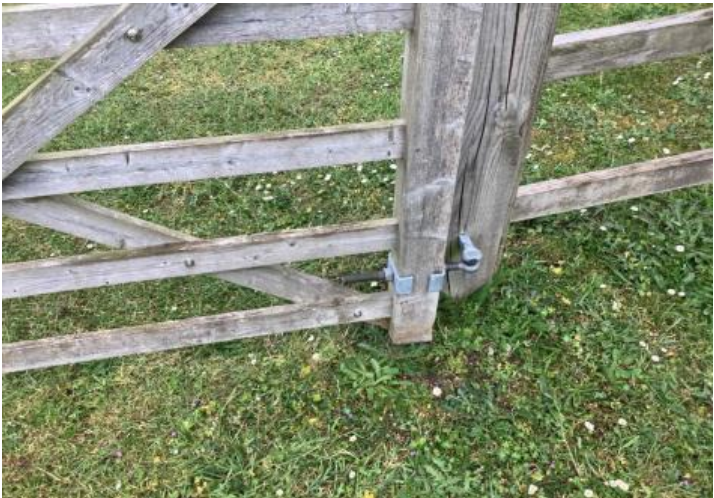
| <b>Finding:</b> There are projecting bolt thread(s) present | | <b>Action:</b> Remove excess thread length and deburr or provide cap | |

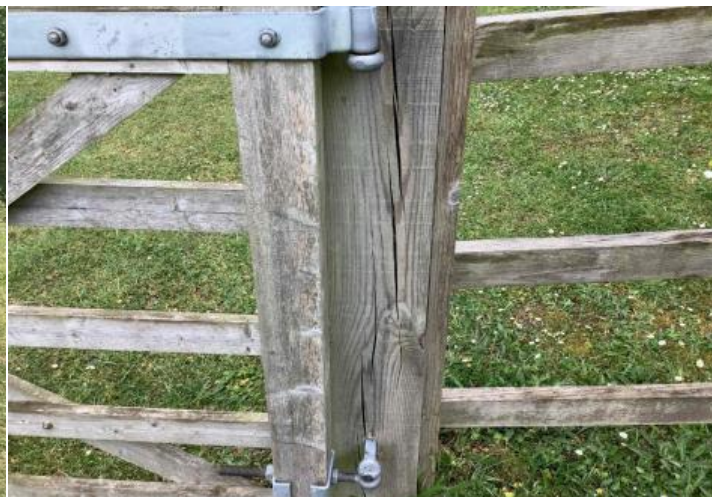
**Finding:** The timber has a number of splits/shakes or air cracks and this may affect the stability or allow water ingress which will accelerate the rotting process. Timber splits may also create rough / splintering edges.

**Action:** Monitor, sand down any rough edges and ensure the splits do not cross through fixing points of the structure and/or cause any instability

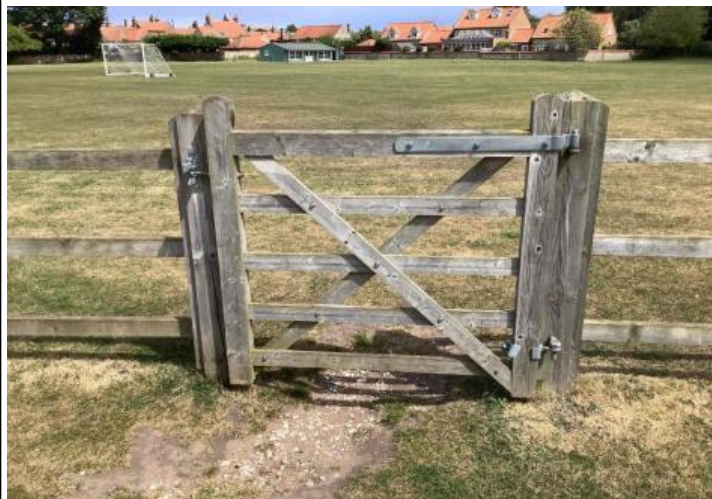
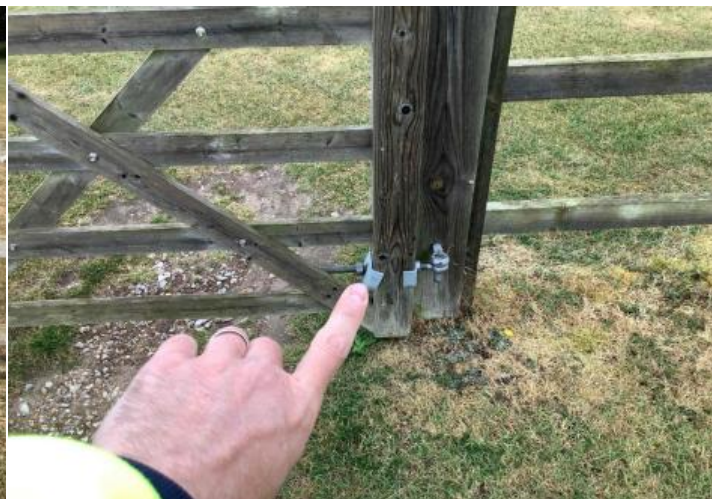
**Finding:** A number of fixing(s) have worked loose

**Action:** Secure all loose fixings

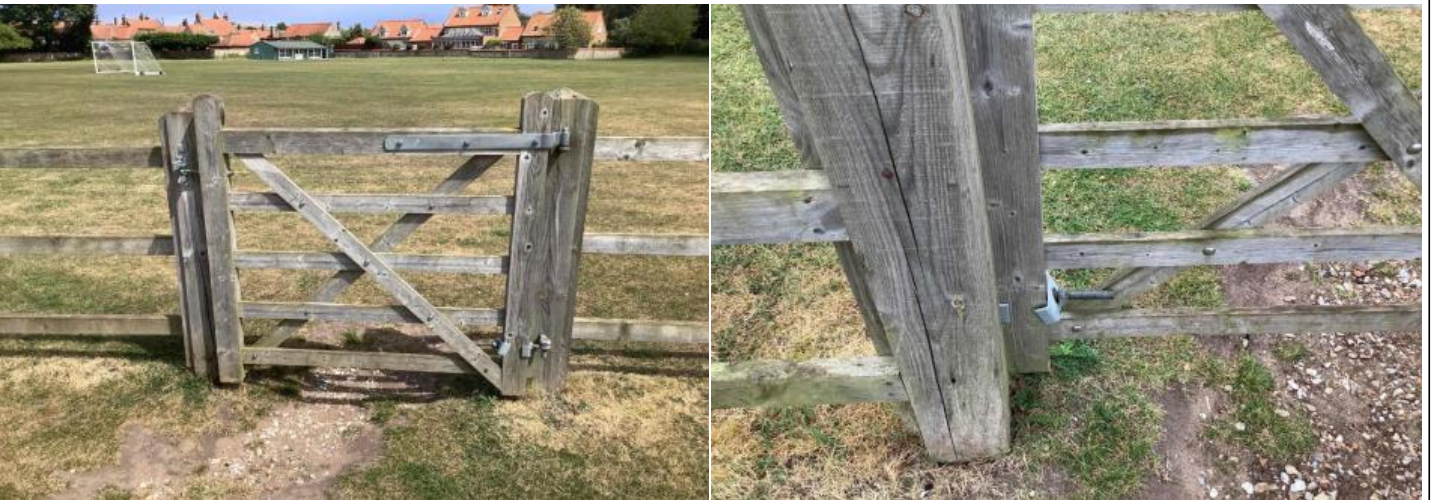
| <b>Finding:</b> There are projecting bolt thread(s) present | <b>Action:</b> Remove excess thread length and deburr or provide cap |

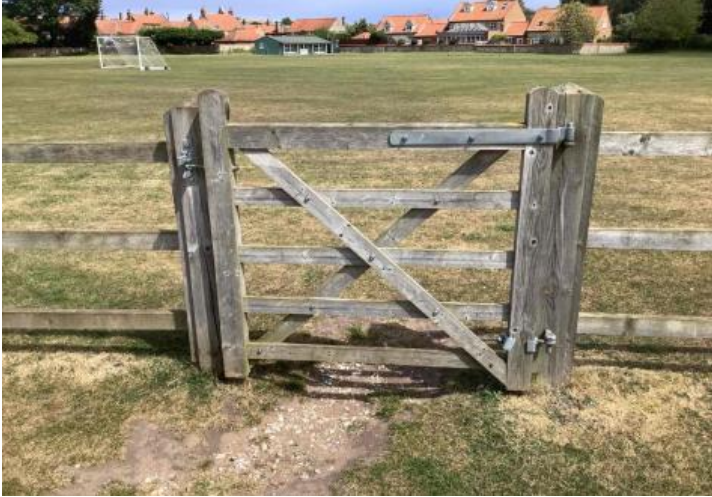
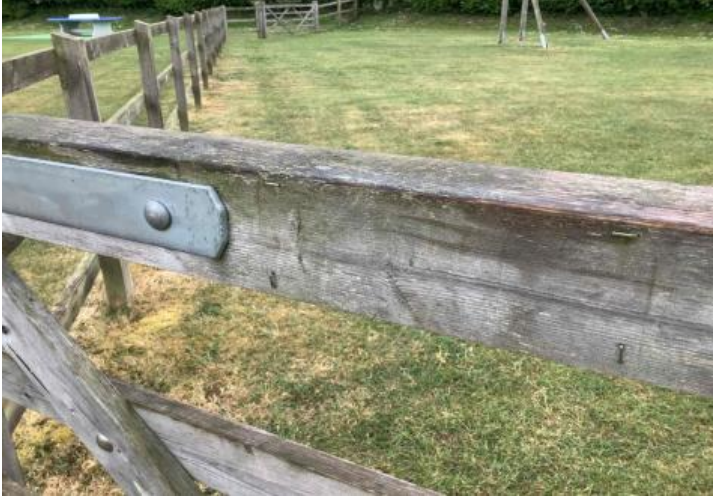
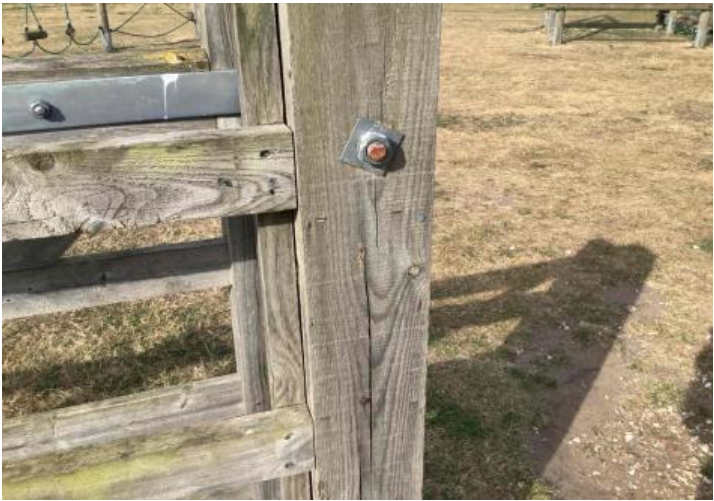
Finding: There are sharp protruding staples on the item

Action: Remove staples

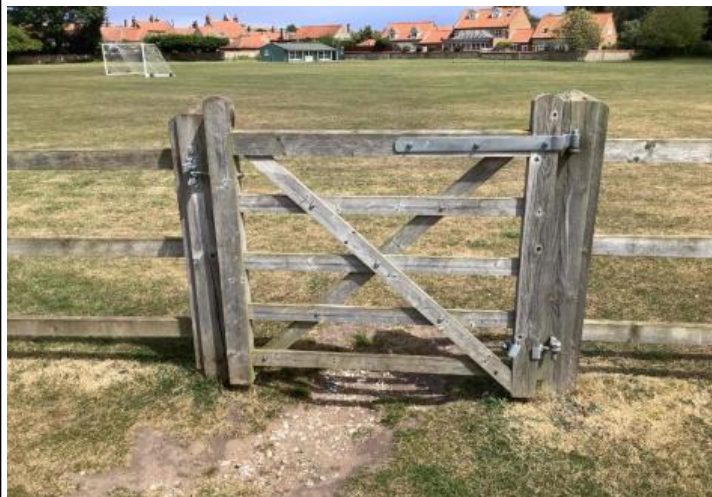
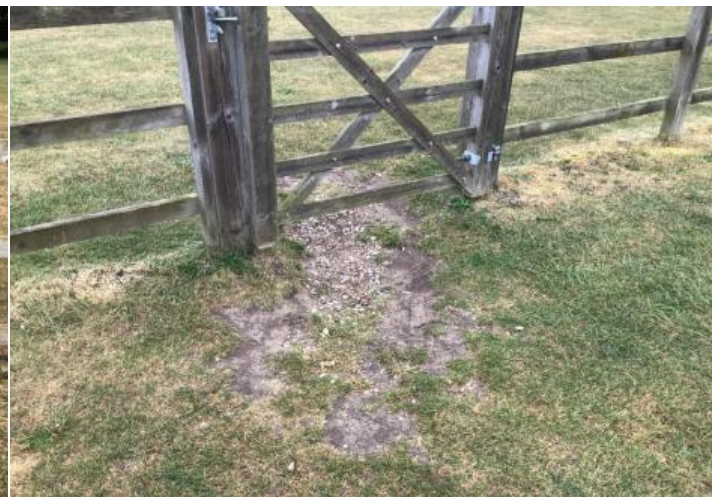
**Finding:** The surface has eroded in some areas and may be slippery in wet conditions  
**Action:** Reinstate the surface

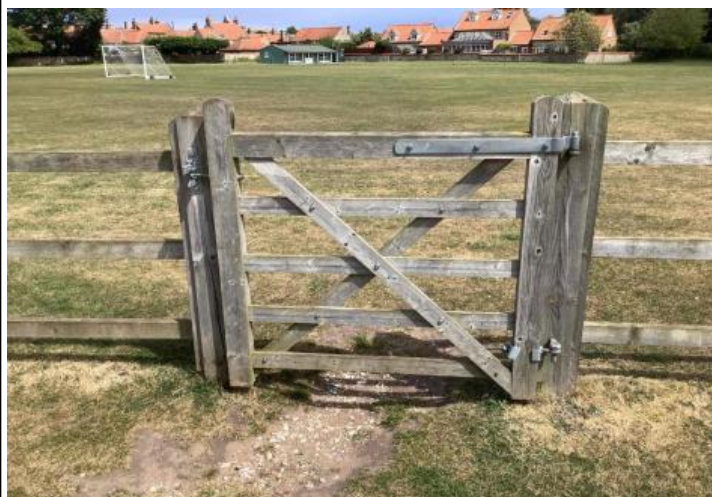
**Finding:** The timber has a number of splits/shakes or air cracks and this may affect the stability or allow water ingress which will accelerate the rotting process. Timber splits may also create rough / splintering edges.  
**Action:** Monitor, sand down any rough edges and ensure the splits do not cross through fixing points of the structure and/or cause any instability

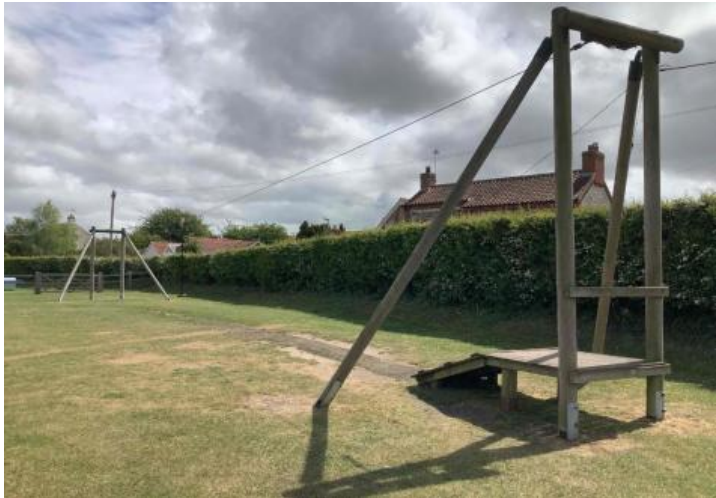
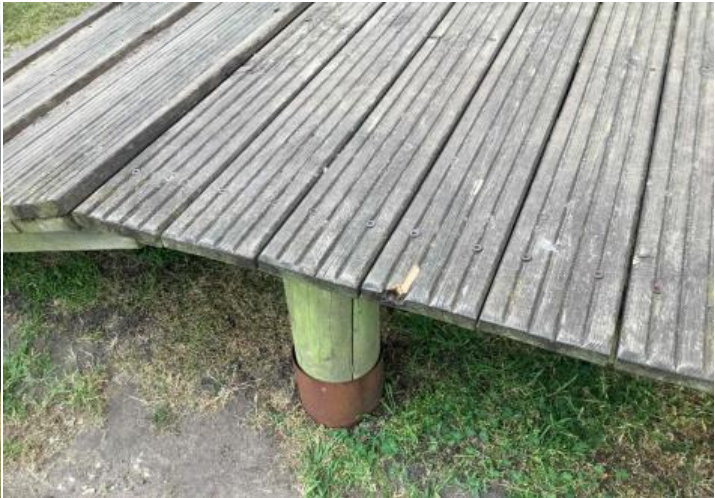
| <b>Finding:</b> The item has been damaged | | <b>Action:</b> Monitor for any further deterioration and replace as required | |

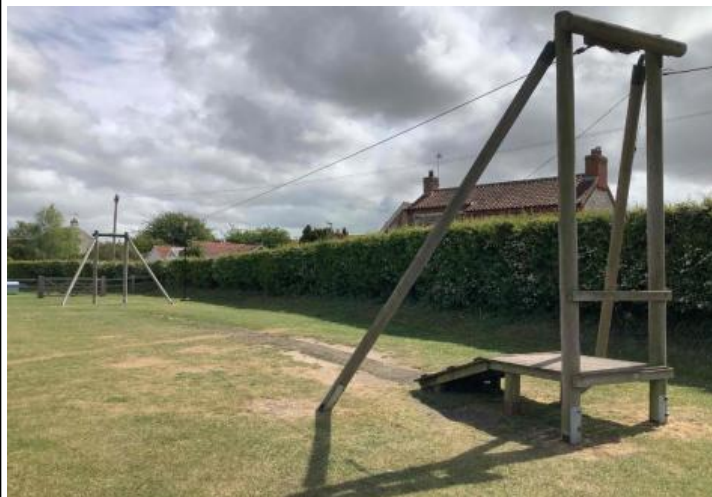
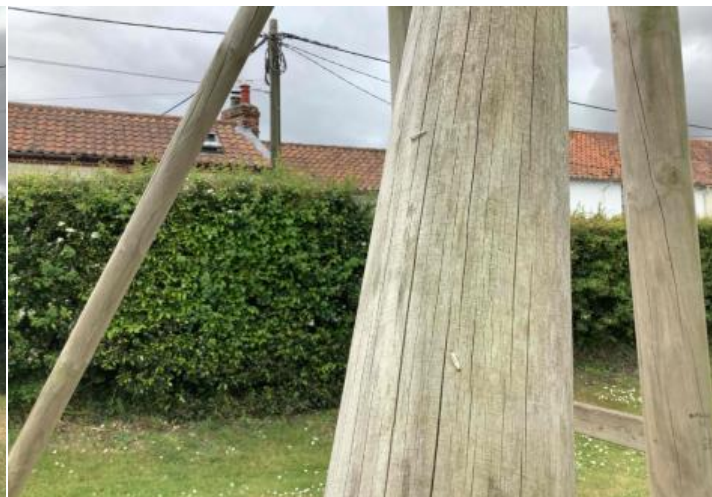
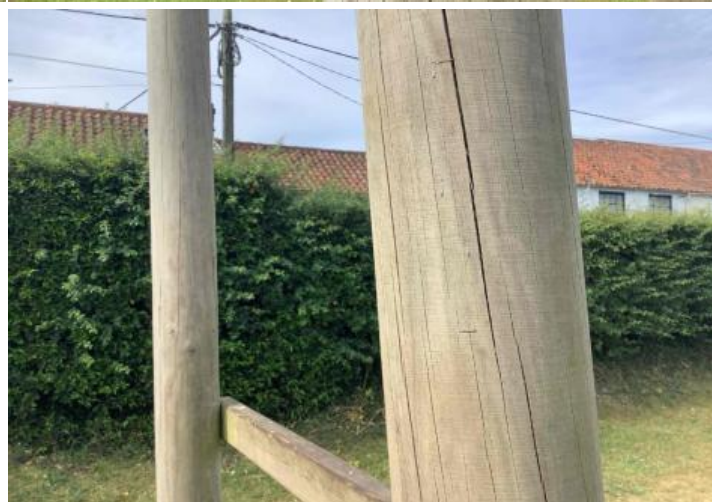
**Finding:** There are sharp protruding staples on the item

**Action:** Remove staples

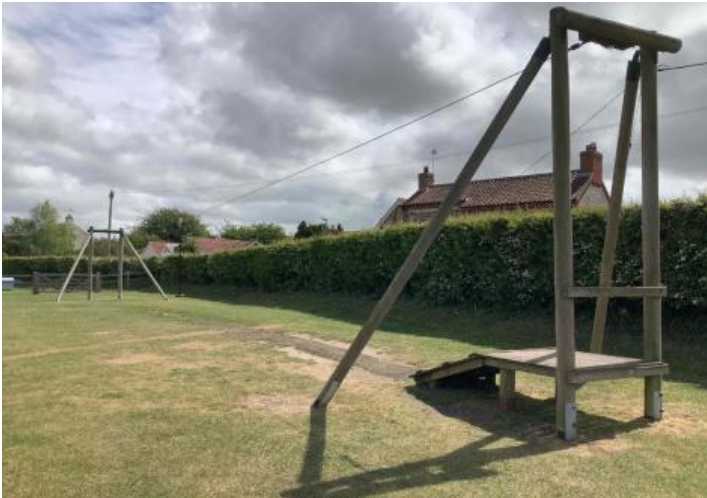
**Finding:** There are gaps opening between the surfacing and the edging surround or between the joints in the surfacing **Action:** Monitor for any further deterioration and repair as required

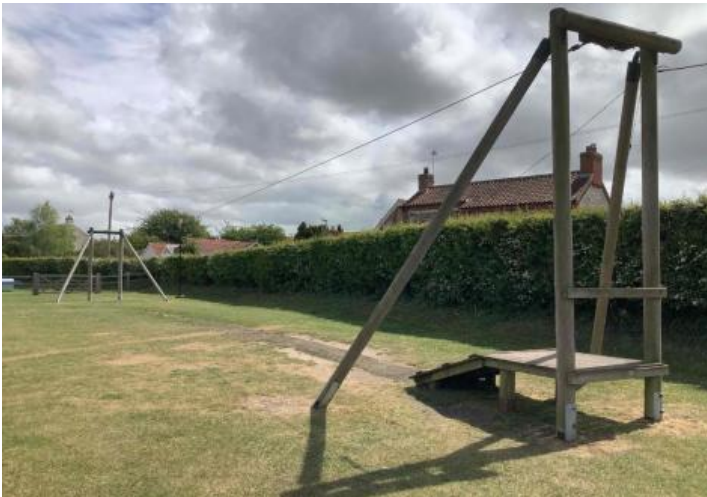
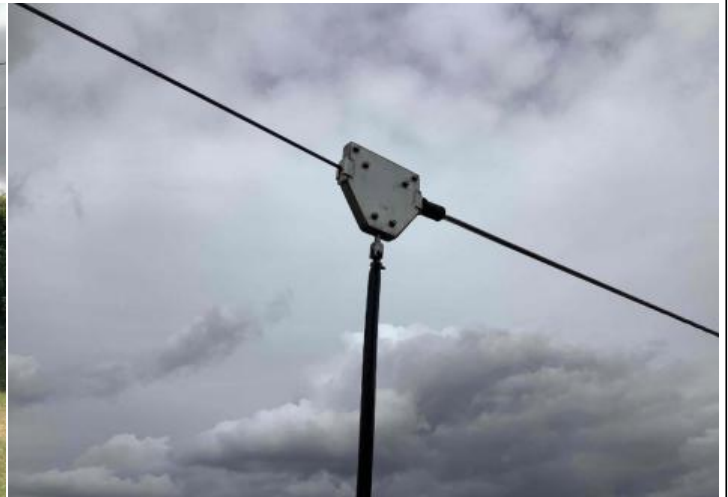
**Finding:** There is some notable evidence of chain wear **Action:** Monitor for any further deterioration and replace when 40% worn

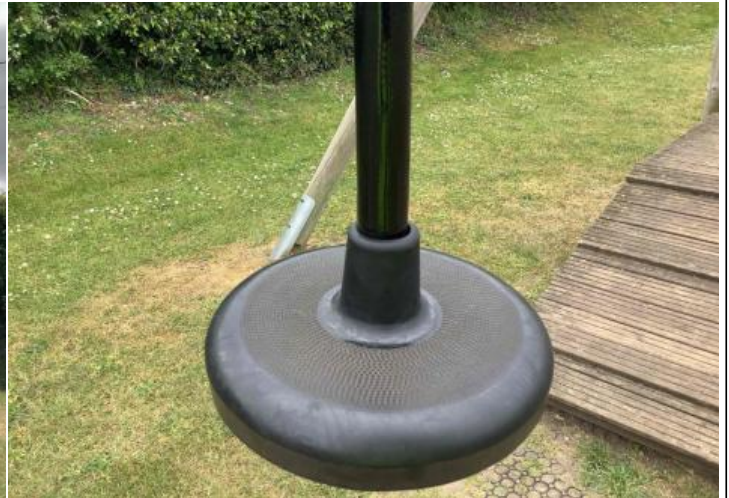
**Finding:** The seat connection cannot be inspected without dismantling the seat

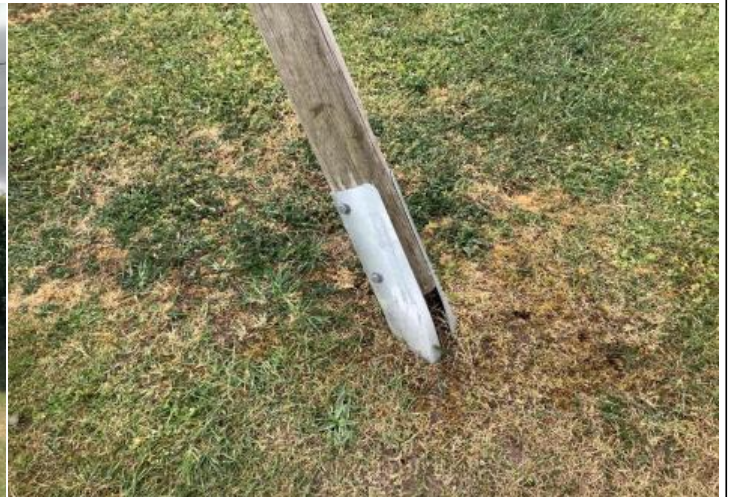
**Finding:** Bolt cap cover/s missing or damaged

**Action:** Replace

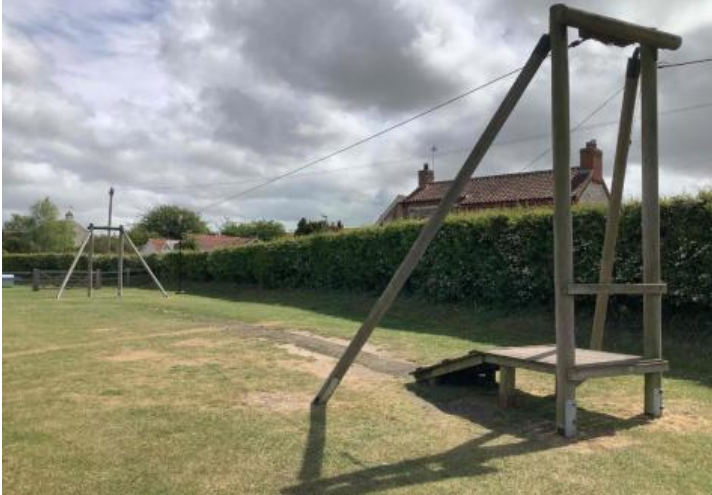
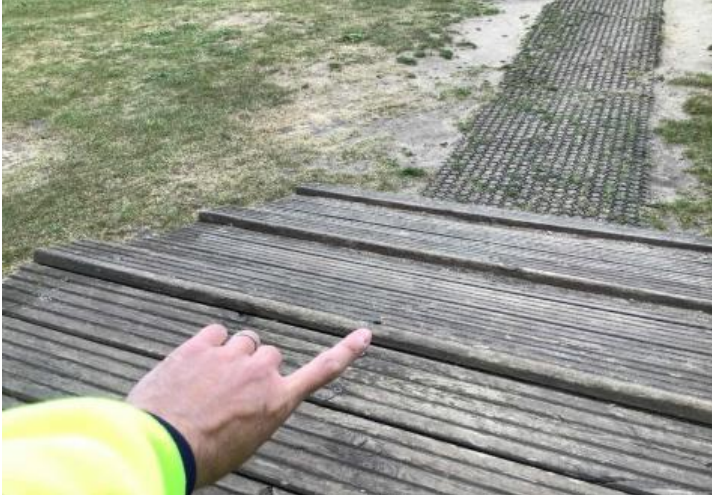
| Item: | Other - Cable Runway | Risk Level: | L - Low Risk |

| Finding: There are projecting fixings present | | Action: Tighten / replace as required | |

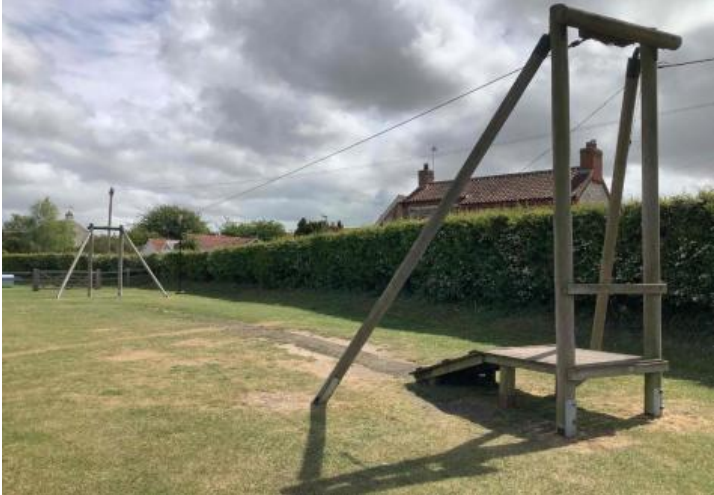
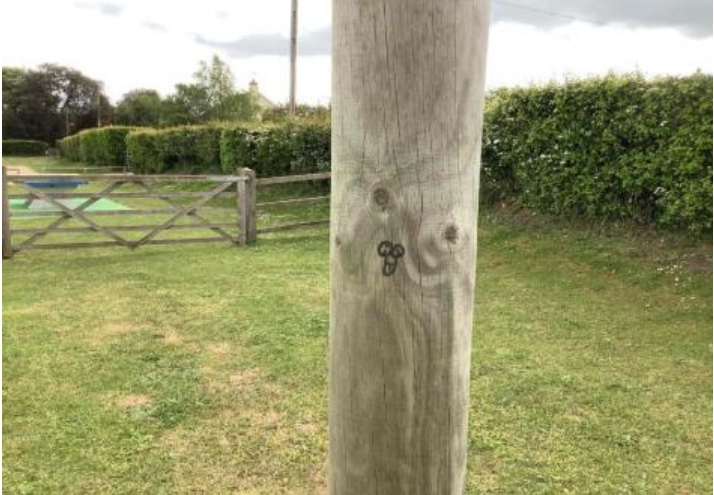
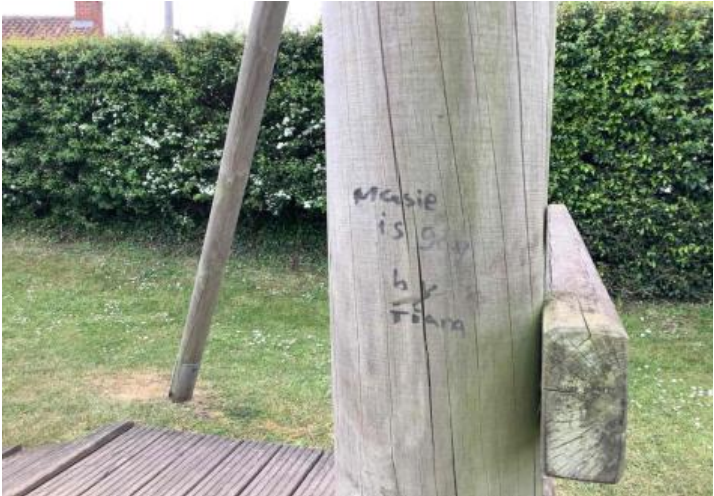
| <div> <div> <div></div> <div>0 - Risk Assessment not Undertaken (Finding 8)</div> </div> </div> | | | |

| <div> <div> <div></div> <div>0 - Risk Assessment not Undertaken (Finding 8)</div> </div> </div> | | | |
|---|---|---|---|
| <div>Finding: There is offensive graffiti present</div> | | <div>Action: Remove as soon as practicable</div> | |

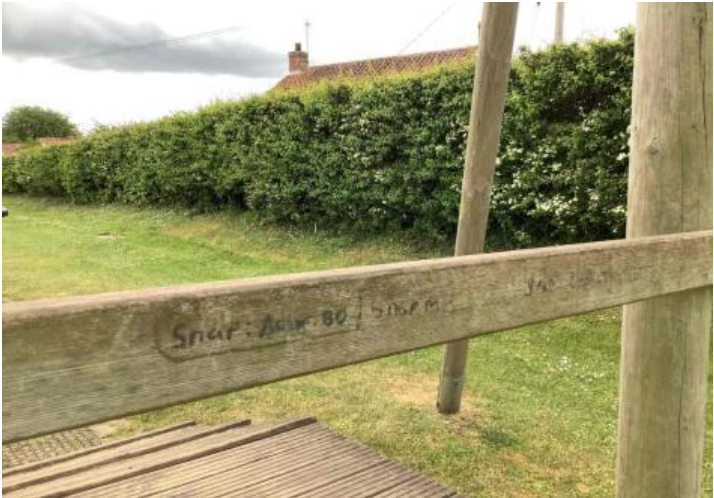
**i** 0 - Risk Assessment not Undertaken (Finding 9)

**Finding:** There is some graffiti present

**Action:** Remove the graffiti

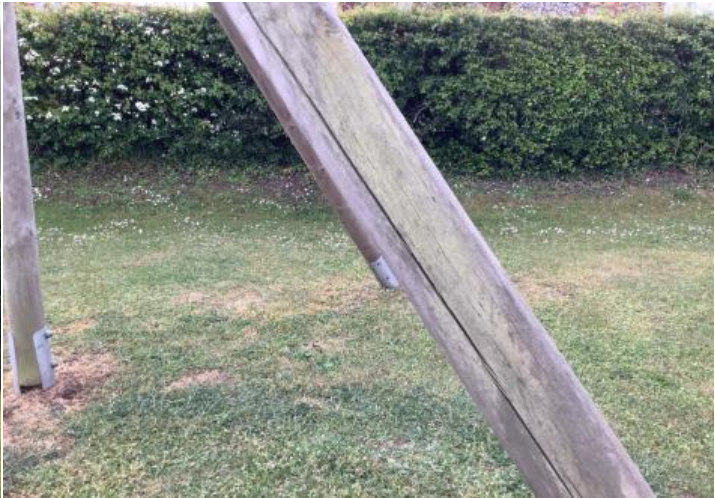
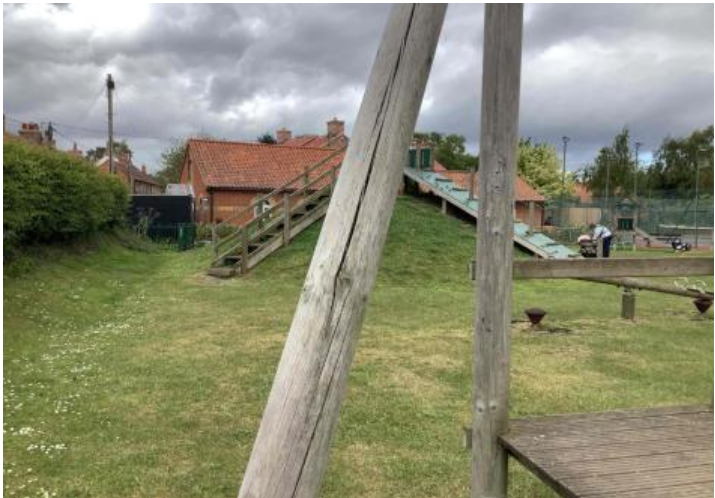
| <div> <div></div> <div>6 - Low Risk (Finding 10)</div> </div> | | | |
|---|--|---|--|
| <div> <b>Finding:</b> The timber has a number of splits/shakes or air cracks and this may affect the stability or allow water ingress which will accelerate the rotting process. Timber splits may also create rough / splintering edges. </div> | | <div> <b>Action:</b> Monitor, sand down any rough edges and ensure the splits do not cross through fixing points of the structure and/or cause any instability </div> | |

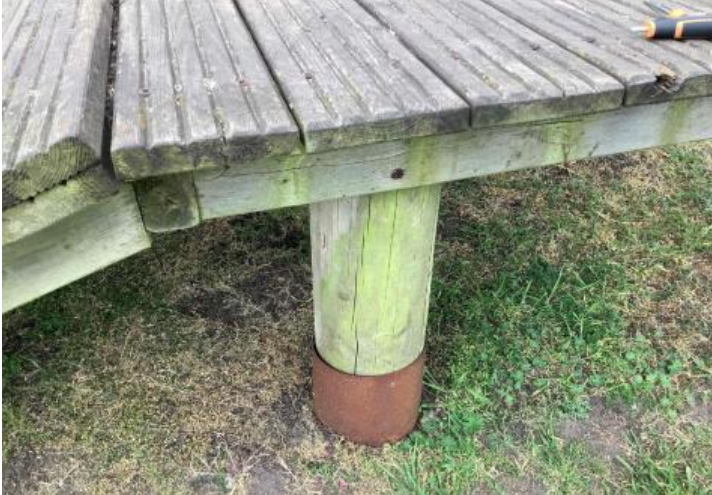
| <div> <div></div> <div>0 - Risk Assessment not Undertaken (Finding 11)</div> </div> | | | |
|---|---|---|---|
| <b>Finding:</b> There are post protectors around the timber posts that are preventing the inspector from thoroughly testing for signs of decay and we are unable to verify the condition of the posts in these locations. NOTE - timber rot / decay is possible even with the post protectors in place | | <b>Action:</b> Refer to manufacturer inspection / maintenance recommendations | |

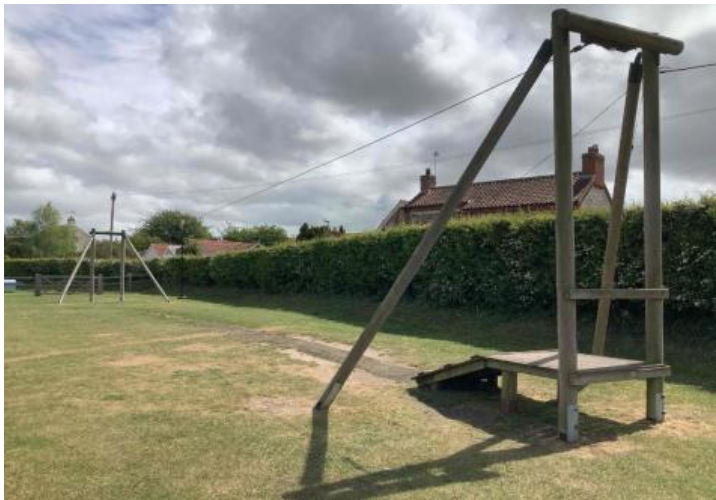
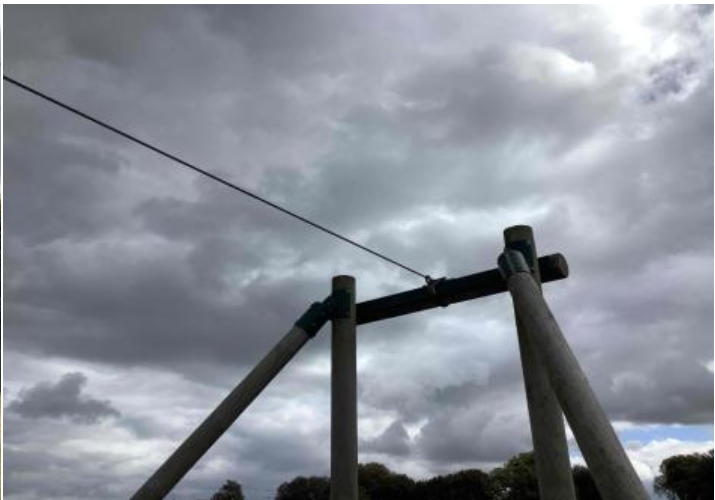
| <div> 0 - Risk Assessment not Undertaken (Finding 12) </div> | | | |
|---|---|---|---|
| <b>Finding:</b> We have completed a visual inspection of the suspension links, cable and fixing points from ground level, however it is not possible to fully inspect these areas without either hiring equipment to gain access or removing the cable and suspension and inspecting at ground level. We recommend that the main cable and fixing security is thoroughly inspected at least in accordance with the manufacturers recommendations to check for wear, damage, security or internal rusting; this will help to ensure the continued safe use of the equipment | | <b>Action:</b> Inspect in accordance with the manufacturers recommendations | |

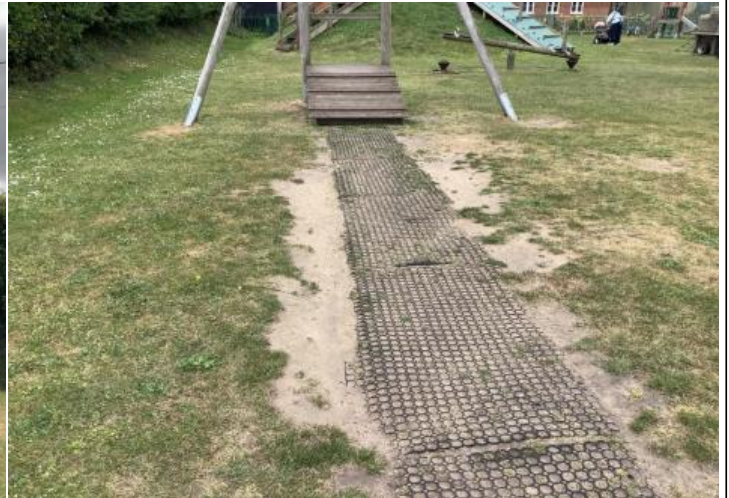
**Finding:** The surface has eroded in some areas and may be slippery in wet conditions  
**Action:** Reinstate the surface

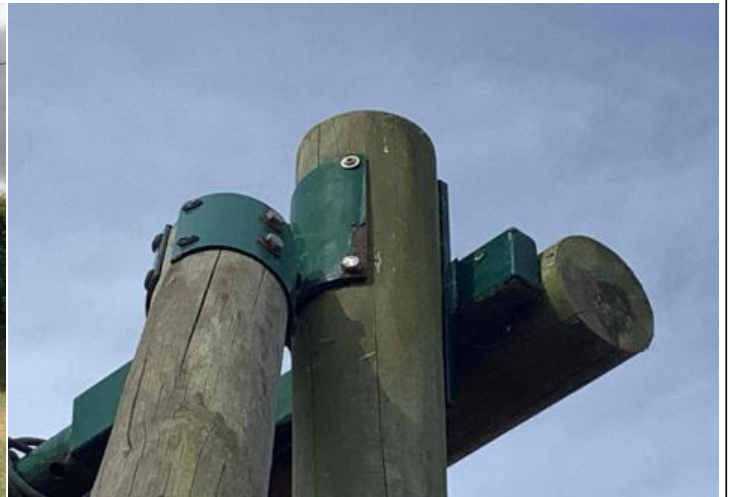
**Finding:** The paintwork on this item has been damaged or worn exposing the metal underneath which is rusting / corroding  
**Action:** Treat affected areas and repaint

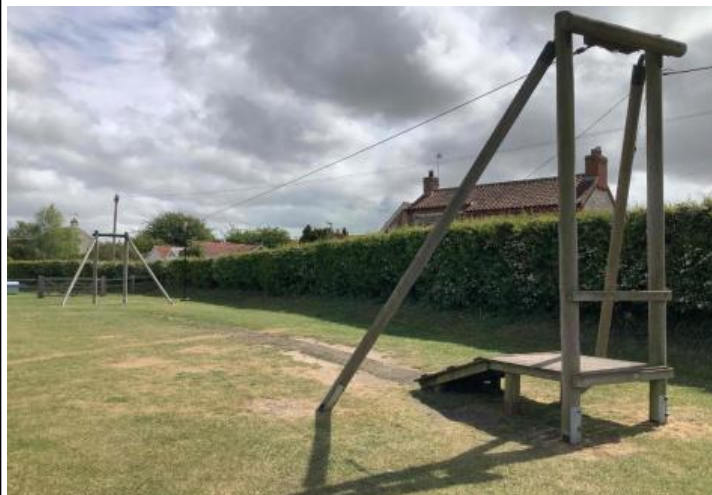
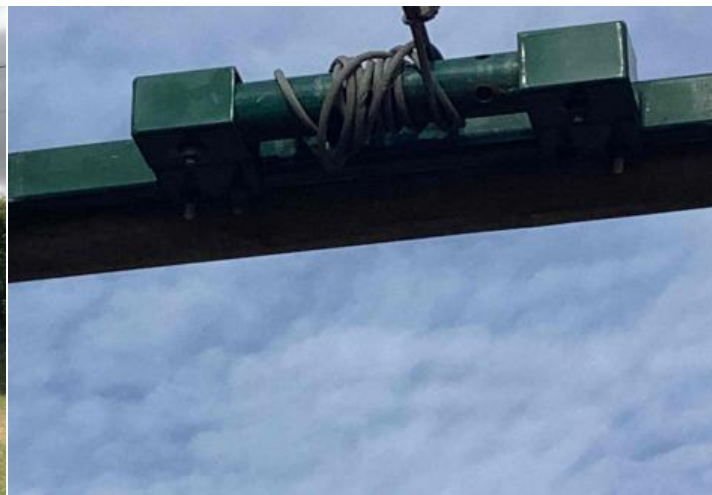
**i** 4 - Very Low Risk (Finding 15)

**Finding:** There are projecting bolt thread(s) present

**Action:** Remove excess thread length and deburr or provide cap

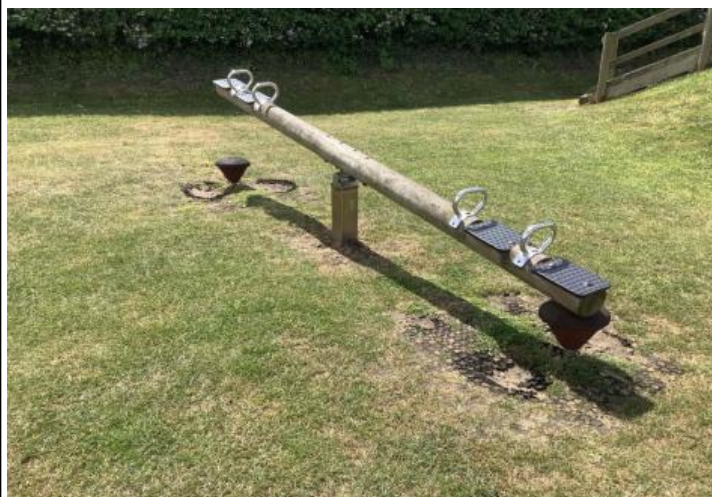
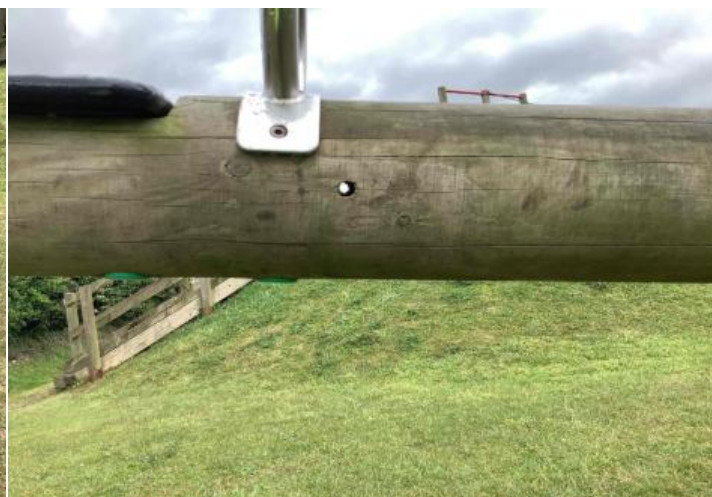
**Item:** Rocking Equipment - See Saw  
**Manufacturer:** Not Identified

**Finding:** There are redundant holes on the item

**Action:** Fill or provide cap / insert

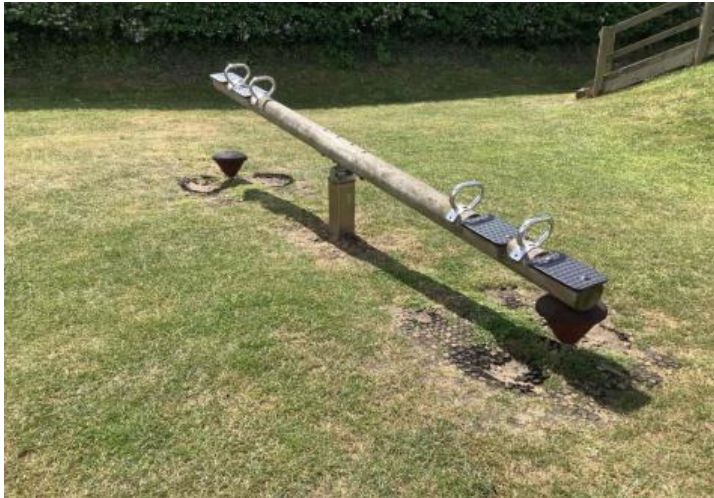
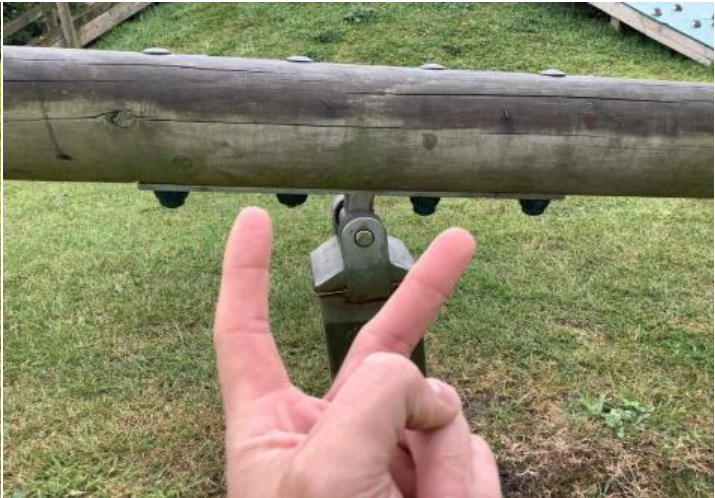
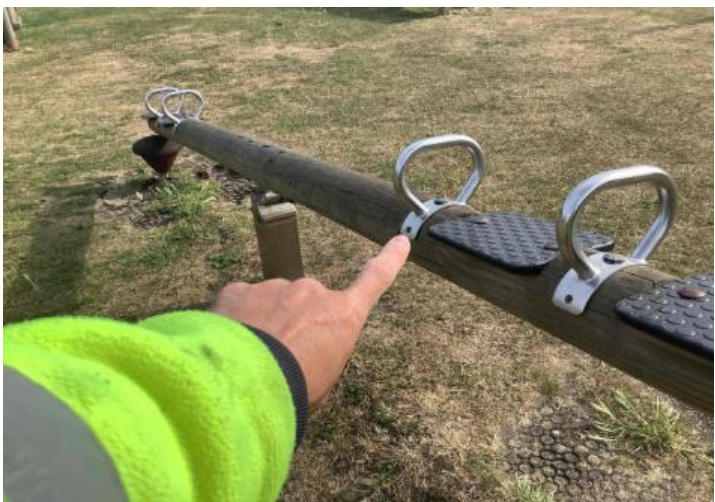
| <b>Item:</b> | Rocking Equipment - See Saw | <b>Risk Level:</b> | L - Low Risk |

**Finding:** A number of fixing(s) have worked loose

**Action:** Secure all loose fixings

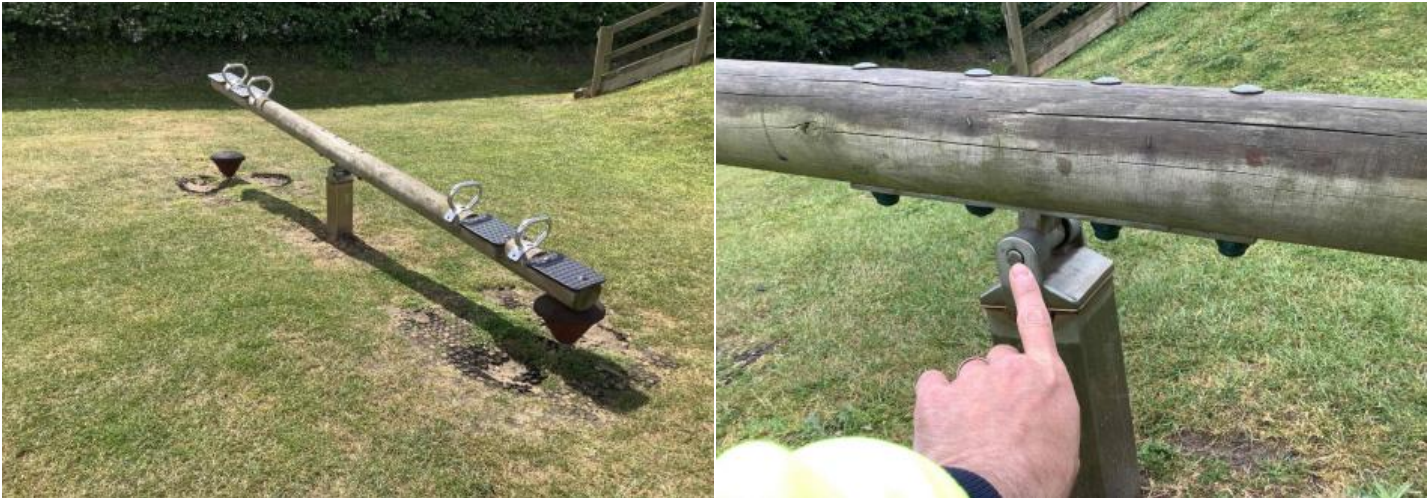
**Finding:** There is wear apparent to the central pivot resulting in excessive sideways movement

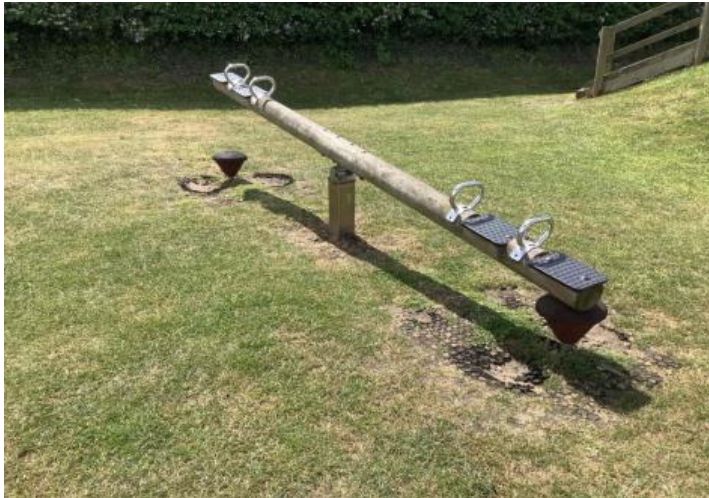
**Item:** Rocking Equipment - See Saw  
**Manufacturer:** Not Identified

**Finding:** Bolt cap cover/s missing or damaged

**Action:** Replace

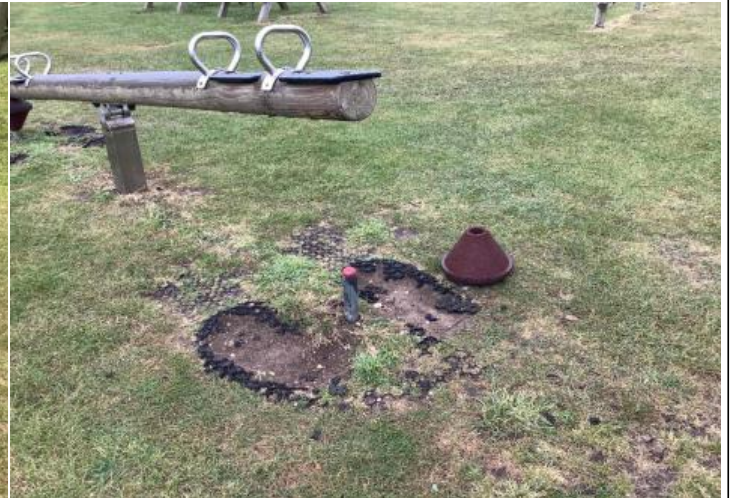
**Finding:** The dampeners are loose and can be lifted from the posts

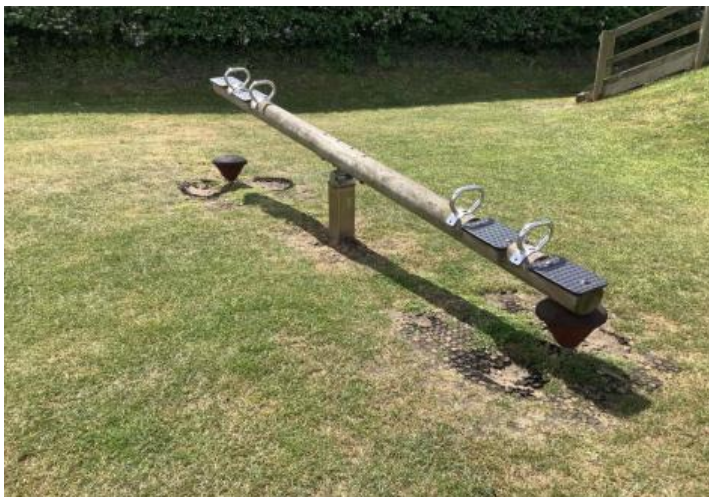
**Item:** Rocking Equipment - See Saw  
**Manufacturer:** Not Identified

**Finding:** The timber has a number of splits/shakes or air cracks and this may affect the stability or allow water ingress which will accelerate the rotting process. Timber splits may also create rough / splintering edges.

**Action:** Monitor, sand down any rough edges and ensure the splits do not cross through fixing points of the structure and/or cause any instability

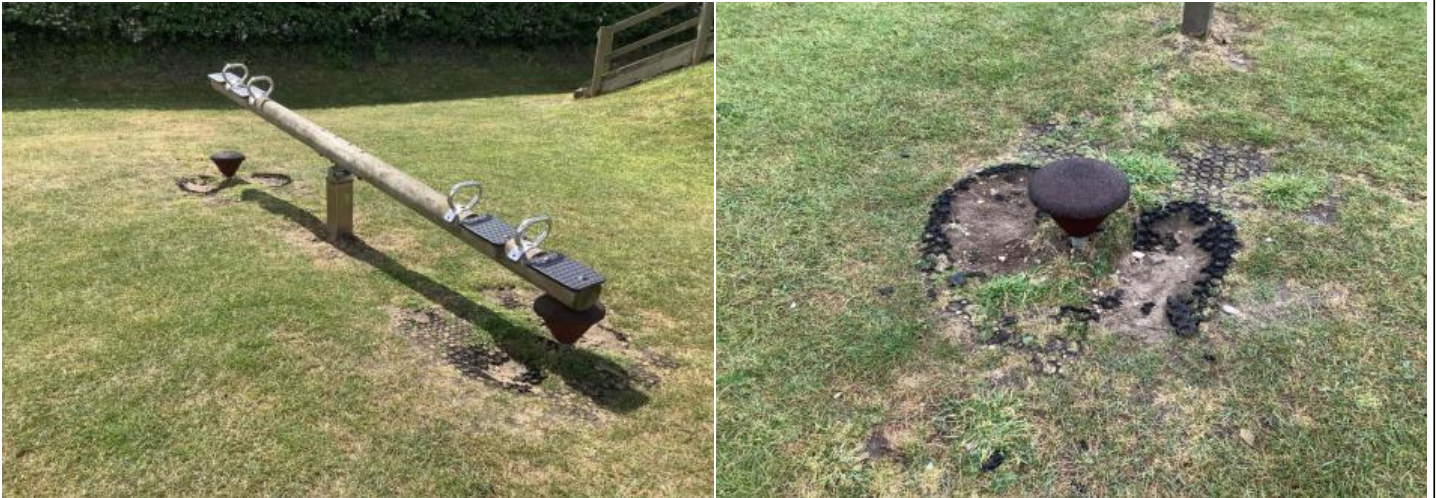
**Finding:** The surface has eroded in some areas and may be slippery in wet conditions  
**Action:** Reinstate the surface

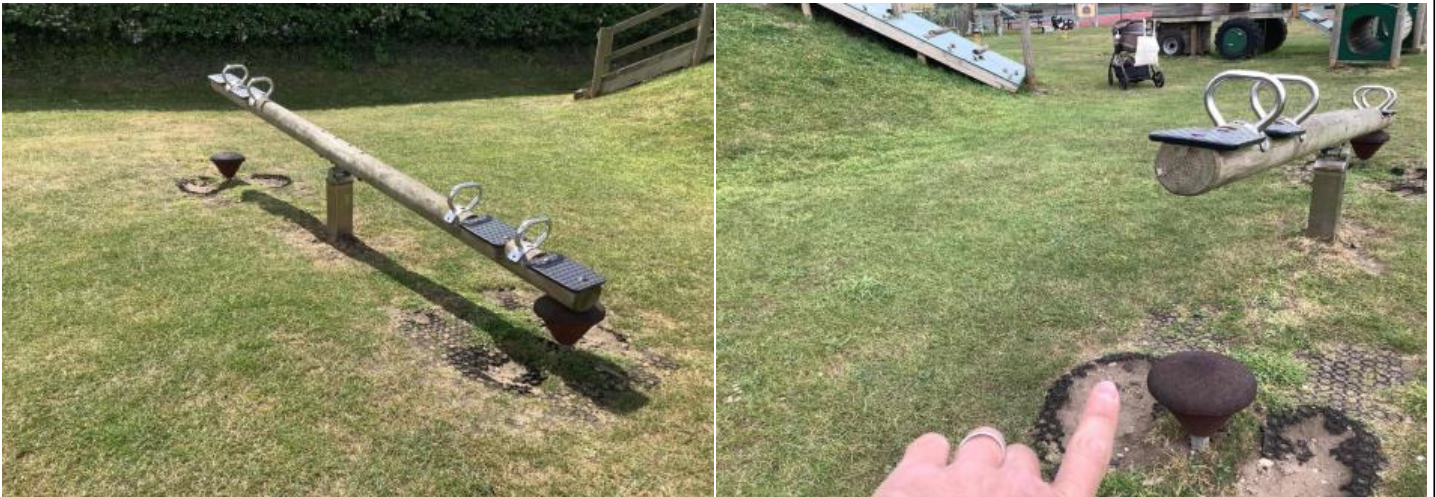
**Finding:** There are trip hazards present  
**Action:** Remove trip hazard

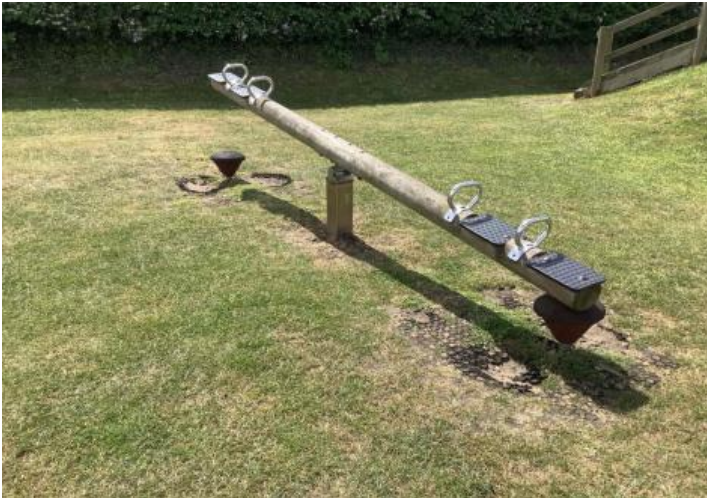
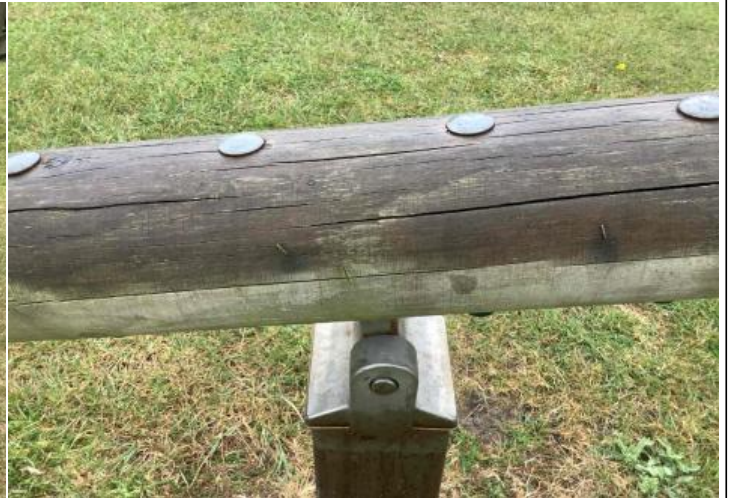
**Item:** Rocking Equipment - See Saw  
**Manufacturer:** Not Identified

**Finding:** There are sharp protruding staples on the item

**Action:** Remove staples

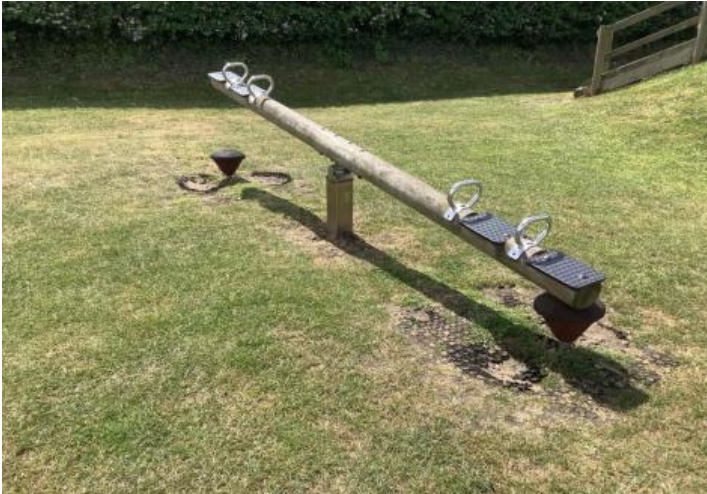
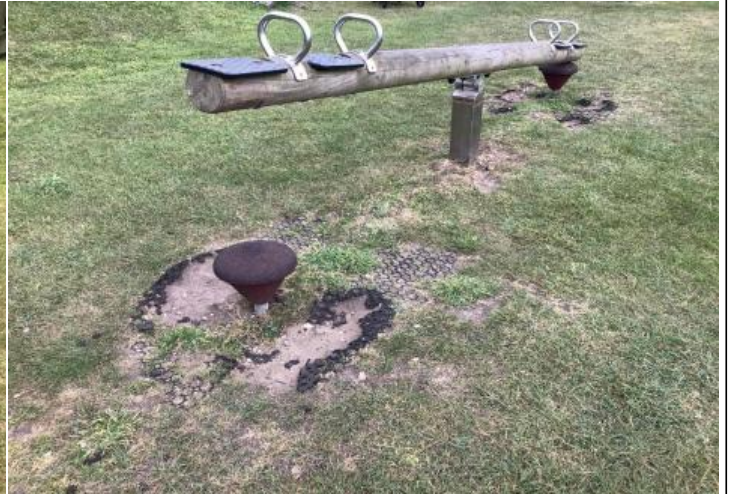
**Item:** Rocking Equipment - See Saw  
**Manufacturer:** Not Identified

**Finding:** The surfacing is severely damaged

**Action:** Repair damaged areas of surfacing

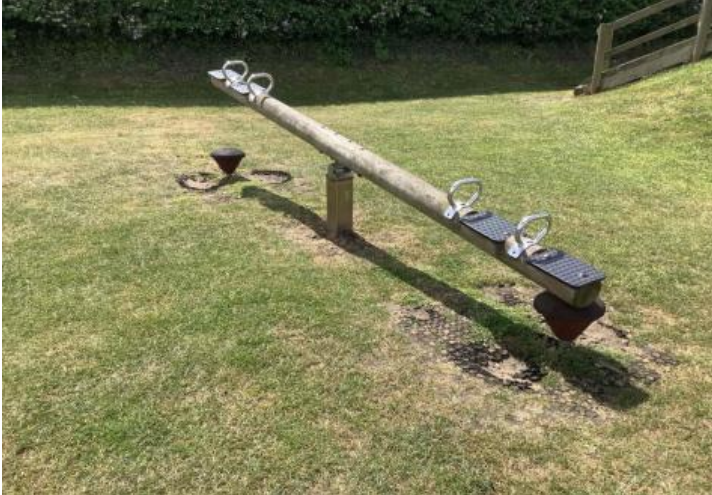
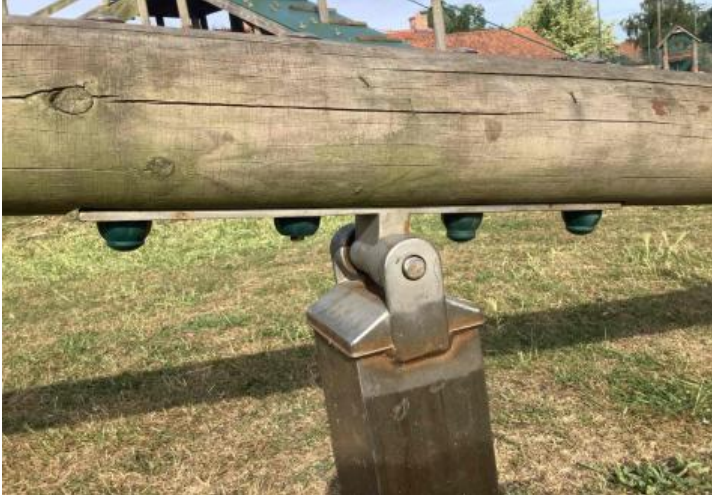
| <div> <div>Item:</div> <div>Rocking Equipment - See Saw</div> </div> | | <div> <div>Risk Level:</div> <div>L - Low Risk</div> </div> | |

| <div> <div>Finding:</div> <div>There are projecting bolt thread(s) present</div> </div> | | <div> <div>Action:</div> <div>Remove excess thread length and deburr or provide cap</div> </div> | |
