## BURNHAM MARKET PARISH COUNCIL ANNUAL GENERAL MEETING Minutes

Date: Wednesday 6<sup>th</sup> May 2026 at 6.30pm |

## Burnham Market Play Area

# Safety Inspection Report

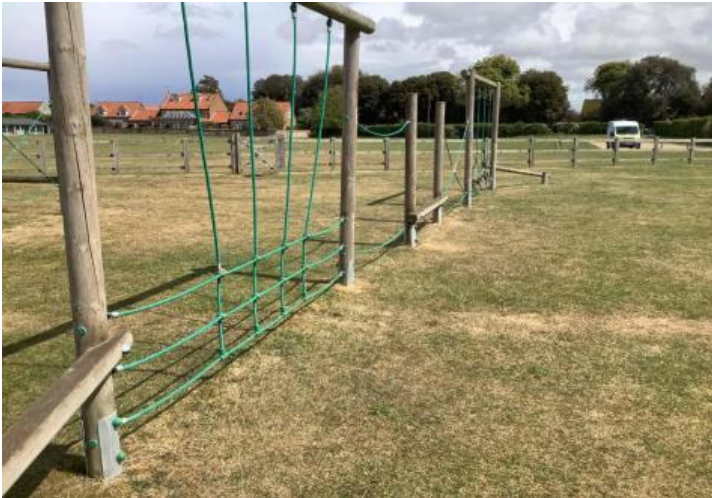
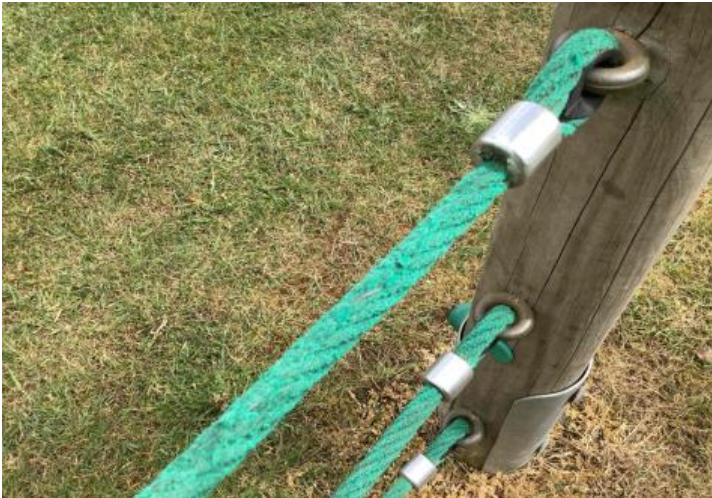
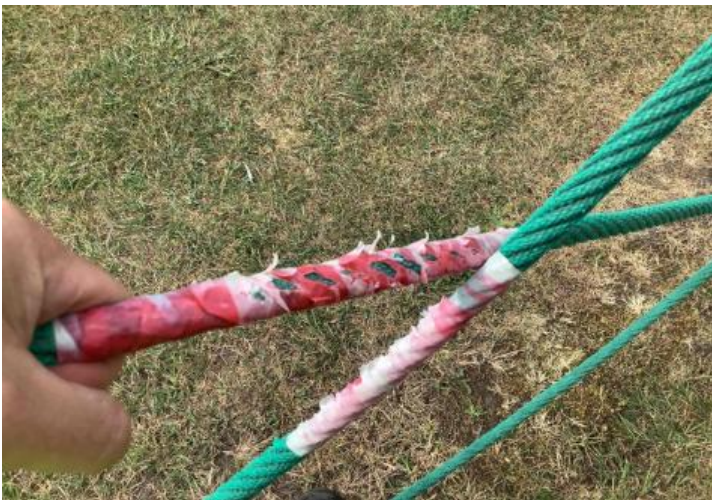
| <div> <div></div> <div>6 - Low Risk (Finding 1)</div> </div> | | | |

| <div> <div></div> <div>6 - Low Risk (Finding 1)</div> </div> | | | |
|---|--|---|--|
| <div>Finding: The ropes/nets are worn/damaged in places</div> | | <div>Action: Monitor for any further deterioration and repair or replace as required</div> | |

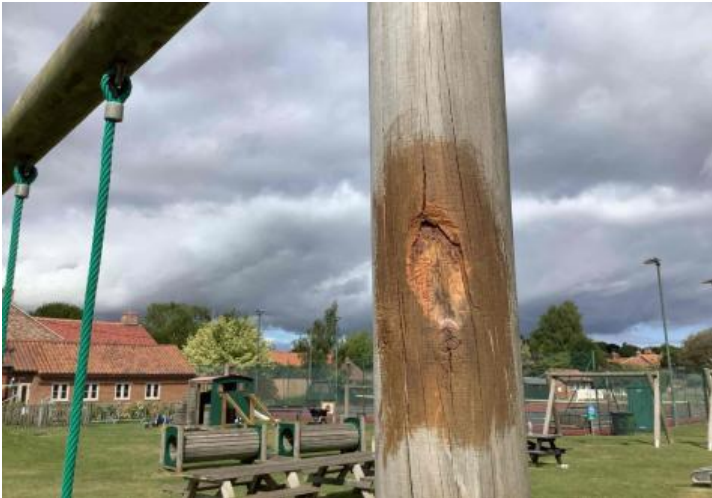
| <div> <div></div> <div>6 - Low Risk (Finding 2)</div> </div> | | | |

| <b>Finding:</b> The item has been damaged | | <b>Action:</b> Monitor for any further deterioration and replace as required | |

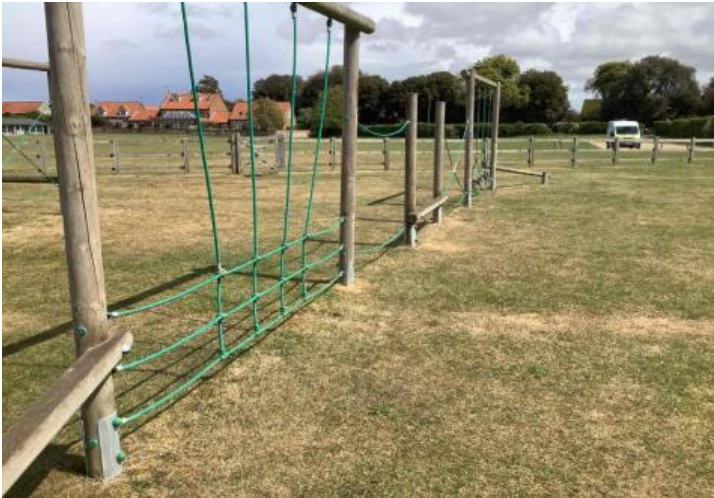
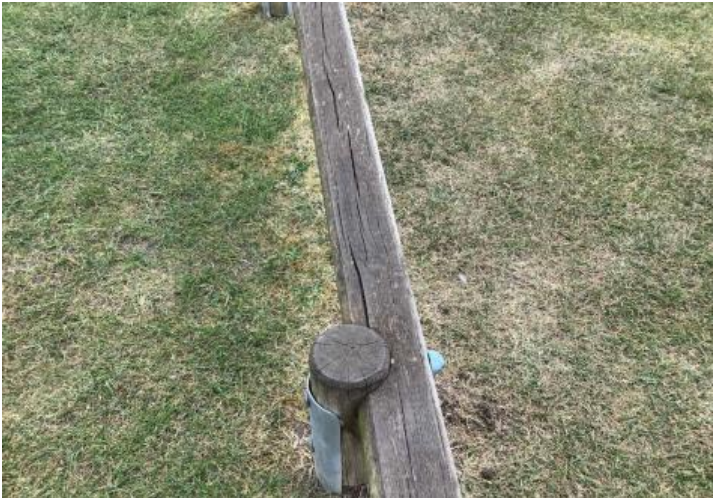
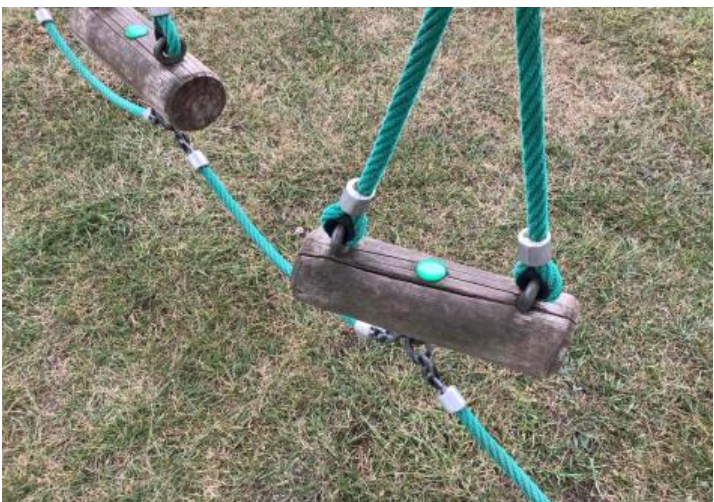
| <p><b>Finding:</b> The timber has a number of splits/shakes or air cracks and this may affect the stability or allow water ingress which will accelerate the rotting process. Timber splits may also create rough / splintering edges.</p> | | <p><b>Action:</b> Monitor, sand down any rough edges and ensure the splits do not cross through fixing points of the structure and/or cause any instability</p> | |

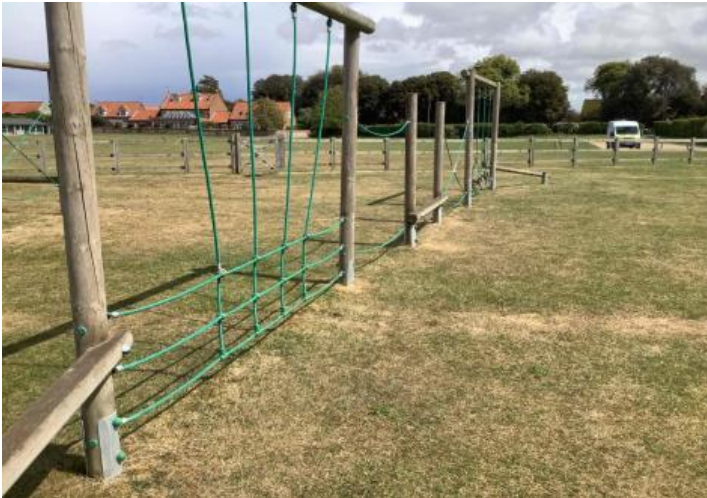
**i** 0 - Risk Assessment not Undertaken (Finding 4)

**Finding:** The ropes on this item have been taped and we are unable to fully assess the condition of the rope, ensure no wire strands are broken beneath the tape

**Action:** Repair or replace as required

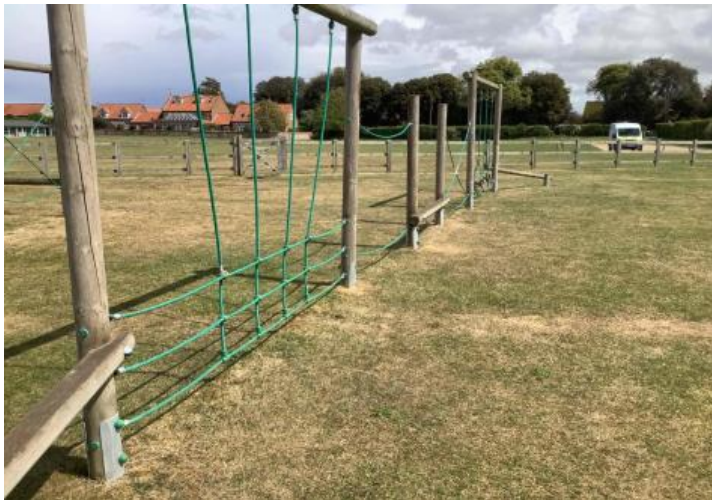
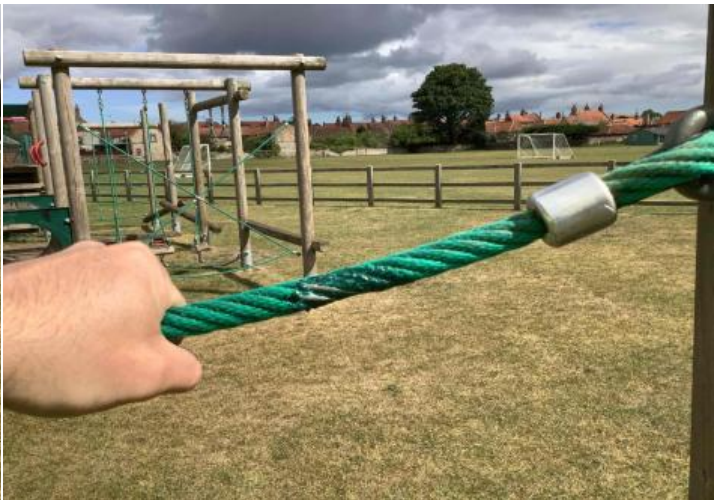
There is some evidence of fire damage to the item

Monitor for any further deterioration and repair as required

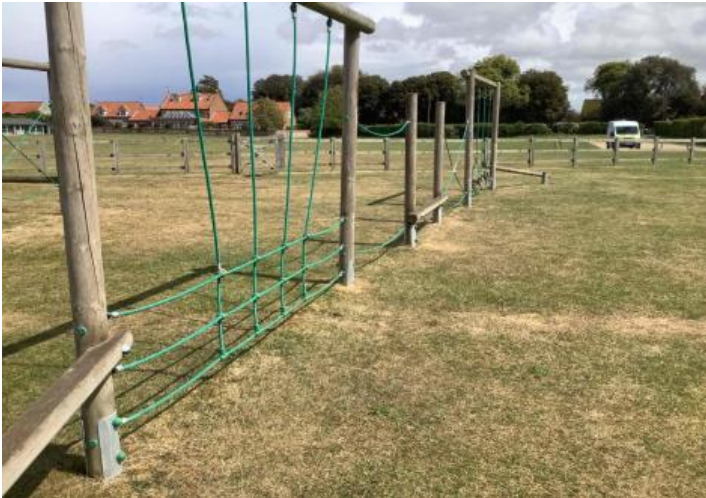
**Item:** Activity Equipment - Trim Trail  
**Manufacturer:** Action Play and Leisure

**Finding:** There is some wear to the shackles

**Action:** Monitor for any further deterioration and replace when 40% worn

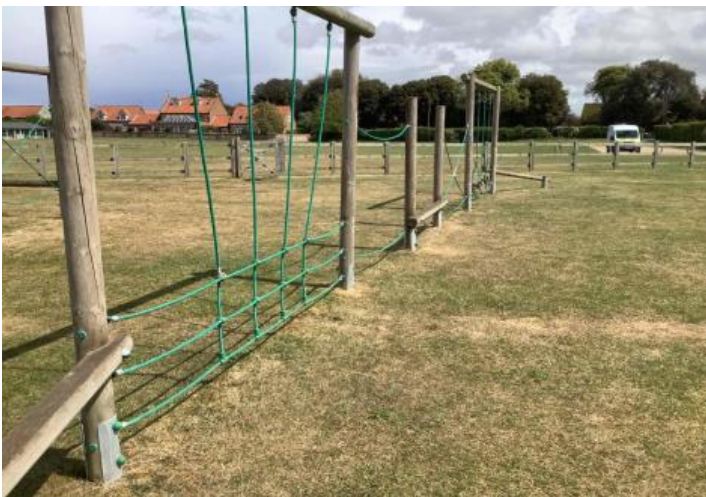
**Item:** Activity Equipment - Trim Trail  
**Manufacturer:** Action Play and Leisure

**Finding:** There is some wear to the suspension lugs

**Action:** Monitor and replace when 40% worn

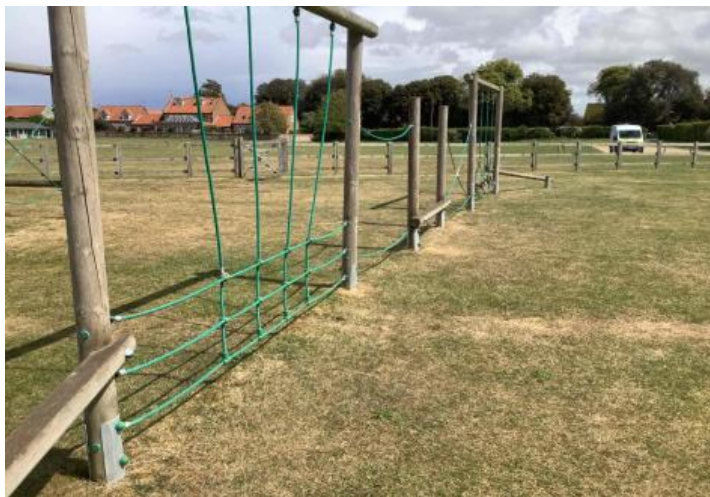
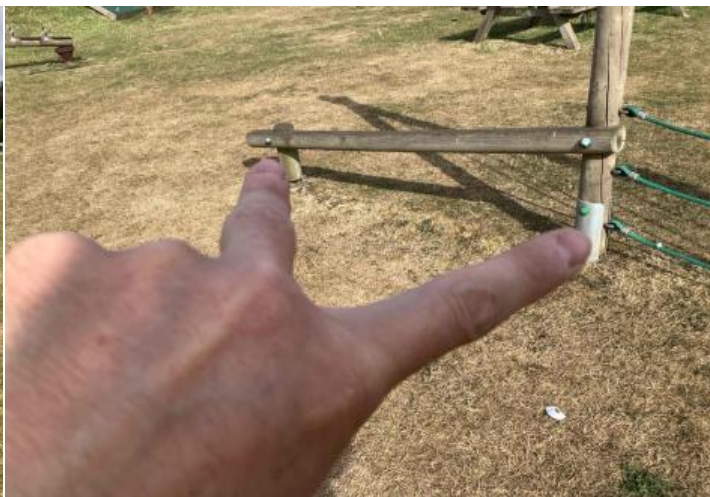
**Item:** Activity Equipment - Trim Trail  
**Manufacturer:** Action Play and Leisure

**Risk Level:** L - Low Risk  
**Surface:** Grass

**Finding:** A number of fixing(s) have worked loose

**Action:** Secure all loose fixings

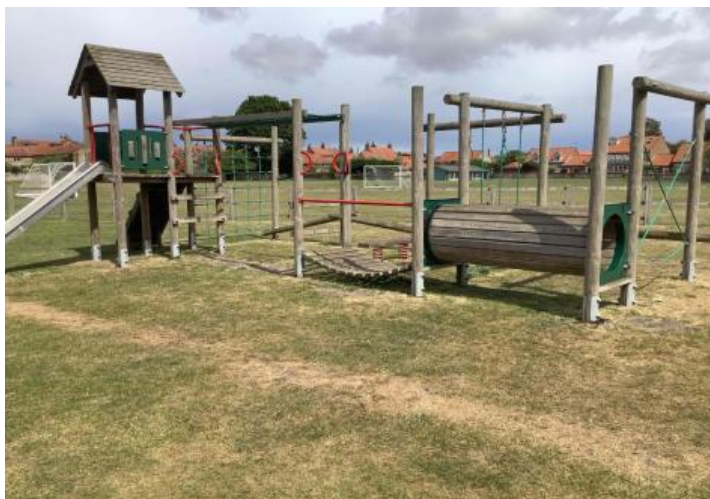
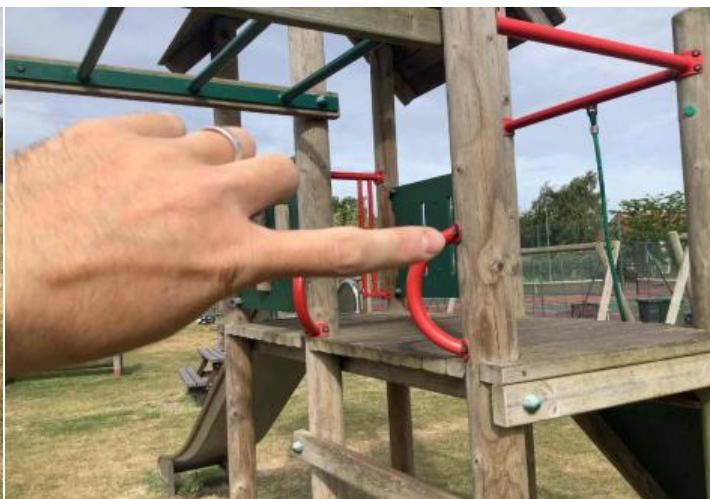
**Item:** Activity Equipment - Multi Play (Junior)  
**Manufacturer:** Action Play and Leisure

**Risk Level:** L - Low Risk  
**Surface:** Grass Matrix Tiles

**Finding:** A number of fixing(s) have worked loose

**Action:** Secure all loose fixings

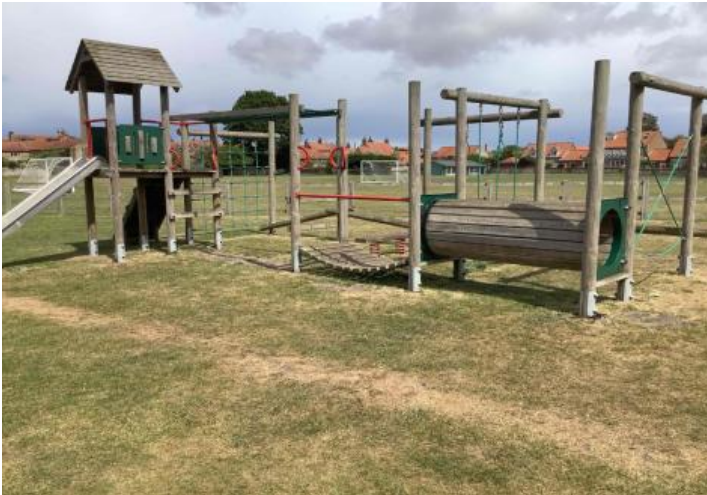
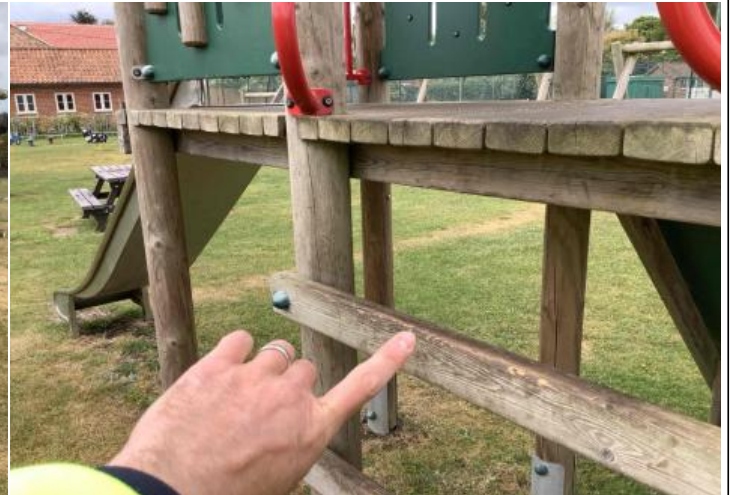
**Item:** Activity Equipment - Multi Play (Junior)  
**Manufacturer:** Action Play and Leisure

**Risk Level:** L - Low Risk  
**Surface:** Grass Matrix Tiles

**Finding:** Parts of the timber are rough or splintered

**Action:** Monitor and remove all rough or sharp edges

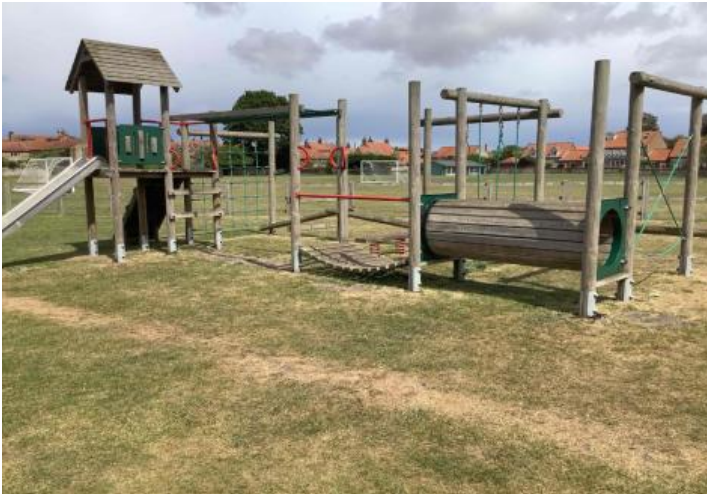
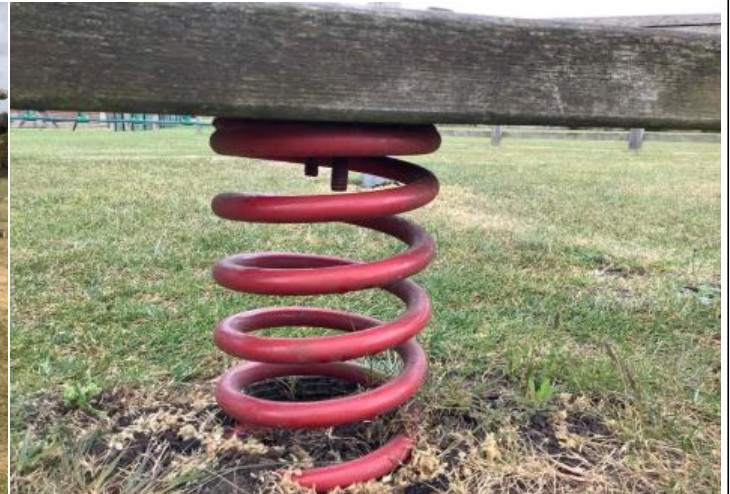
**Item:** Activity Equipment - Multi Play (Junior)  
**Manufacturer:** Action Play and Leisure

**Risk Level:** V - Very Low Risk  
**Surface:** Grass Matrix Tiles

**Finding:** There are projecting bolt thread(s) present

**Action:** Remove excess thread length and deburr or provide cap

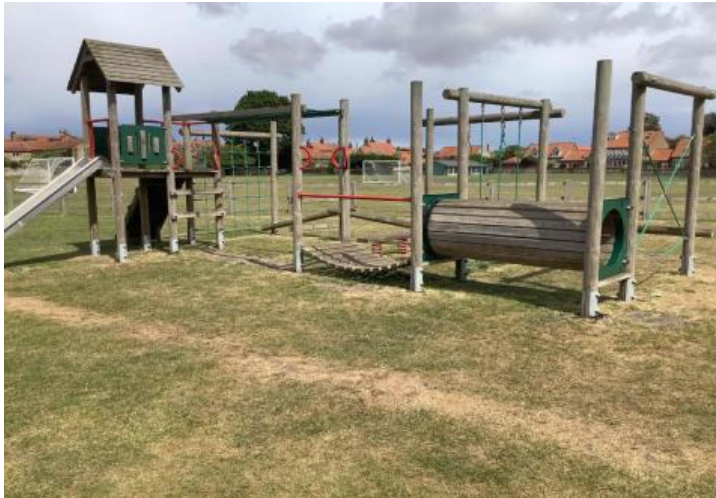
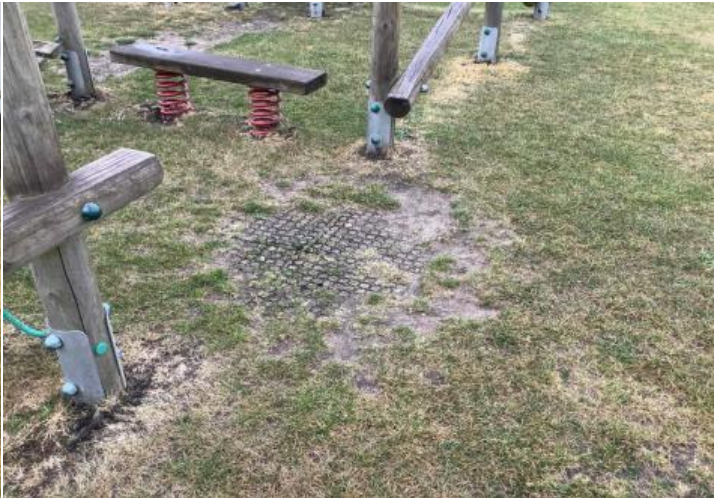
| <b>Item:</b> | Activity Equipment - Multi Play (Junior) | <b>Risk Level:</b> | L - Low Risk |
| <b>Manufacturer:</b> | Action Play and Leisure | <b>Surface:</b> | Grass Matrix Tiles |

**Finding:** The surface has eroded in some areas and may be slippery in wet conditions

**Action:** Reinstate the surface

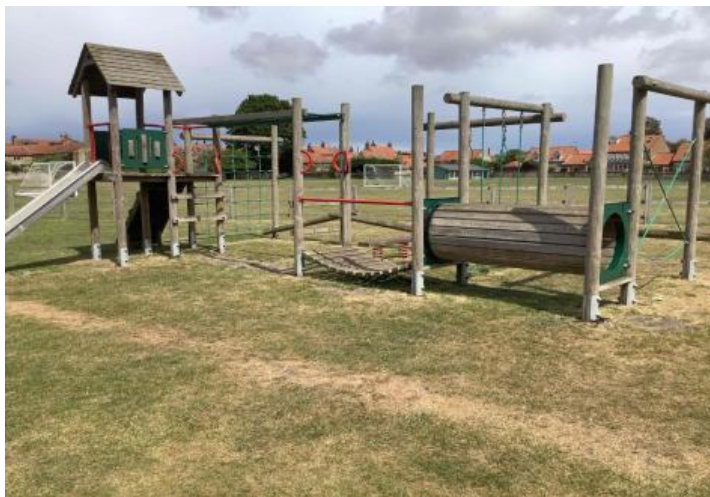
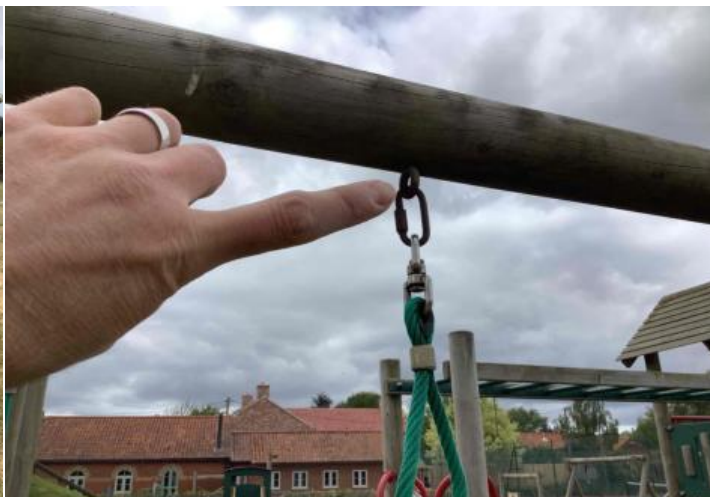
**Item:** Activity Equipment - Multi Play (Junior)  
**Manufacturer:** Action Play and Leisure

**Risk Level:** L - Low Risk  
**Surface:** Grass Matrix Tiles

**Finding:** There is some wear to the suspension lugs

**Action:** Monitor and replace when 40% worn

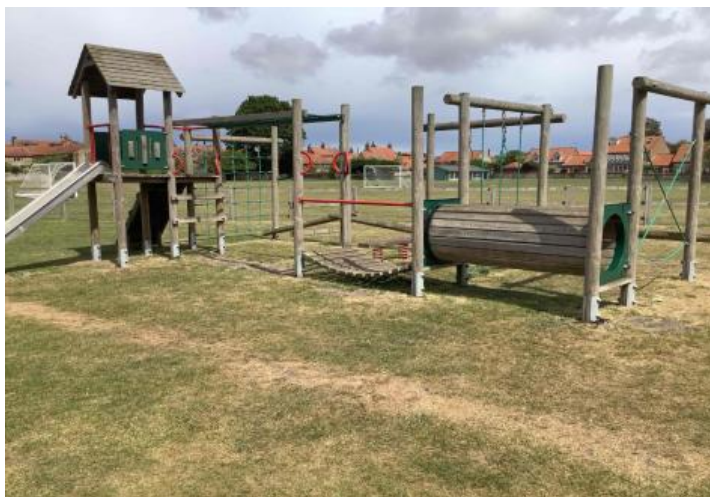
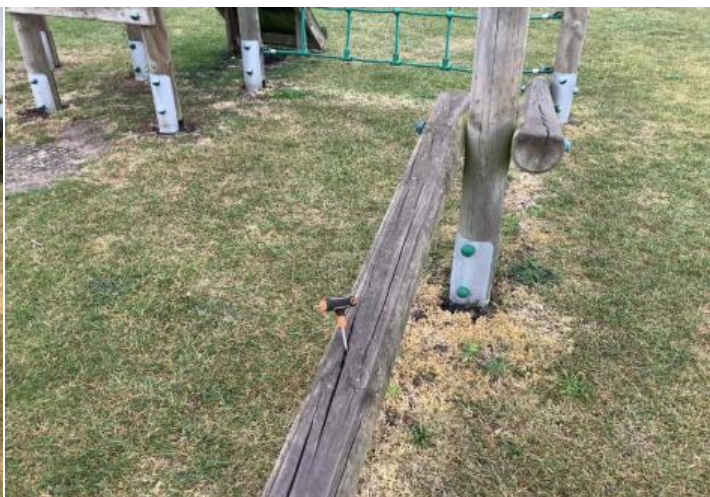
**Item:** Activity Equipment - Multi Play (Junior)  
**Manufacturer:** Action Play and Leisure

**Risk Level:** L - Low Risk  
**Surface:** Grass Matrix Tiles

**Finding:** There is some evidence of rot in the timber

**Action:** Monitor for any further deterioration and replace as required

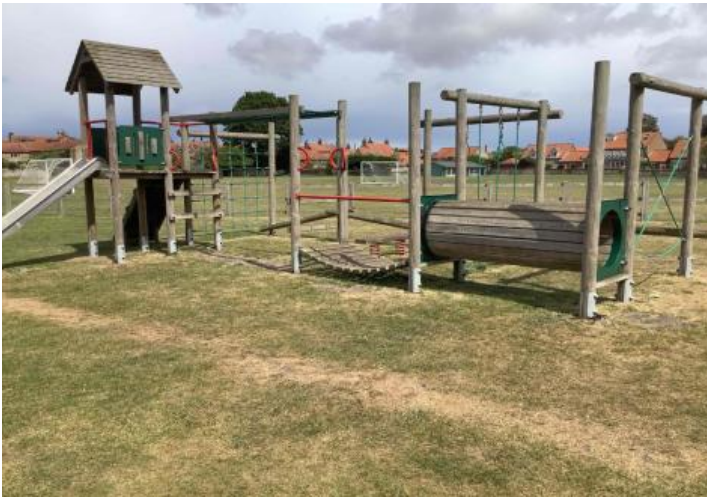
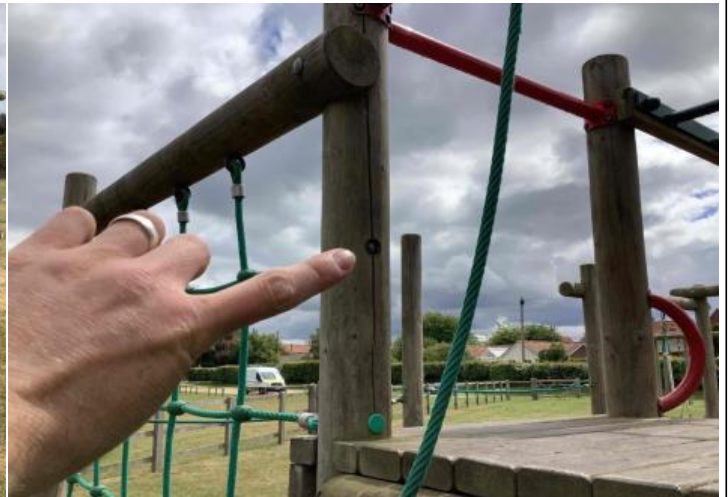
**Item:** Activity Equipment - Multi Play (Junior)  
**Manufacturer:** Action Play and Leisure

**Risk Level:** V - Very Low Risk  
**Surface:** Grass Matrix Tiles

**Finding:** Bolt cap cover/s missing or damaged

**Action:** Replace

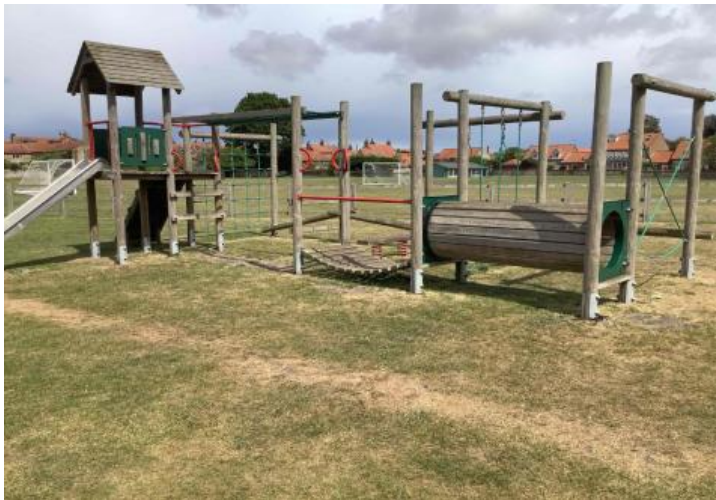
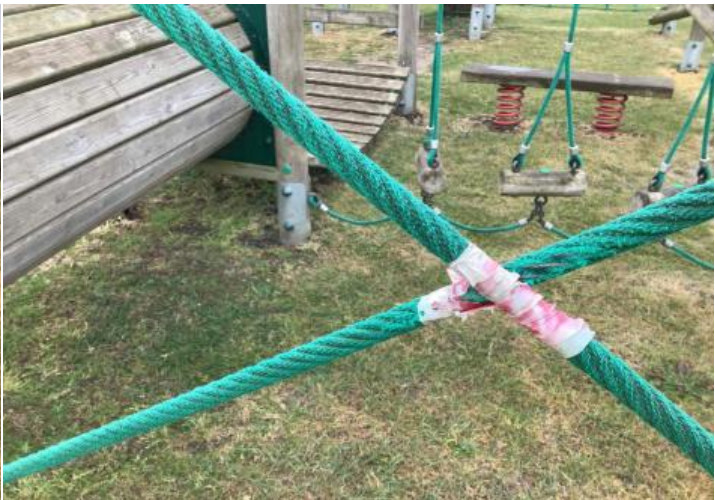
| <div> <div> 0 - Risk Assessment not Undertaken (Finding 10) </div> </div> | | | |

| <div> <div> 0 - Risk Assessment not Undertaken (Finding 10) </div> </div> | | | |
|---|--|---|--|
| <div> <div>Item:</div> <div>Activity Equipment - Multi Play (Junior)</div> </div> <div> <div>Manufacturer:</div> <div>Action Play and Leisure</div> </div> | | <div> <div>Risk Level:</div> <div>N - Risk Assessment not Undertaken</div> </div> <div> <div>Surface:</div> <div>Grass Matrix Tiles</div> </div> | |
| <div>Finding:</div> <div>The ropes on this item have been taped and we are unable to fully assess the condition of the rope, ensure no wire strands are broken beneath the tape</div> | | <div>Action:</div> <div>Repair or replace as required</div> | |

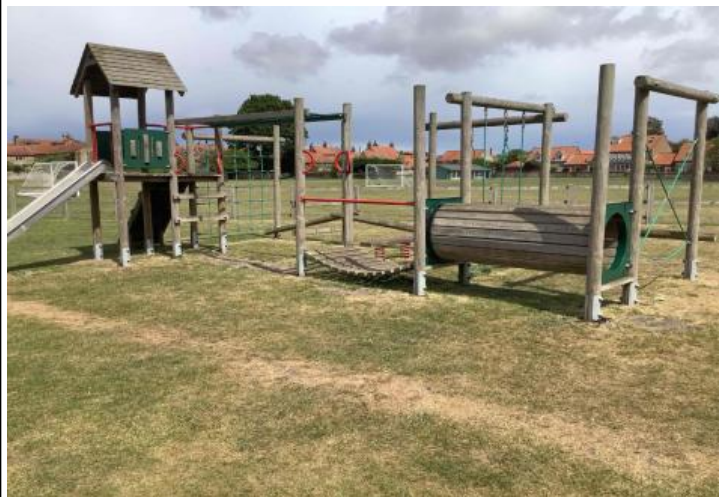
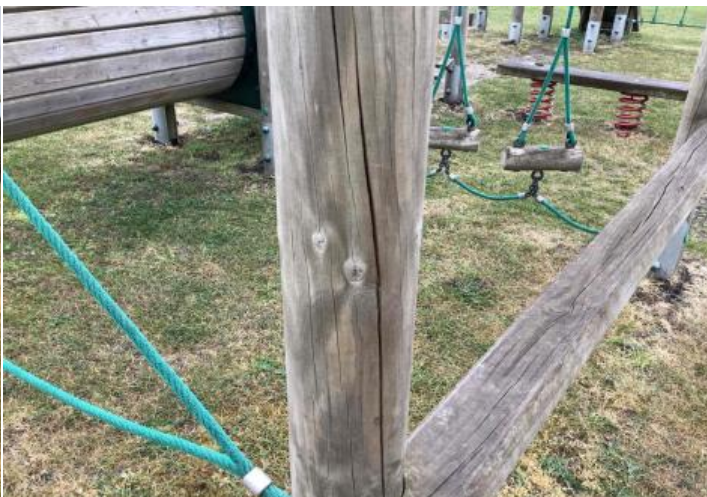
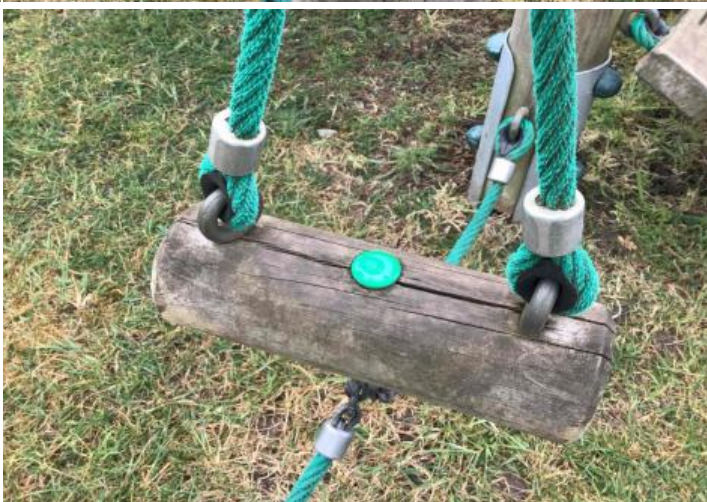
**i** 6 - Low Risk (Finding 11)

**Item:** Activity Equipment - Multi Play (Junior)  
**Manufacturer:** Action Play and Leisure

**Risk Level:** L - Low Risk  
**Surface:** Grass Matrix Tiles

**Finding:** The timber has a number of splits/shakes or air cracks and this may affect the stability or allow water ingress which will accelerate the rotting process. Timber splits may also create rough / splintering edges.

**Action:** Monitor, sand down any rough edges and ensure the splits do not cross through fixing points of the structure and/or cause any instability

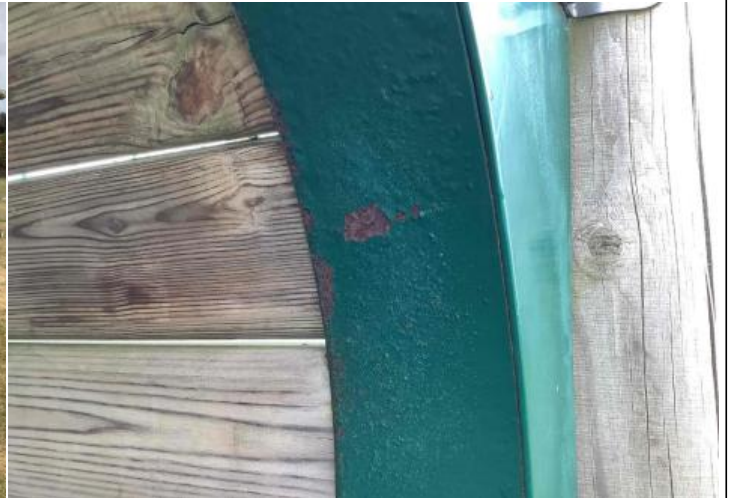
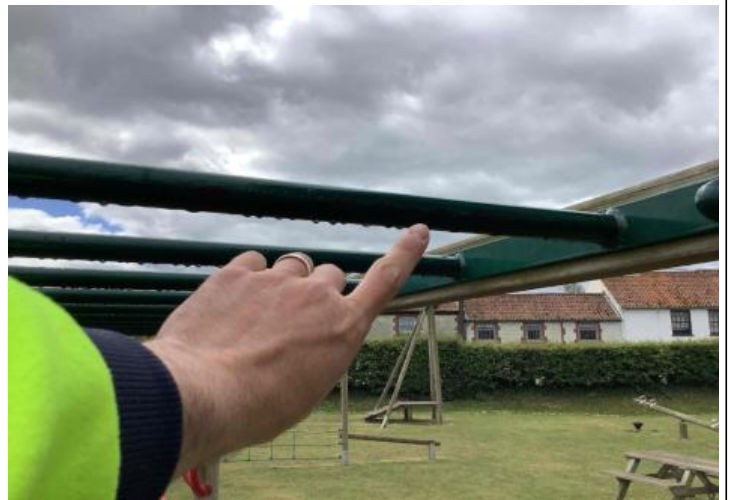
**Finding:** The paintwork on this item has been damaged or worn exposing the metal underneath which is rusting / corroding

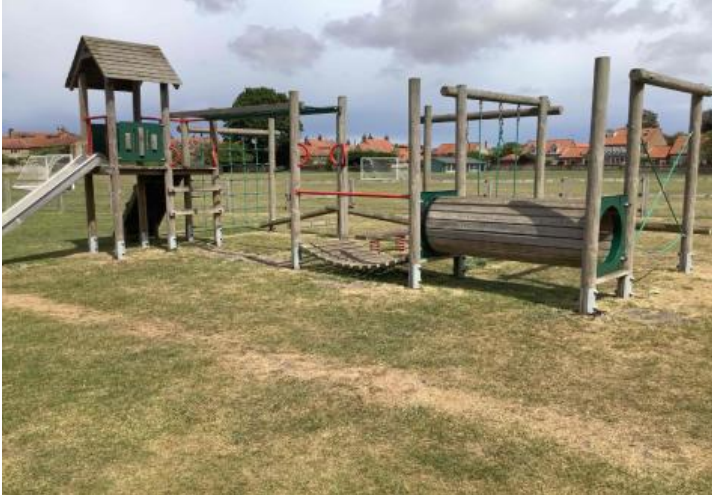
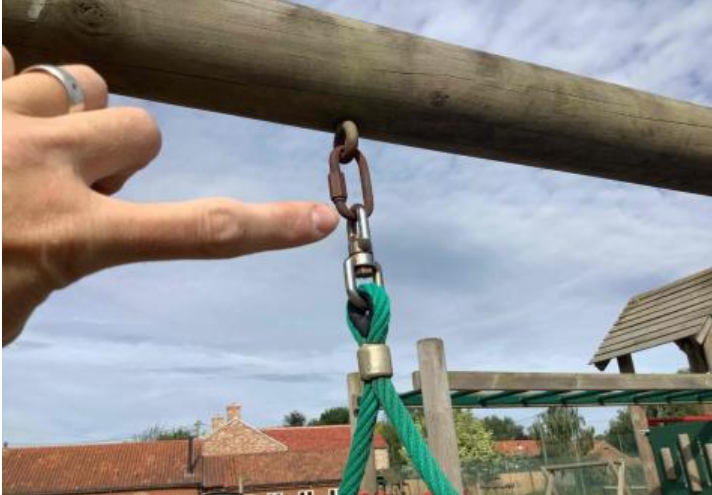
| Item: | Activity Equipment - Multi Play (Junior) | Risk Level: | L - Low Risk |
| Manufacturer: | Action Play and Leisure | Surface: | Grass Matrix Tiles |
| <b>Finding:</b> There is some wear to the shackles | | <b>Action:</b> Monitor for any further deterioration and replace when 40% worn | |

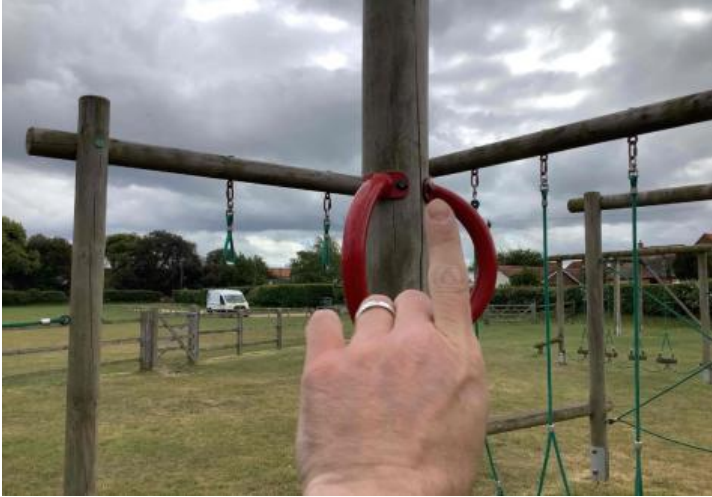
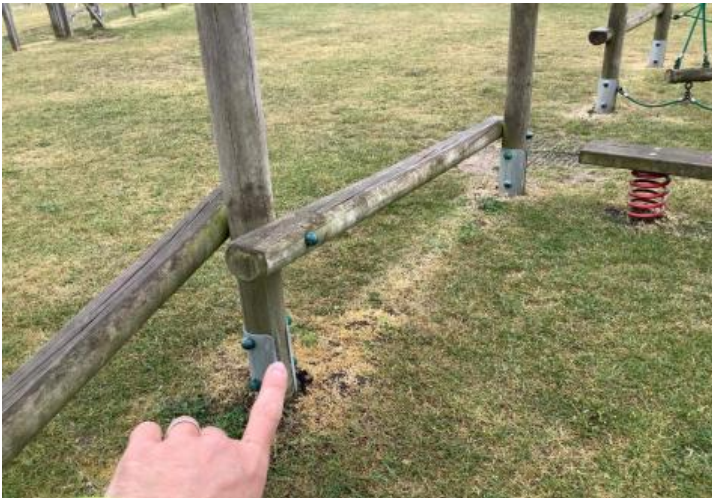
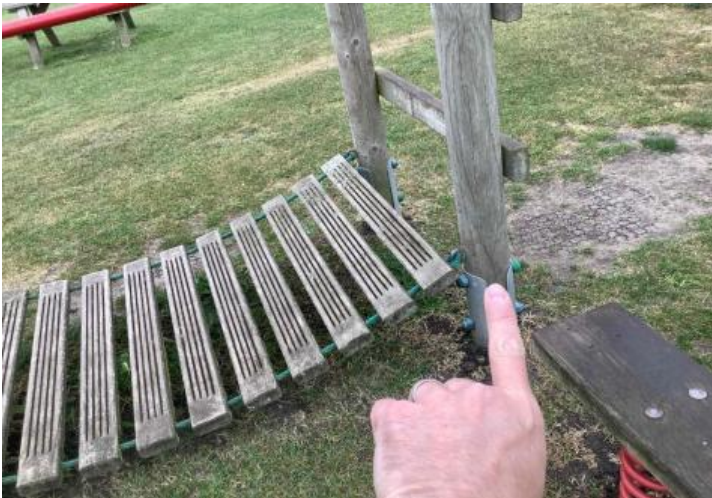
| <b>Item:</b> | Activity Equipment - Multi Play (Junior) | <b>Risk Level:</b> | L - Low Risk |
| <b>Manufacturer:</b> | Action Play and Leisure | <b>Surface:</b> | Grass Matrix Tiles |

**Finding:** A number of fixing(s) have worked loose

**Action:** Secure all loose fixings

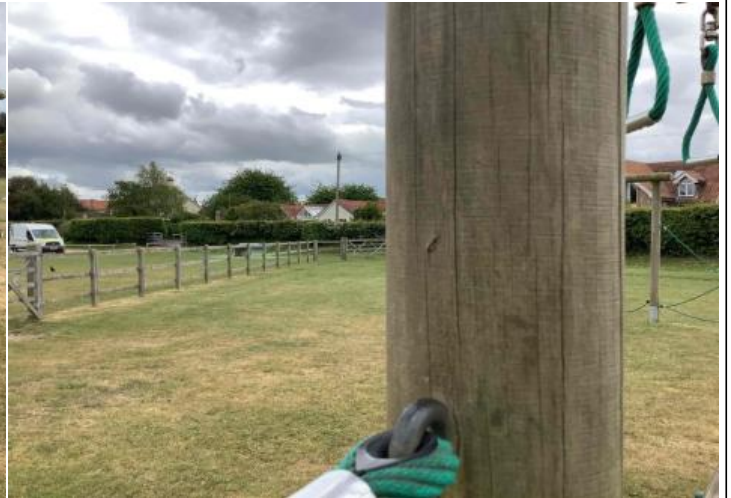
**Item:** Activity Equipment - Multi Play (Junior)  
**Manufacturer:** Action Play and Leisure

**Risk Level:** L - Low Risk  
**Surface:** Grass Matrix Tiles

**Finding:** There are staples on the item

**Action:** Remove staples

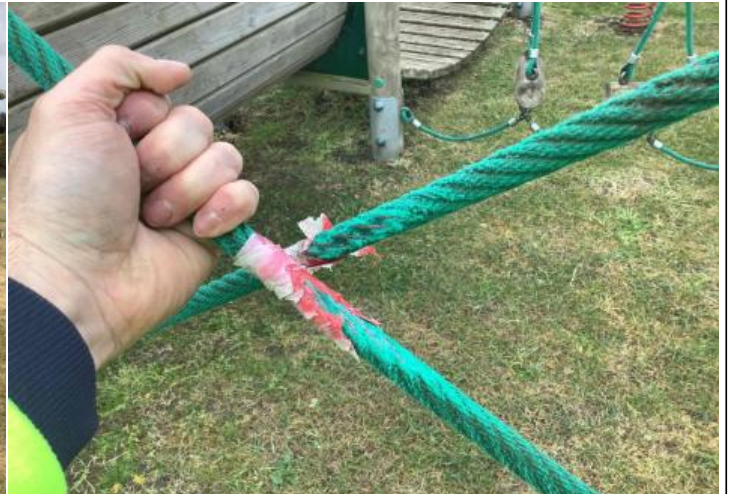
**Item:** Activity Equipment - Multi Play (Junior)  
**Manufacturer:** Action Play and Leisure

**Risk Level:** L - Low Risk  
**Surface:** Grass Matrix Tiles

**Finding:** The ropes/nets are worn/damaged in places

**Action:** Monitor for any further deterioration and repair or replace as required

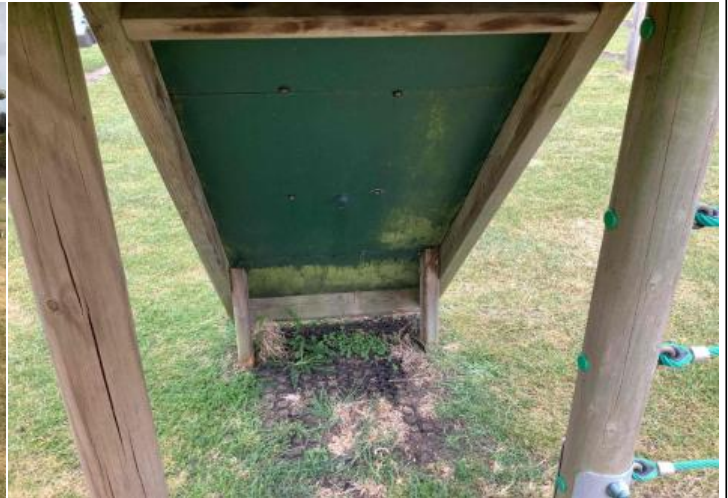
**Item:** Activity Equipment - Multi Play (Junior)  
**Manufacturer:** Action Play and Leisure

**Risk Level:** L - Low Risk  
**Surface:** Grass Matrix Tiles

**Finding:** There is algae or moss on the surface of the equipment

**Action:** Clean and treat appropriately

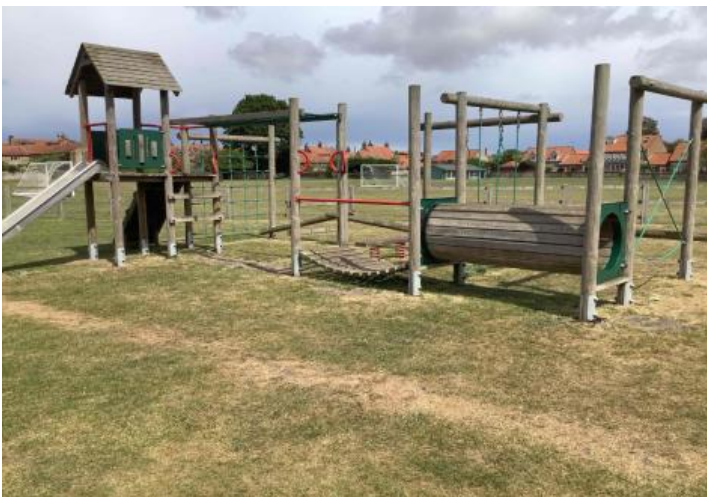
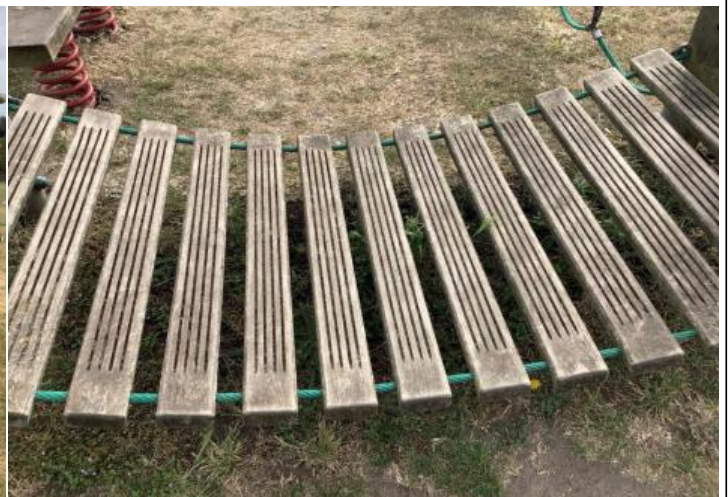
**Item:** Activity Equipment - Multi Play (Junior)  
**Manufacturer:** Action Play and Leisure

**Risk Level:** L - Low Risk  
**Surface:** Grass Matrix Tiles

**Finding:** There is weed / vegetation growth within the surface

**Action:** Remove weed / vegetation growth

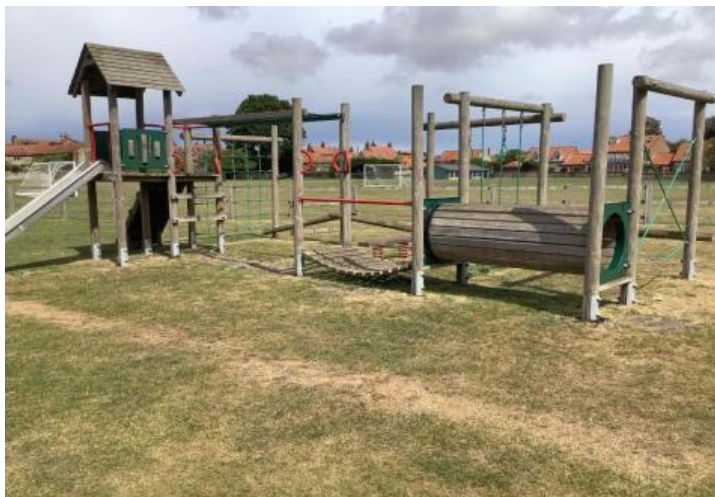
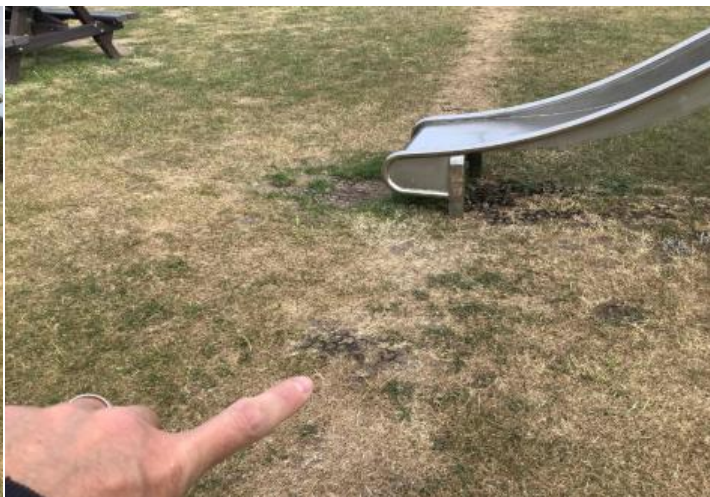
**Item:** Activity Equipment - Multi Play (Junior)  
**Manufacturer:** Action Play and Leisure

**Risk Level:** V - Very Low Risk  
**Surface:** Grass Matrix Tiles

**Finding:** There is some minor damage to the surface

**Action:** Monitor for any further deterioration and repair as required

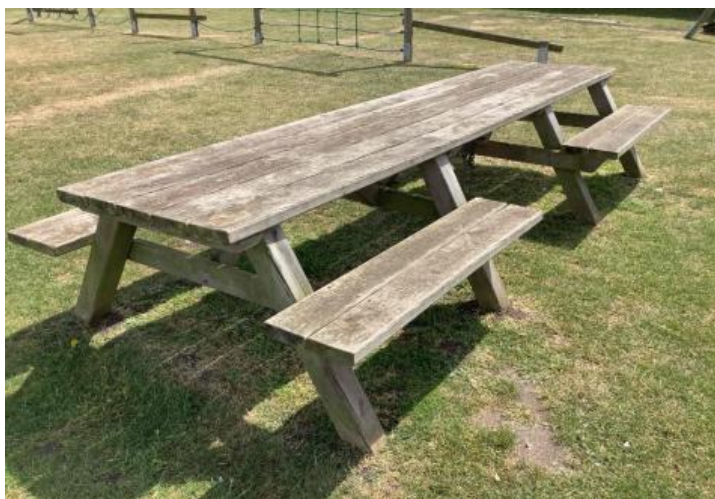
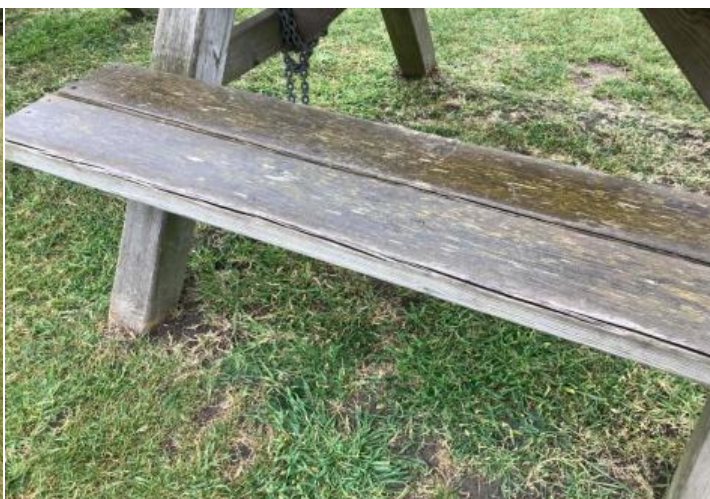
**Item:** Ancillary Items - Picnic Table  
**Manufacturer:** Action Play and Leisure

**Risk Level:** L - Low Risk  
**Surface:** Grass

**Finding:** The timber has a number of splits/shakes or air cracks and this may affect the stability or allow water ingress which will accelerate the rotting process. Timber splits may also create rough / splintering edges.

**Action:** Monitor, sand down any rough edges and ensure the splits do not cross through fixing points of the structure and/or cause any instability

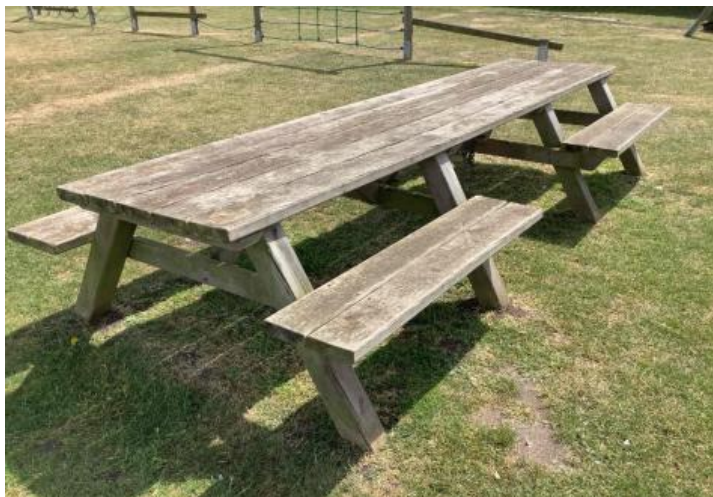
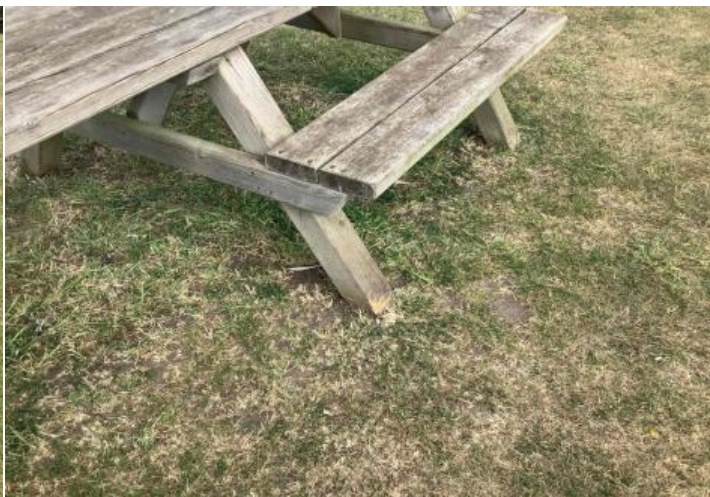
**Item:** Ancillary Items - Picnic Table  
**Manufacturer:** Action Play and Leisure

**Finding:** There is some strimmer / machinery damage apparent on the legs, this can penetrate the preservative applied to the timber and accelerate the rotting process

**Action:** Monitor for any deterioration (rot) and replace as required

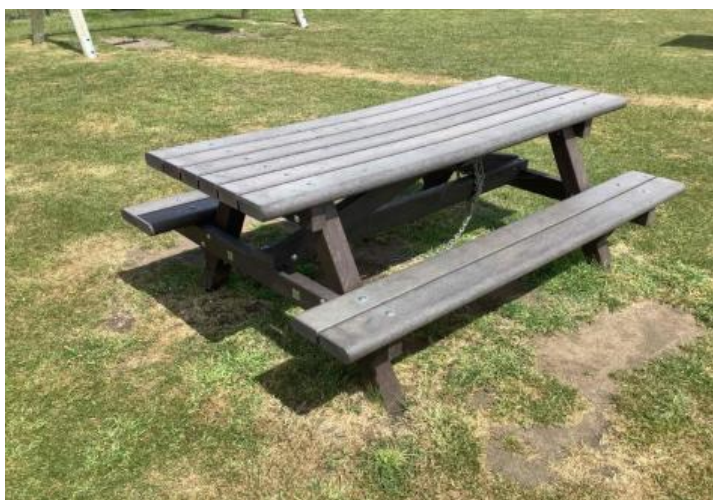
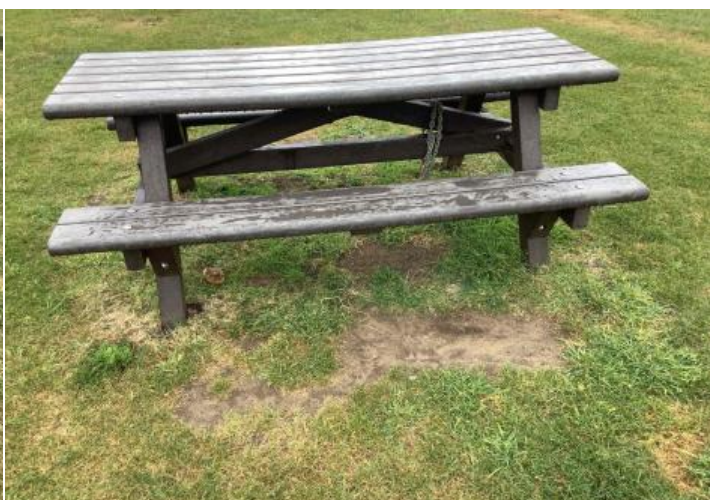
**Item:** Ancillary Items - Picnic Table  
**Manufacturer:** Glasdon

**Finding:** The surface has eroded in some areas and may be slippery in wet conditions

**Action:** Reinststate the surface

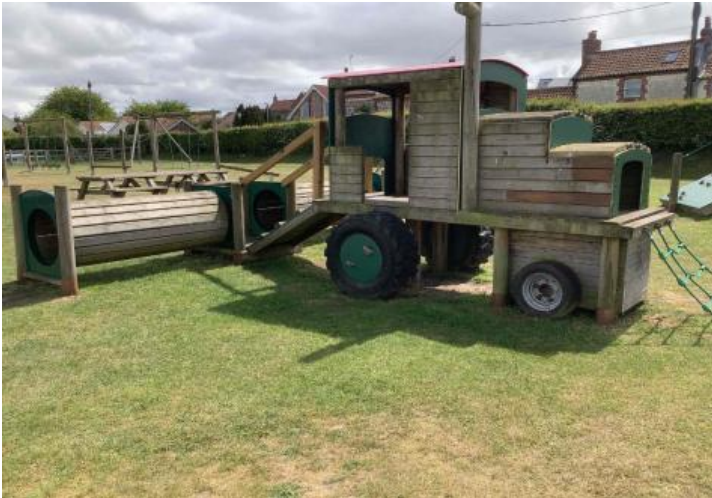
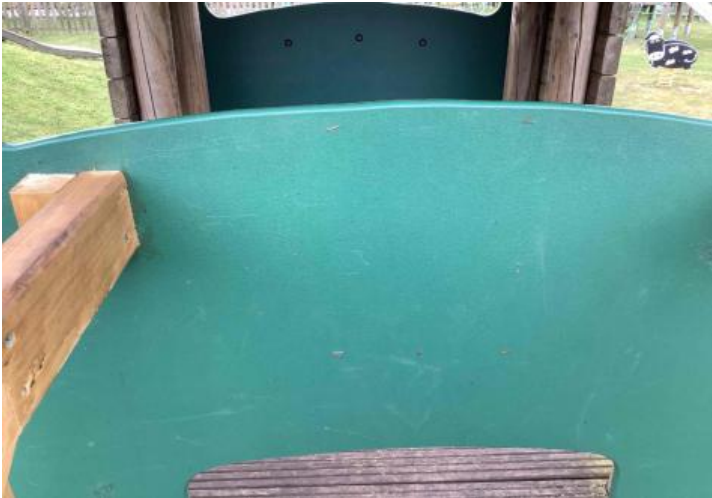
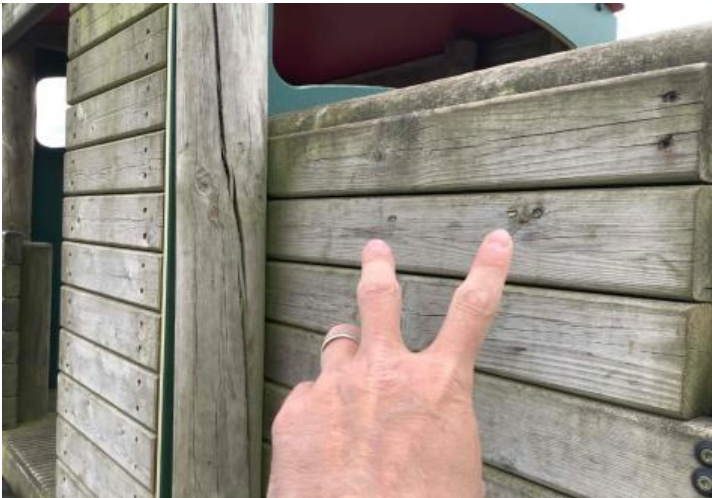
| <div> <div></div> <div>6 - Low Risk (Finding 1)</div> </div> | | | |
|---|--|---|--|
| <div> <div>Item:</div> <div>Activity Equipment - Tractor</div> </div> | | <div> <div>Risk Level:</div> <div>L - Low Risk</div> </div> | |

| <div> <div></div> <div>6 - Low Risk (Finding 1)</div> </div> | | | |
|---|--|---|--|
| <div>Finding: There are sharp protruding staples on the item</div> | | <div>Action: Remove staples</div> | |

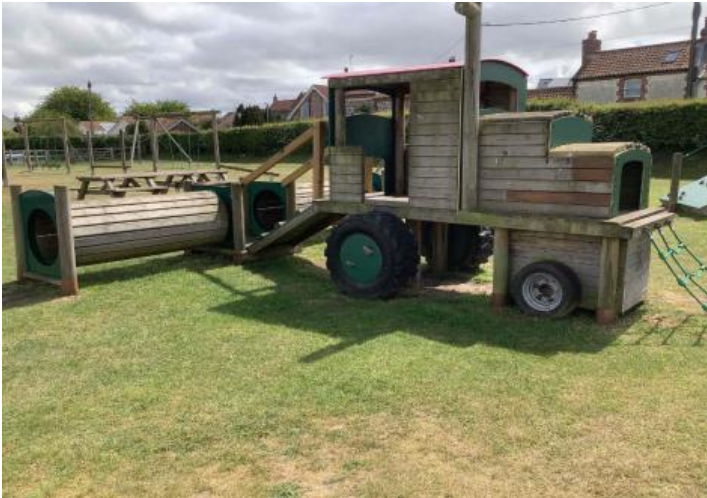
**Item:** Activity Equipment - Tractor  
**Manufacturer:** Not Identified

**Finding:** The timber has a number of splits/shakes or air cracks and this may affect the stability or allow water ingress which will accelerate the rotting process. Timber splits may also create rough / splintering edges.

**Action:** Monitor, sand down any rough edges and ensure the splits do not cross through fixing points of the structure and/or cause any instability
