## BURNHAM MARKET PARISH COUNCIL ANNUAL GENERAL MEETING Minutes

Date: Wednesday 6<sup>th</sup> May 2026 at 6.30pm |

## Burnham Market Play Area

# Safety Inspection Report

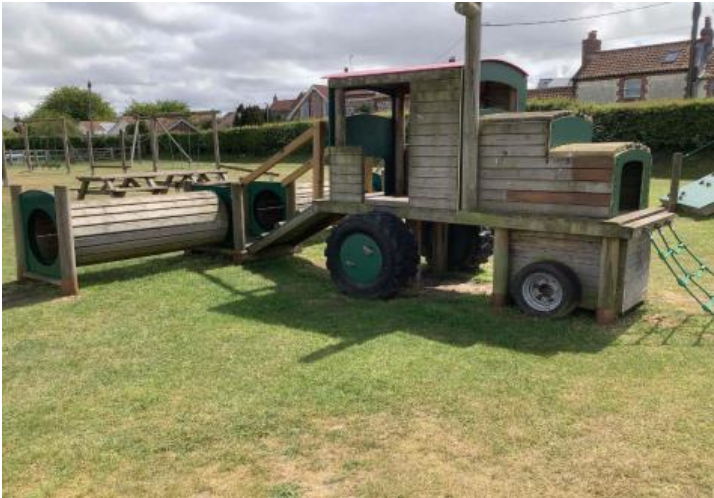
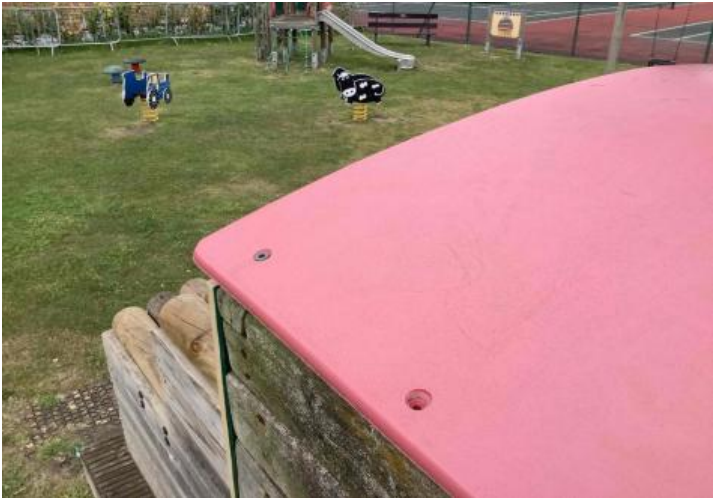
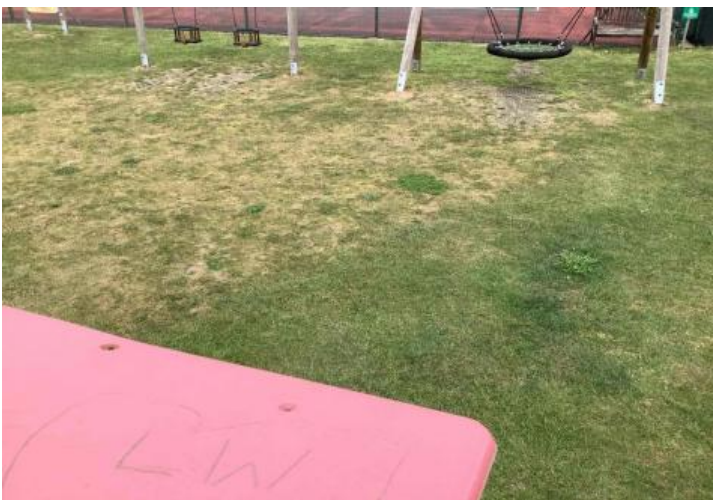
| <div> 8 - Low Risk (Finding 3) </div> | | | |
|---|--|---|--|
| <b>Item:</b> Activity Equipment - Tractor<br><b>Manufacturer:</b> Not Identified | | <b>Risk Level:</b> L - Low Risk<br><b>Surface:</b> Grass Matrix Tiles | |

| <div> 8 - Low Risk (Finding 3) </div> | | | |
|---|--|---|--|
| <b>Finding:</b> There is or are fixings missing on the roof | | <b>Action:</b> Replace all missing fixings | |

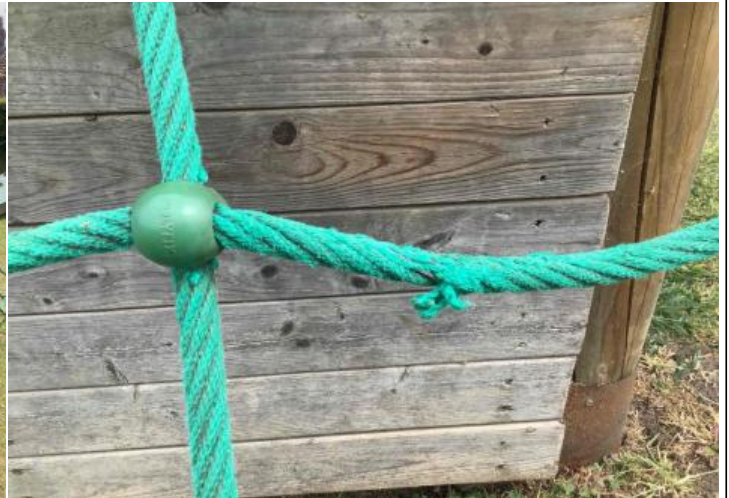
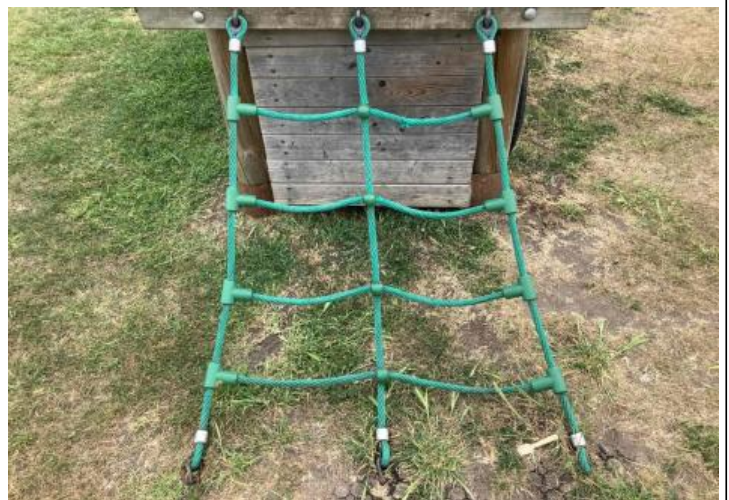
**Finding:** The ropes/nets are worn/damaged in places

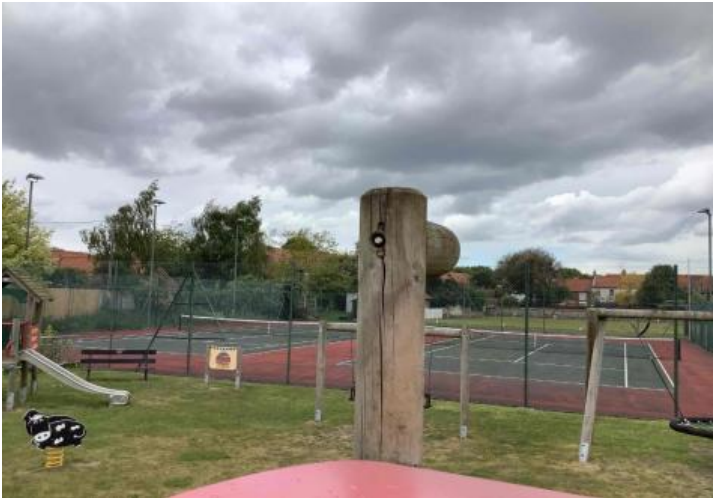
| <div> 4 - Very Low Risk (Finding 5) </div> | | | |
|---|--|---|--|
| <b>Item:</b> Activity Equipment - Tractor | | <b>Risk Level:</b> V - Very Low Risk | |

| <div> 4 - Very Low Risk (Finding 5) </div> | | | |
|---|--|---|--|
| <b>Finding:</b> Bolt cap cover/s missing or damaged | | <b>Action:</b> Replace | |

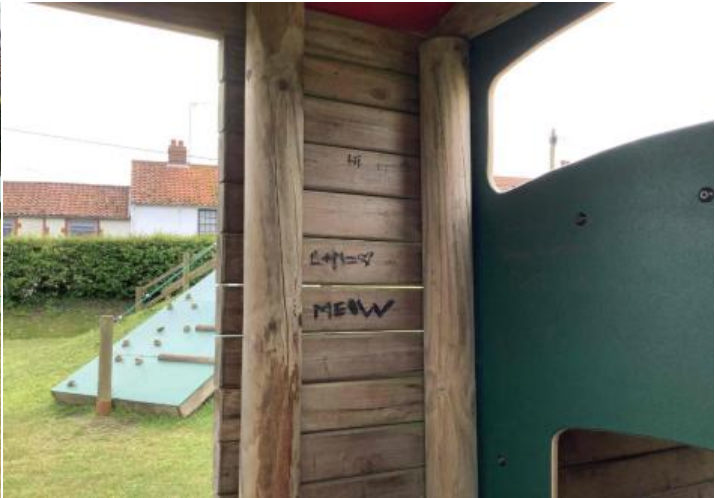
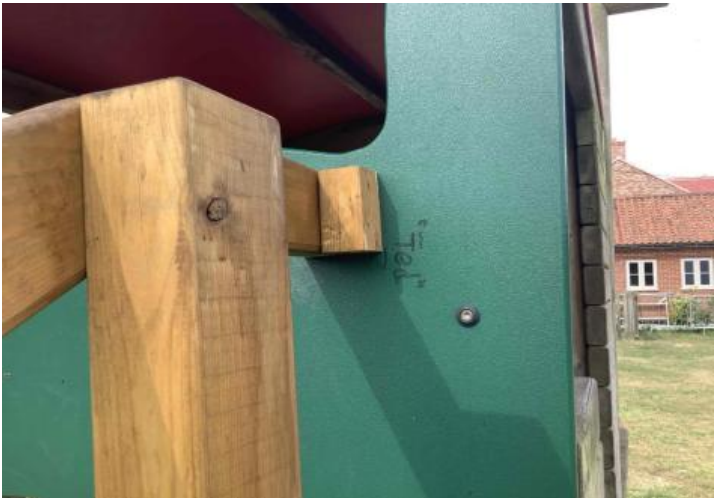
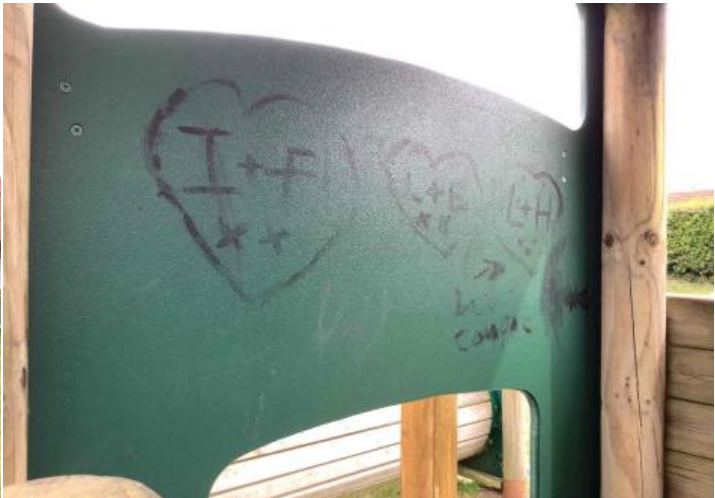
| <div> 0 - Risk Assessment not Undertaken (Finding 6) </div> | | | |
|---|--|---|--|
| <b>Item:</b> Activity Equipment - Tractor<br><b>Manufacturer:</b> Not Identified | | <b>Risk Level:</b> N - Risk Assessment not Undertaken<br><b>Surface:</b> Grass Matrix Tiles | |

| <div> 0 - Risk Assessment not Undertaken (Finding 6) </div> | | | |
|---|--|---|--|
| <b>Finding:</b> There is some graffiti present | | <b>Action:</b> Remove the graffiti | |

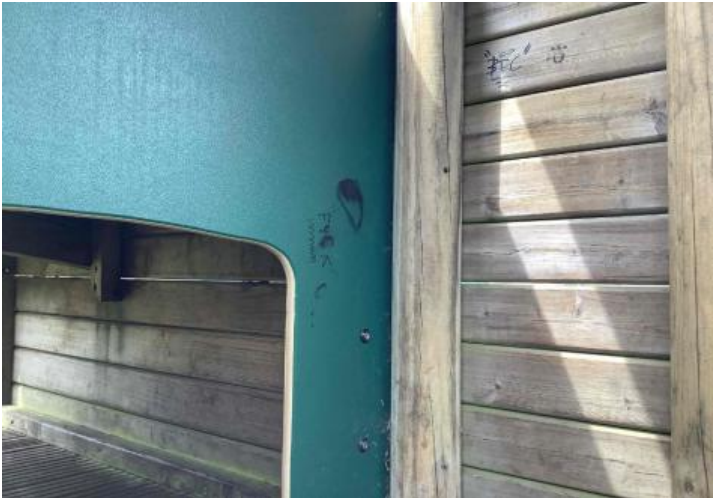
| <div> 0 - Risk Assessment not Undertaken (Finding 7) </div> | | | |
|---|---|---|---|
| <b>Item:</b> | Activity Equipment - Tractor | <b>Risk Level:</b> | N - Risk Assessment not Undertaken |

| <div> 0 - Risk Assessment not Undertaken (Finding 7) </div> | | | |
|---|---|---|---|
| <b>Finding:</b> There is offensive graffiti present | | <b>Action:</b> Remove as soon as practicable | |

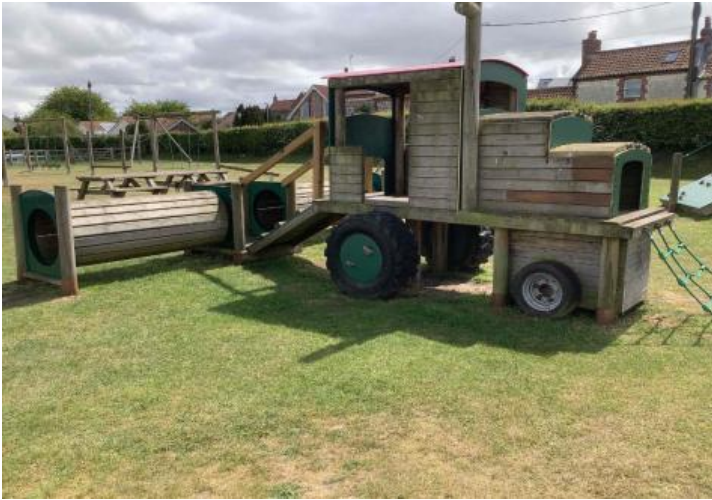
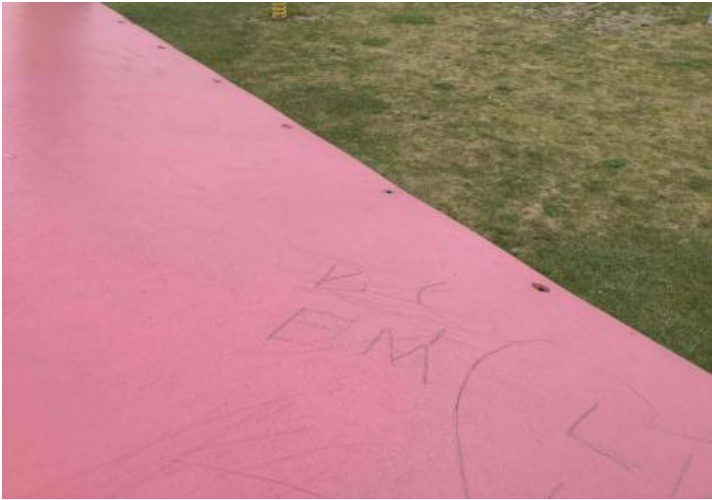
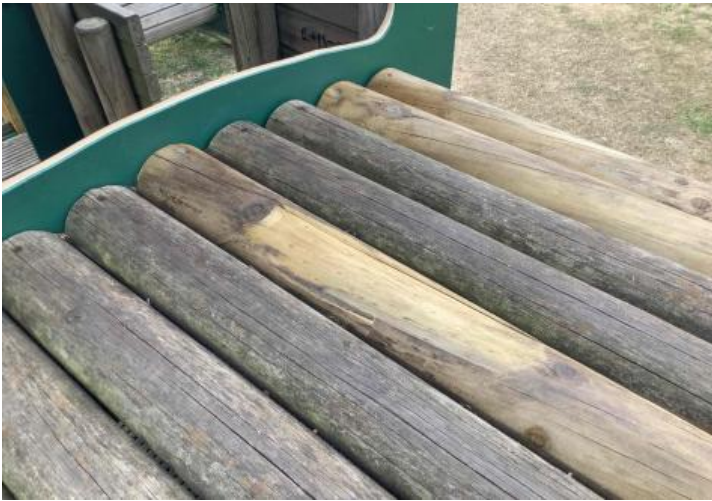
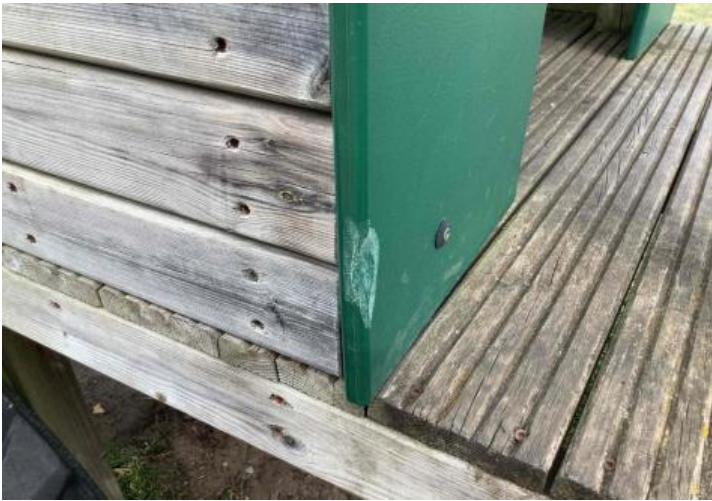
| <div> <div></div> <div>6 - Low Risk (Finding 8)</div> </div> | | | |
|---|--|---|--|
| <div> <div>Item:</div> <div>Activity Equipment - Tractor</div> </div> | | <div> <div>Risk Level:</div> <div>L - Low Risk</div> </div> | |

| <div> <div></div> <div>6 - Low Risk (Finding 8)</div> </div> | | | |
|---|--|---|--|
| <div>Finding: The item has been damaged</div> | | <div>Action: Monitor for any further deterioration and replace as required</div> | |

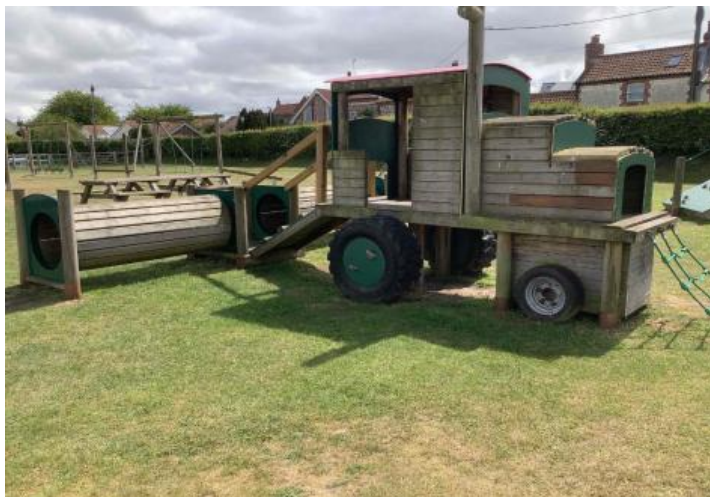
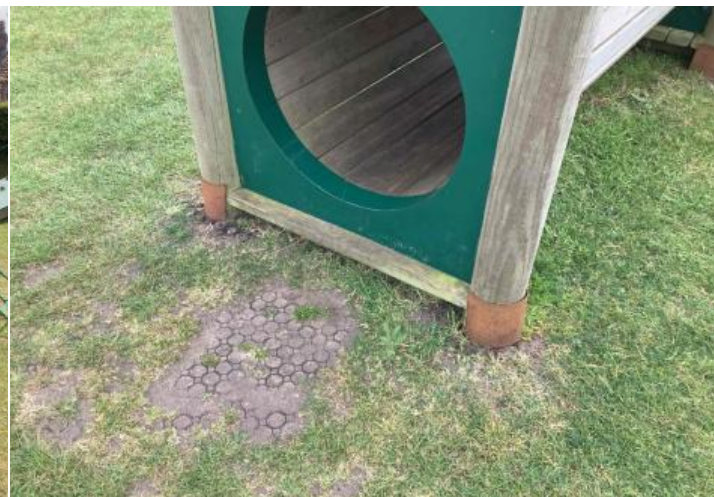
**Item:** Activity Equipment - Tractor  
**Manufacturer:** Not Identified

**Finding:** There are post protectors around the timber posts that are preventing the inspector from thoroughly testing for signs of decay and we are unable to verify the condition of the posts in these locations. NOTE - timber rot / decay is possible even with the post protectors in place

**Action:** Refer to manufacturer inspection / maintenance recommendations

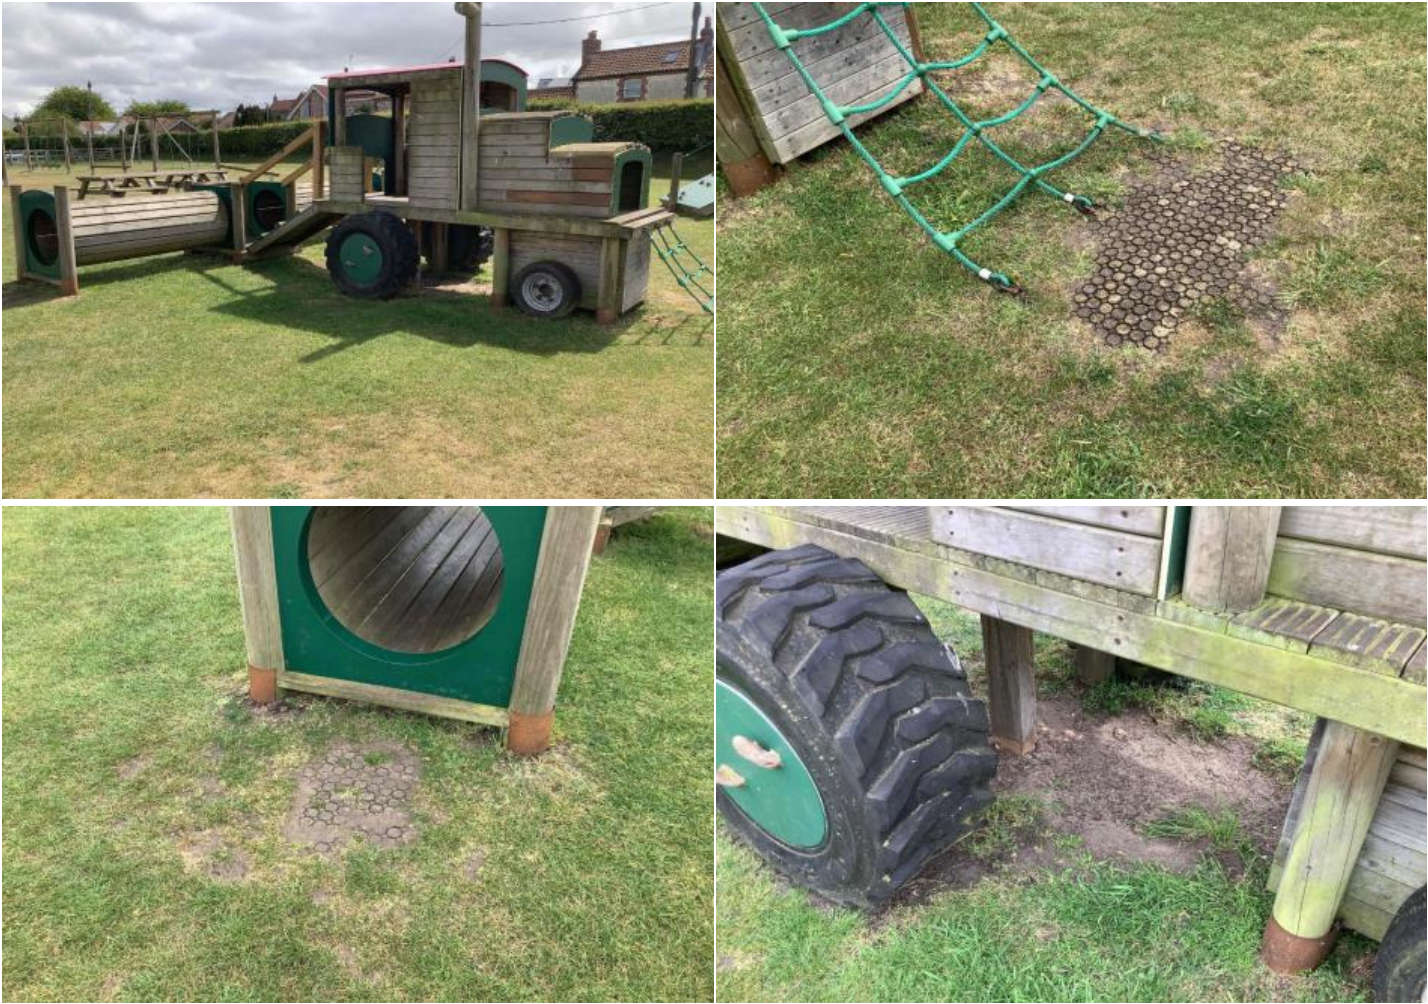
**Finding:** The surface has eroded in some areas and may be slippery in wet conditions  
**Action:** Reinstate the surface

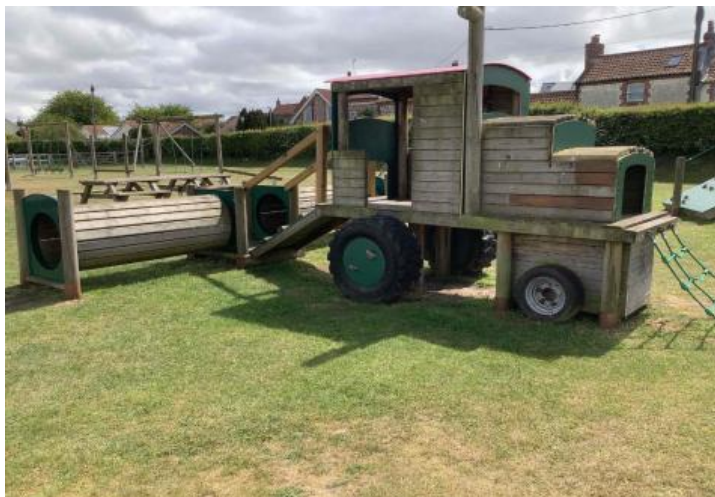
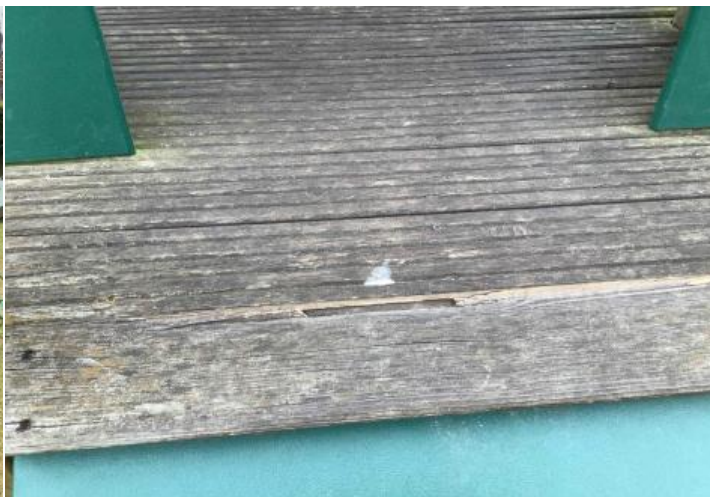
**Item:** Activity Equipment - Tractor  
**Manufacturer:** Not Identified

**Finding:** Parts of the timber are rough or splintered

**Action:** Remove all rough or sharp edges

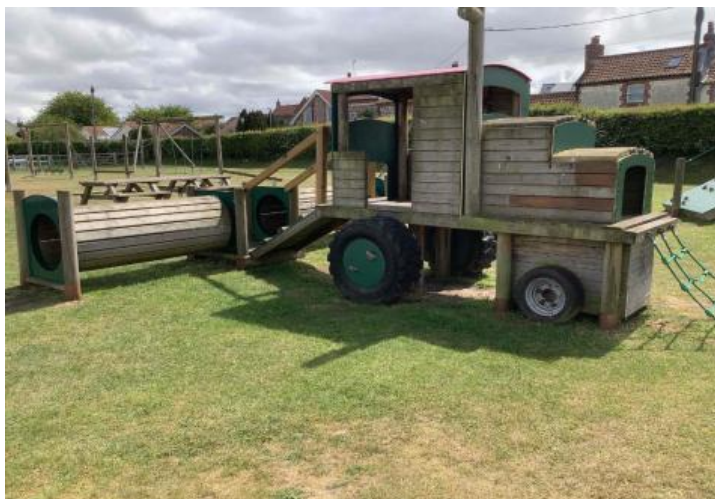
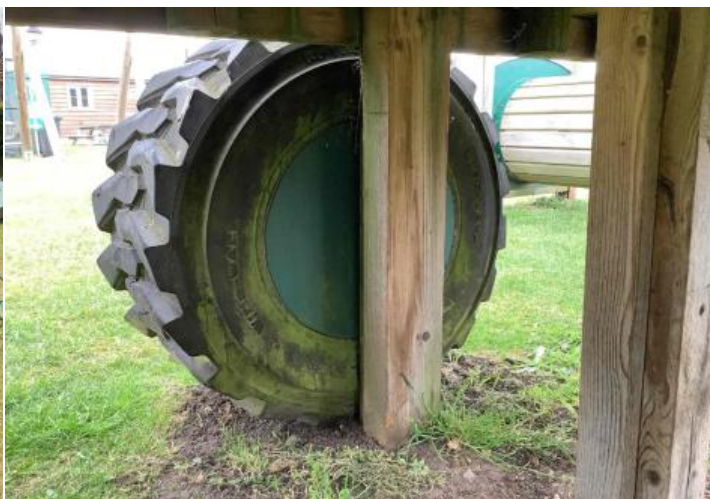
**Item:** Activity Equipment - Tractor  
**Manufacturer:** Not Identified

**Finding:** There is algae or moss on the surface of the equipment

**Action:** Clean and treat appropriately

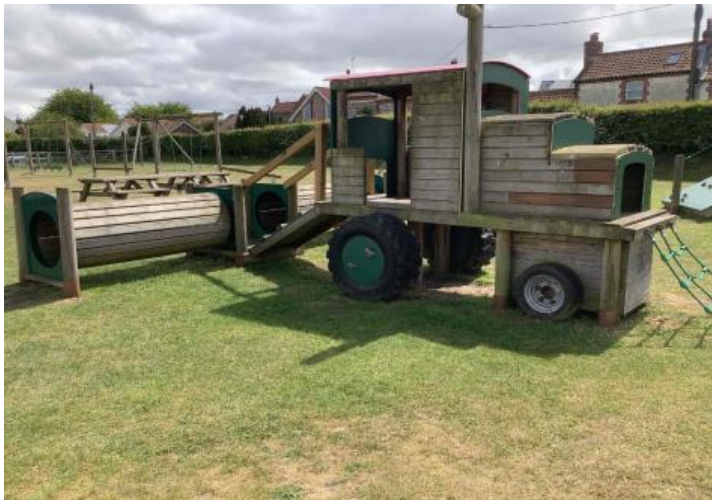
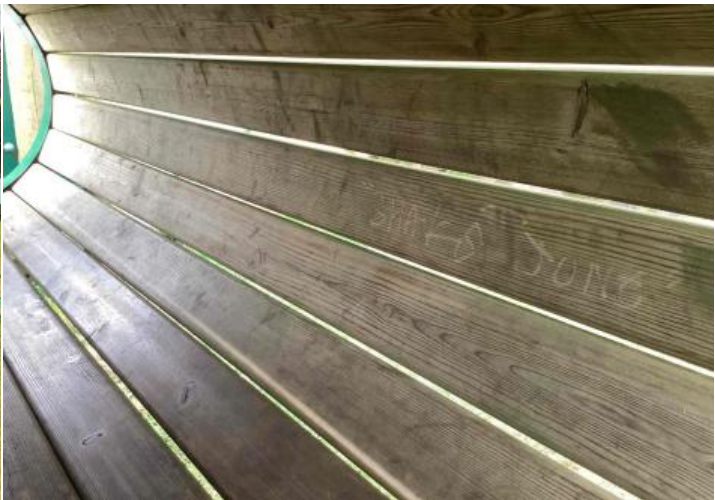
| <b>Item:</b> | Activity Equipment - Tractor | <b>Risk Level:</b> | N - Risk Assessment not Undertaken |

**Finding:** There is some graffiti present

**Action:** Remove the graffiti

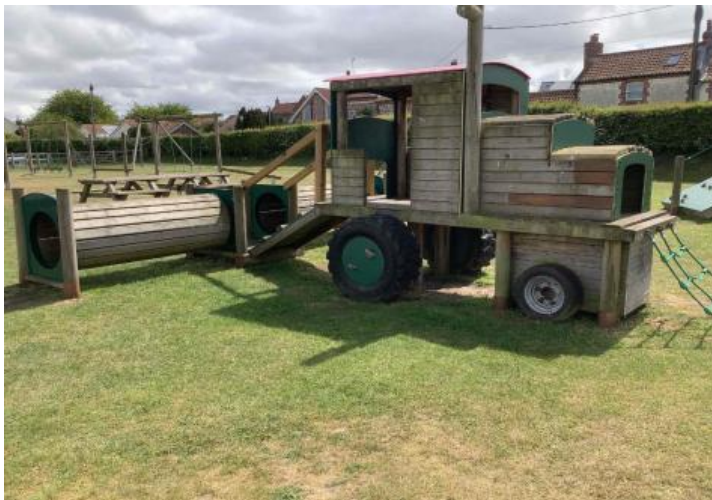
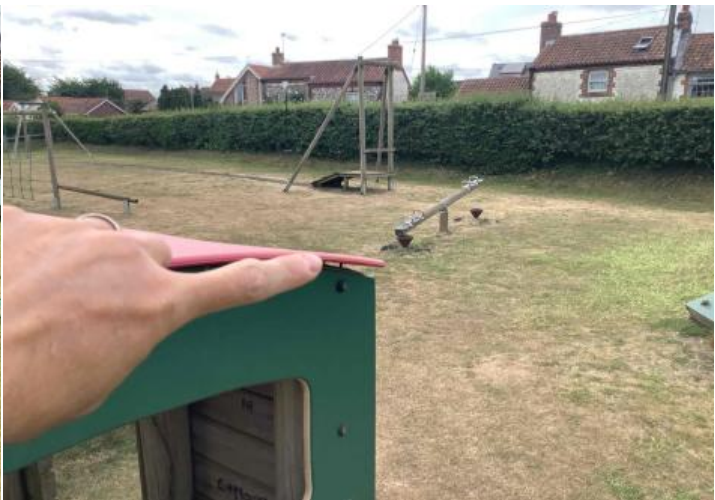
| <b>Item:</b> | Activity Equipment - Tractor | <b>Risk Level:</b> | L - Low Risk |

**Finding:** A number of fixing(s) have worked loose

**Action:** Secure all loose fixings

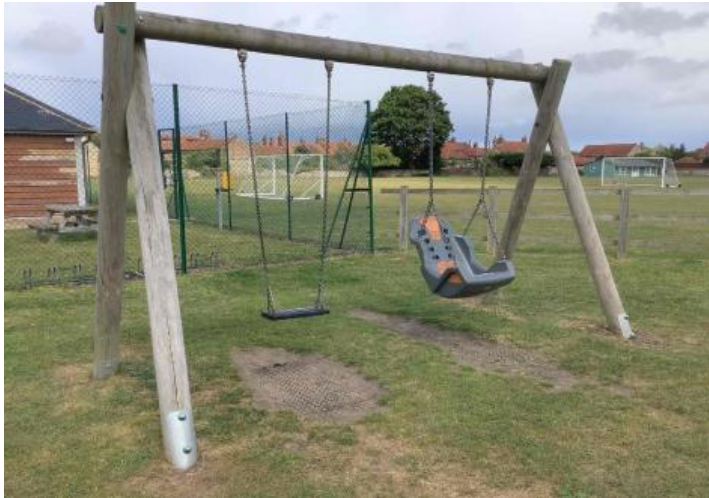
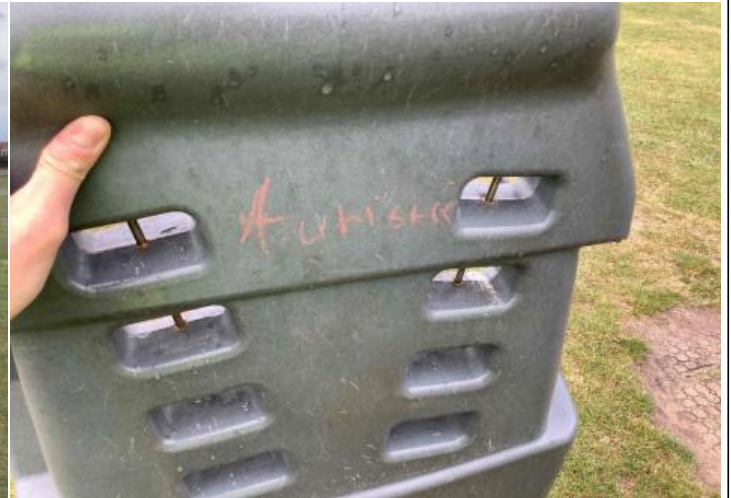
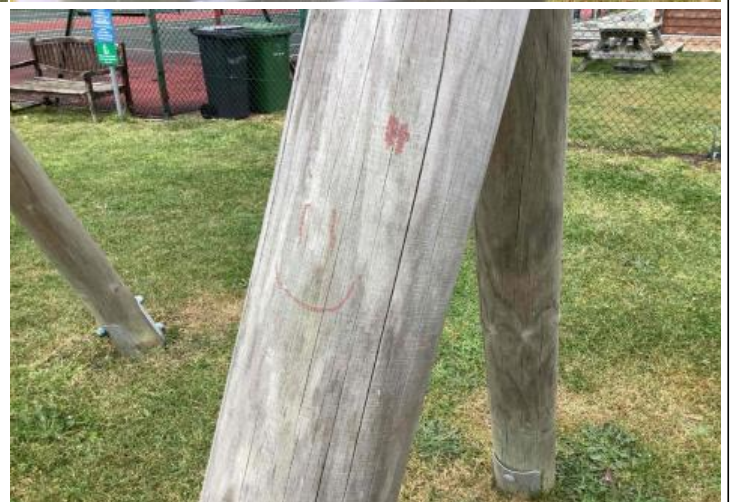
**Item:** Swings - 1 Bay 1 Inclusive 1 Flat Swing  
**Manufacturer:** Action Play and Leisure

**Finding:** There is some graffiti present

**Action:** Remove the graffiti

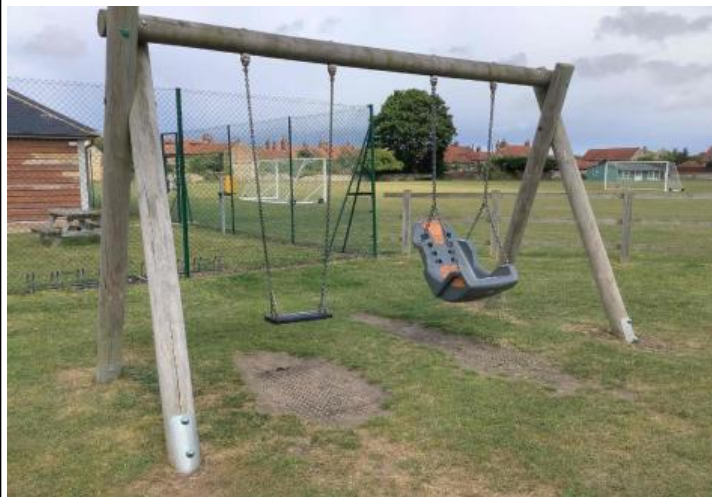
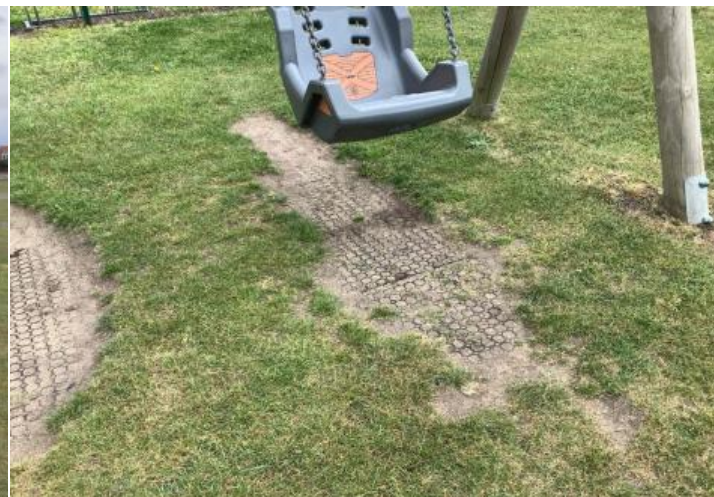
**Item:** Swings - 1 Bay 1 Inclusive 1 Flat Swing  
**Manufacturer:** Action Play and Leisure

**Finding:** There are gaps opening between the surfacing and the edging surround or between the joints in the surfacing  
**Action:** Monitor for any further deterioration and repair as required

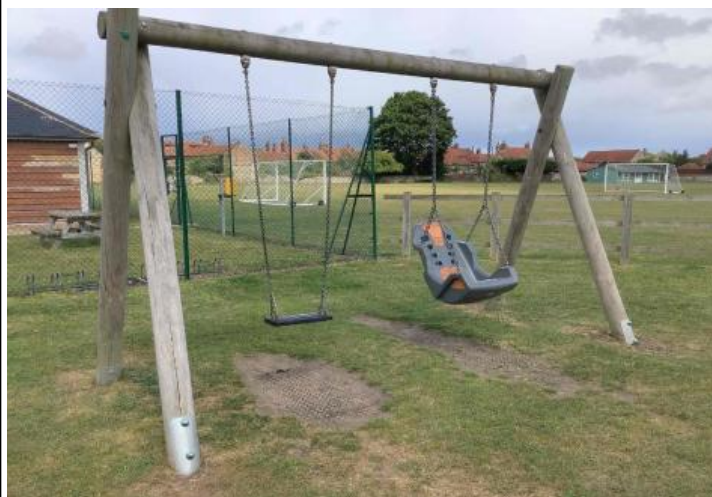
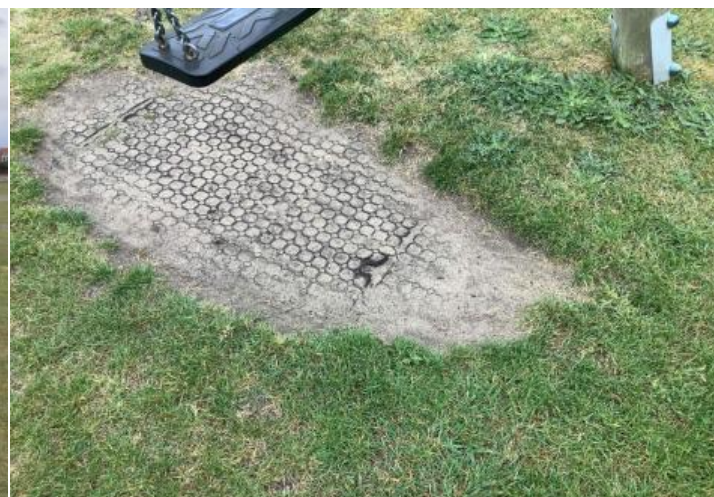
**Item:** Swings - 1 Bay 1 Inclusive 1 Flat Swing  
**Manufacturer:** Action Play and Leisure

**Finding:** There is some minor damage to the surface  
**Action:** Monitor for any further deterioration and repair as required

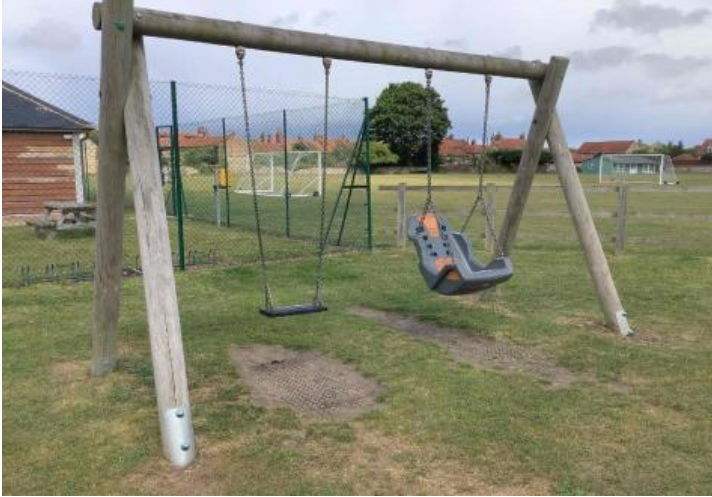
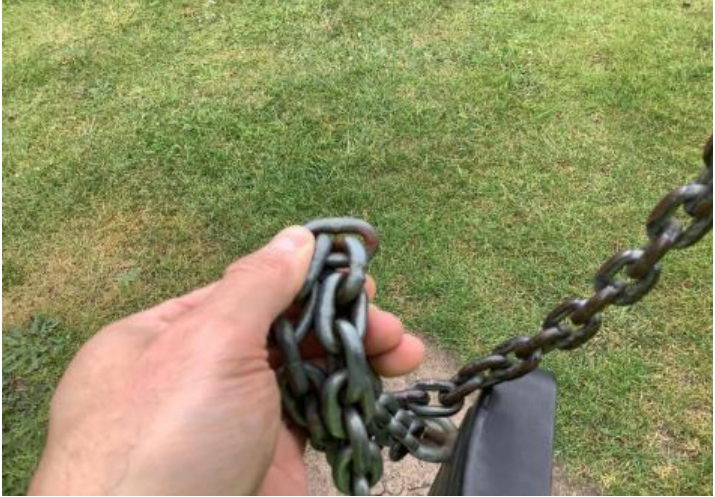
| <div> <div>Finding:</div> <div>There is some notable evidence of chain wear</div> </div> | | <div> </div> <div> <div>Action:</div> <div>Monitor for any further deterioration and replace when 40% worn</div> </div> | |

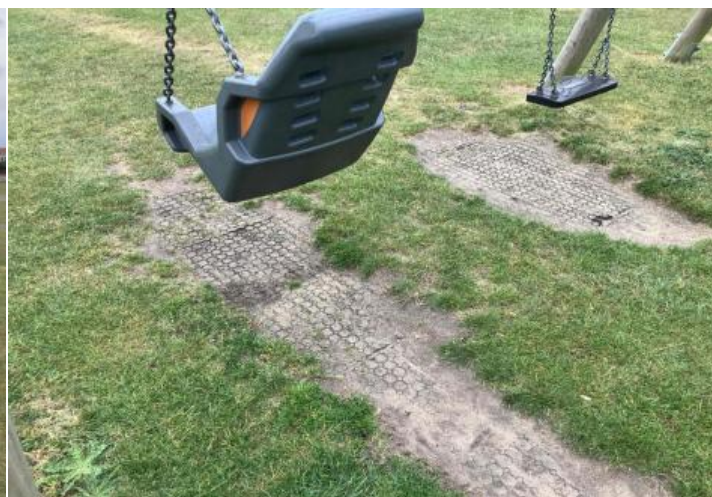
**i** 6 - Low Risk (Finding 5)

**Finding:** The surface has eroded in some areas and may be slippery in wet conditions  
**Action:** Reinstate the surface

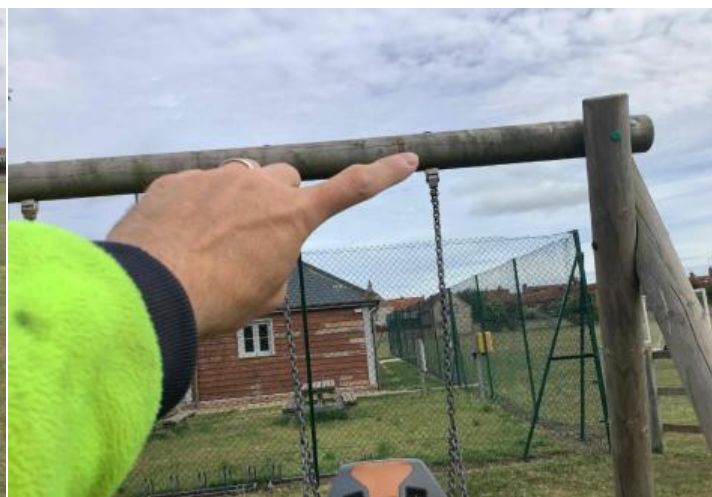
**i** 6 - Low Risk (Finding 6)

**Finding:** A number of fixing(s) have worked loose where the suspensions pass through the cross bar  
**Action:** Secure all loose fixings

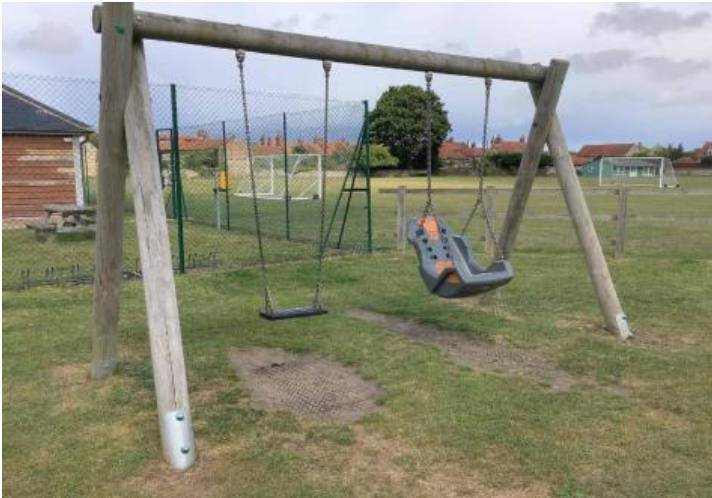
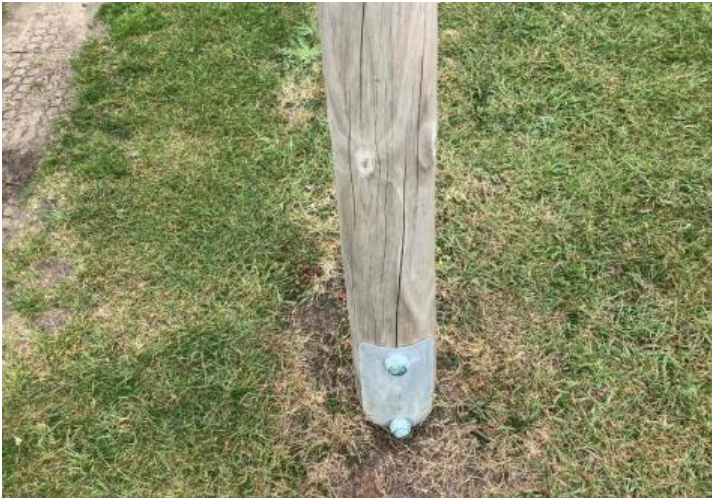
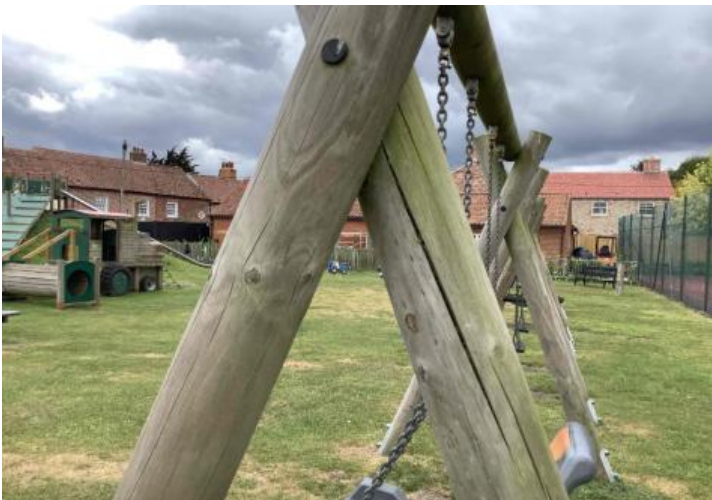
| <b>Finding:</b> The timber has a number of splits/shakes or air cracks and this may affect the stability or allow water ingress which will accelerate the rotting process. Timber splits may also create rough / splintering edges. | | <b>Action:</b> Monitor, sand down any rough edges and ensure the splits do not cross through fixing points of the structure and/or cause any instability | |

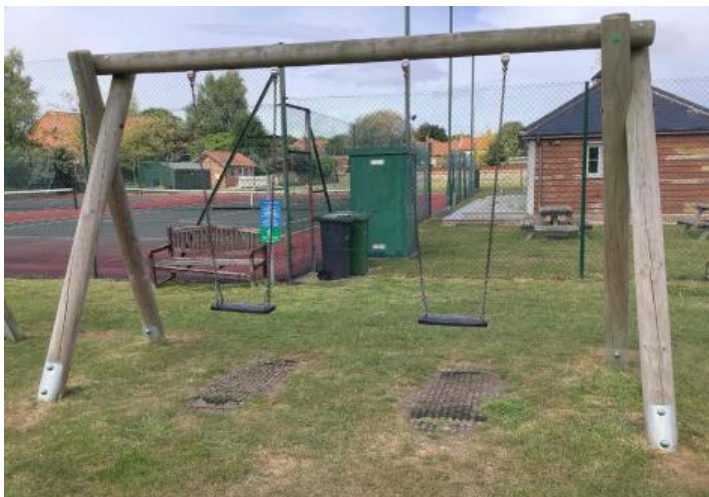
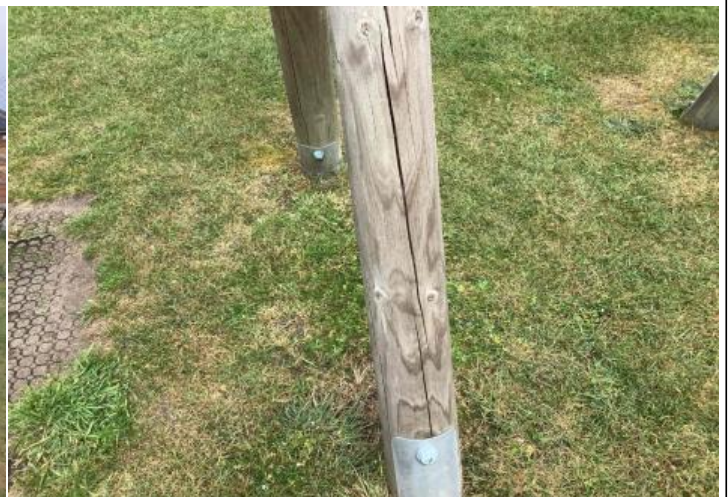
**i** 6 - Low Risk (Finding 2)

**Finding:** The timber has a number of splits/shakes or air cracks and this may affect the stability or allow water ingress which will accelerate the rotting process. Timber splits may also create rough / splintering edges.  
**Action:** Monitor, sand down any rough edges and ensure the splits do not cross through fixing points of the structure and/or cause any instability

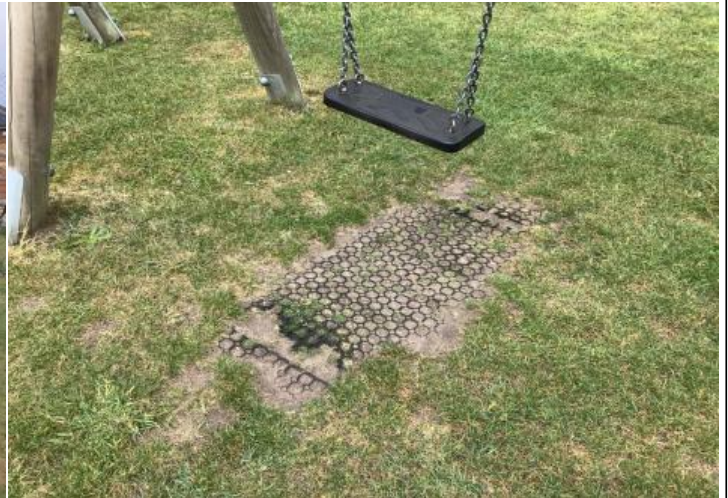
**Finding:** There is moderate damage to the surface

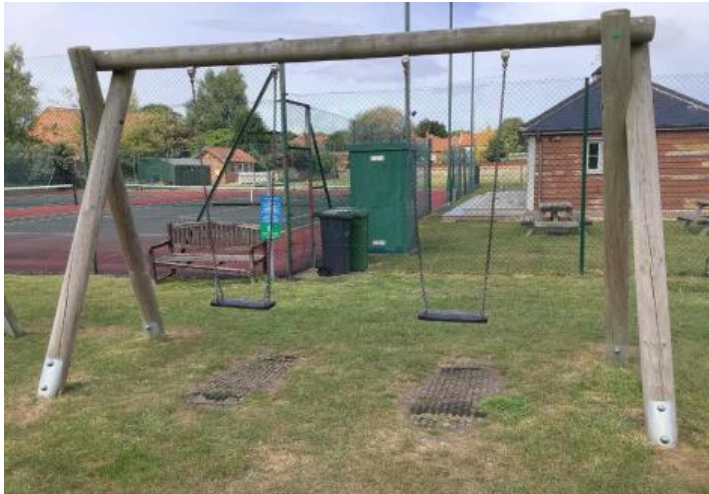
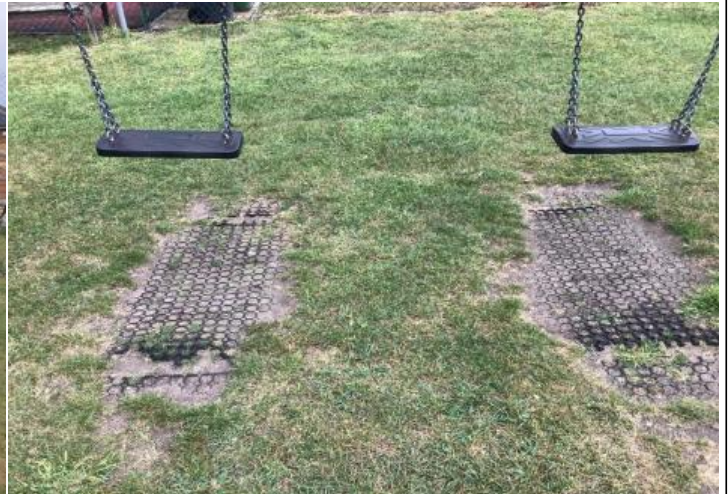
**Finding:** There are gaps opening between the surfacing and the edging surround or between the joints in the surfacing

**Action:** Monitor for any further deterioration and repair as required

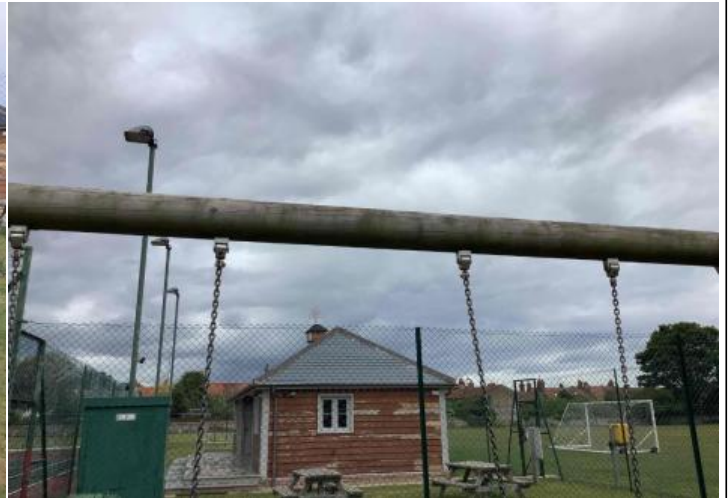
**Finding:** A number of fixing(s) have worked loose where the suspensions pass through the cross bar  
**Action:** Secure all loose fixings

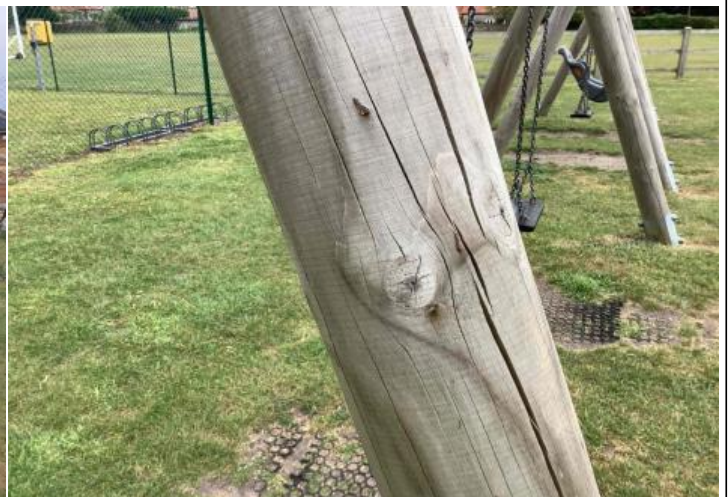
**Finding:** There are sharp protruding staples on the item  
**Action:** Remove staples

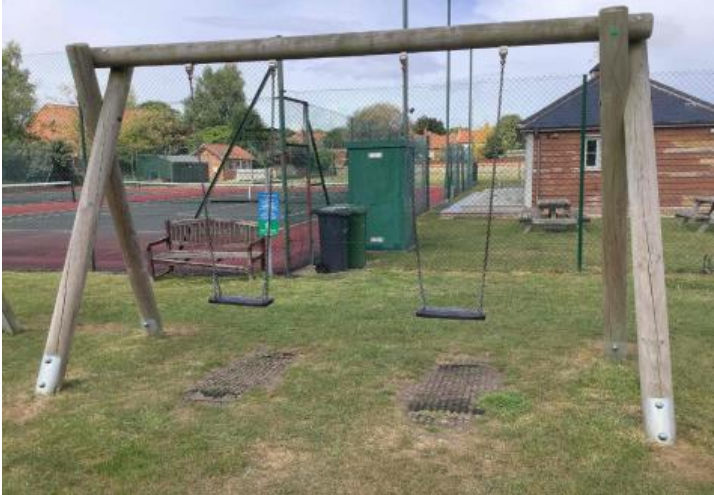
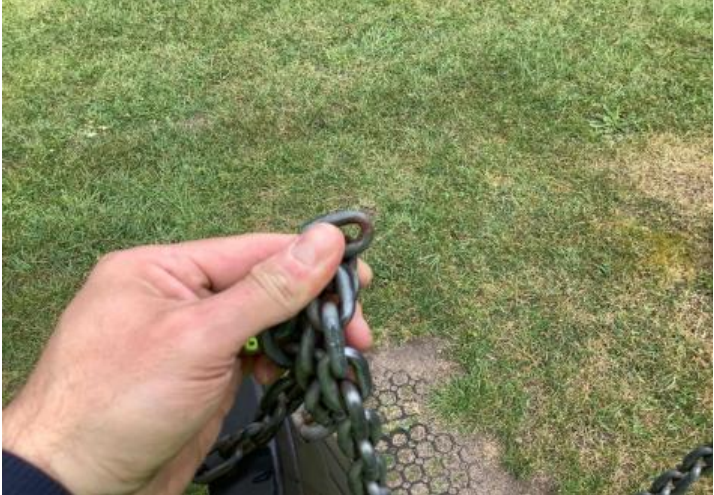
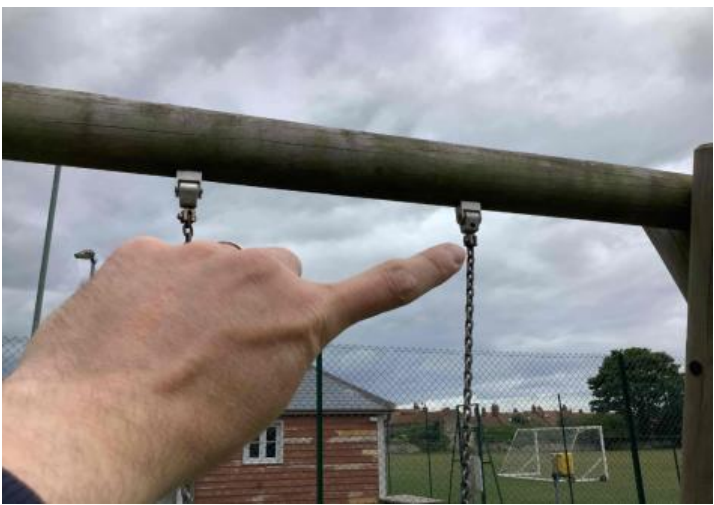
| <div> <div></div> <div>6 - Low Risk (Finding 7)</div> </div> | | | |

| <div> <div></div> <div>6 - Low Risk (Finding 7)</div> </div> | | | |
|---|--|---|--|
| <div> <div>Finding:</div> <div>There is some notable evidence of chain wear</div> </div> | | <div> </div> <div> <div>Action:</div> <div>Monitor for any further deterioration and replace when 40% worn</div> </div> | |

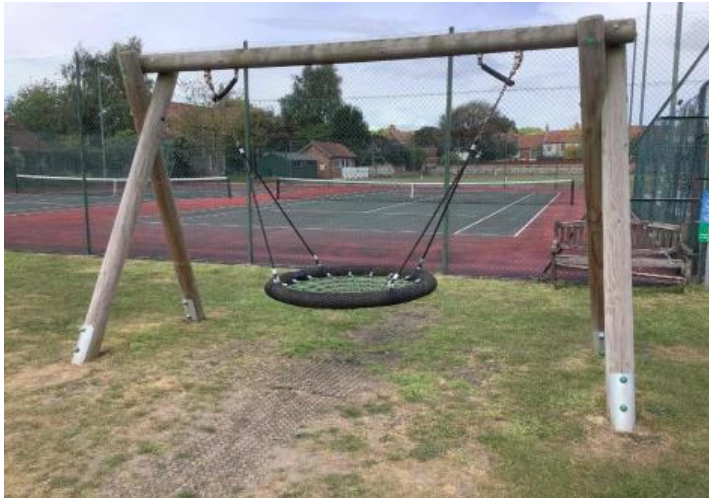
**i** 6 - Low Risk (Finding 1)

**Finding:** A number of fixing(s) have worked loose where the suspensions pass through the cross bar  
**Action:** Secure all loose fixings

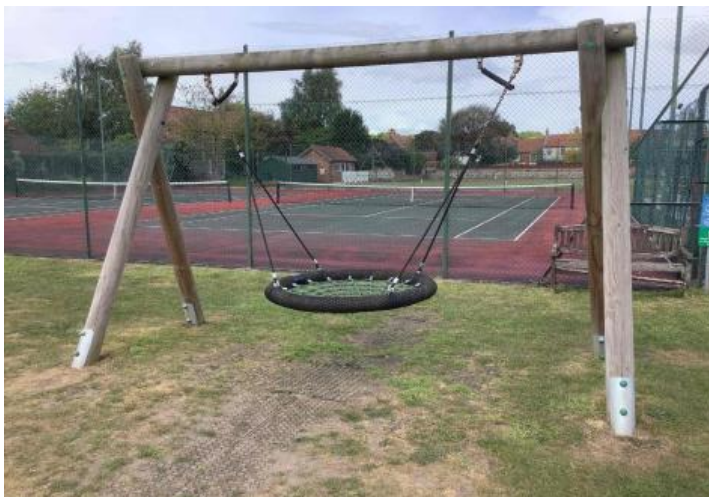
**i** 6 - Low Risk (Finding 2)

**Finding:** The surface has eroded in some areas and may be slippery in wet conditions  
**Action:** Reinstate the surface

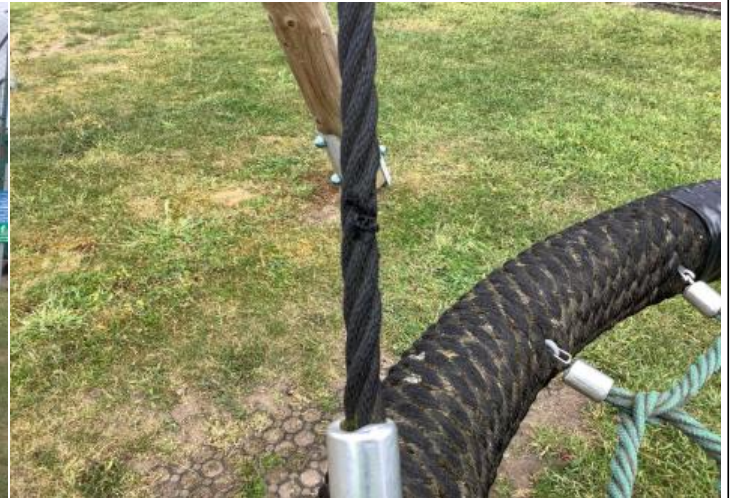
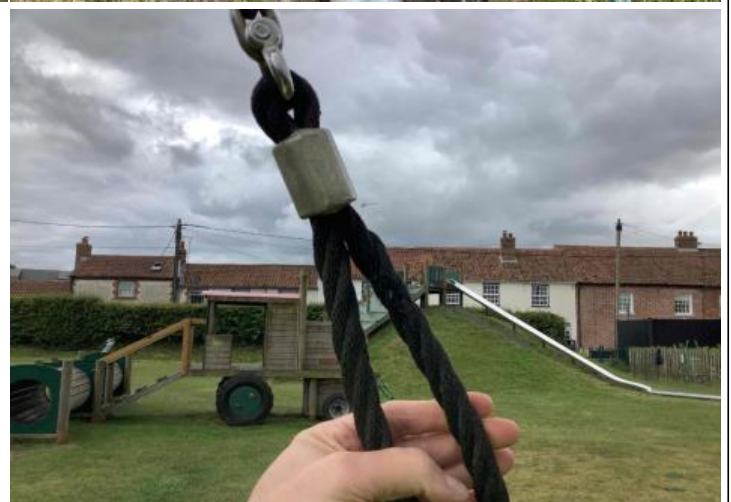
**Finding:** The ropes/nets are worn/damaged in places

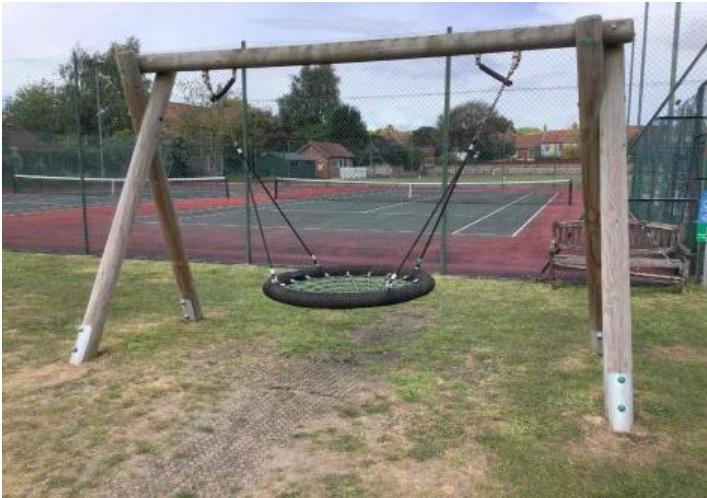
**Finding:** There are gaps opening between the surfacing and the edging surround or between the joints in the surfacing **Action:** Monitor for any further deterioration and repair as required

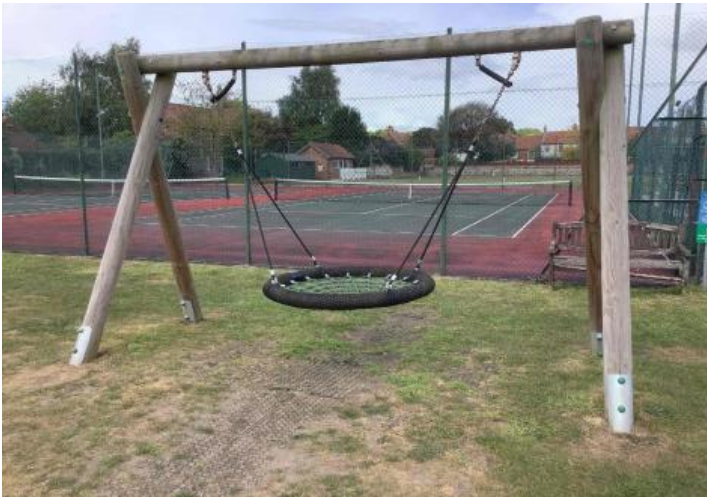
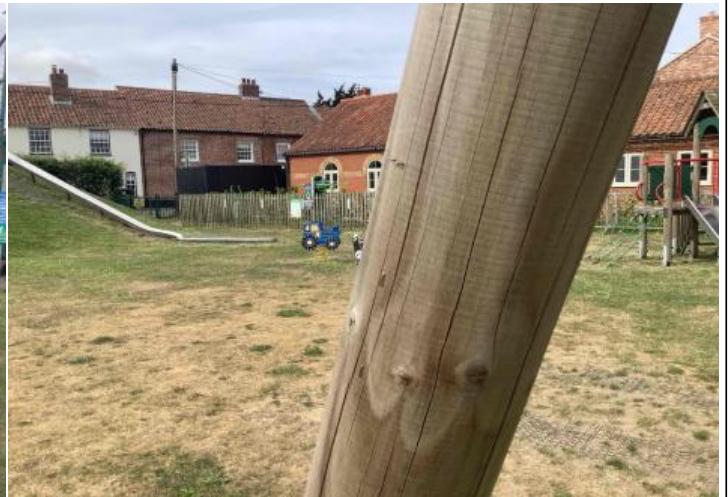
**i** 6 - Low Risk (Finding 5)

**Finding:** There are sharp protruding staples on the item **Action:** Remove staples
