## BURNHAM MARKET PARISH COUNCIL ANNUAL GENERAL MEETING Minutes

Date: Wednesday 6<sup>th</sup> May 2026 at 6.30pm |

## Burnham Market Play Area

# Safety Inspection Report

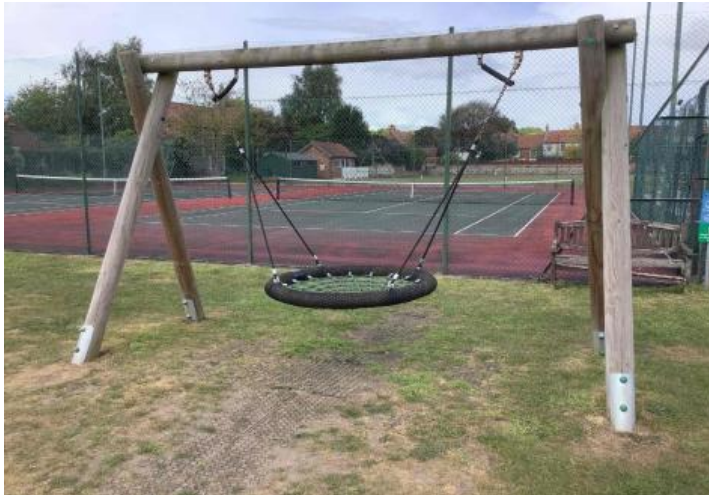
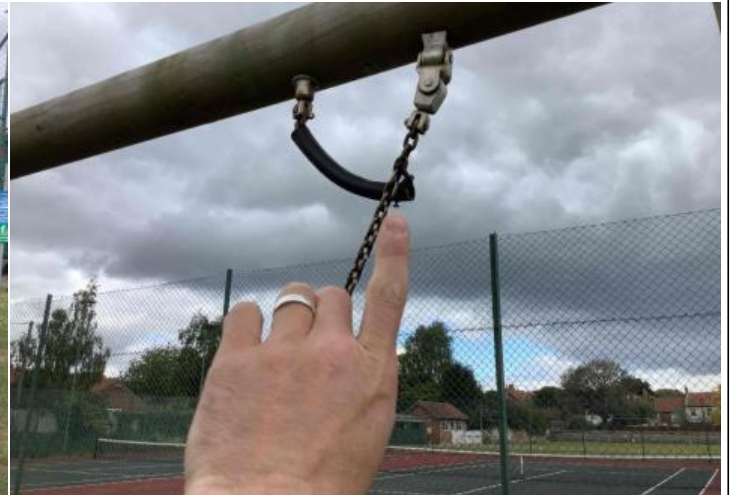
**i** 6 - Low Risk (Finding 6)

**Finding:** A number of fixing(s) have worked loose

**Action:** Secure all loose fixings

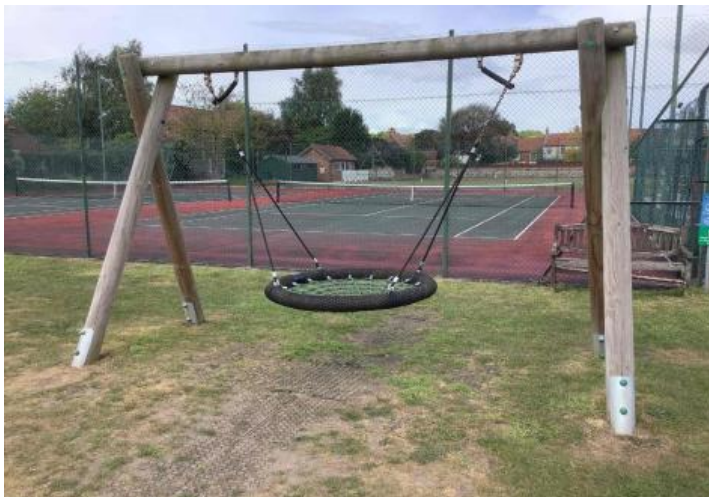
**Finding:** The bush / bushes is / are showing signs of wear

**Action:** Monitor for any further deterioration and replace as required

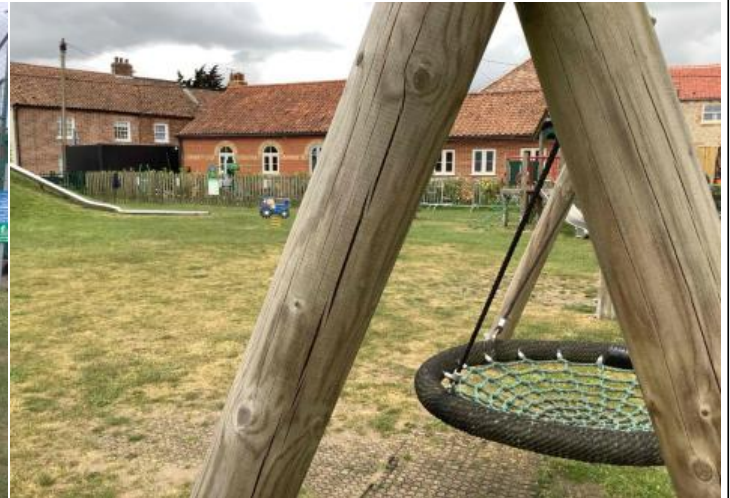
**Finding:** The timber has a number of splits/shakes or air cracks and this may affect the stability or allow water ingress which will accelerate the rotting process. Timber splits may also create rough / splintering edges.

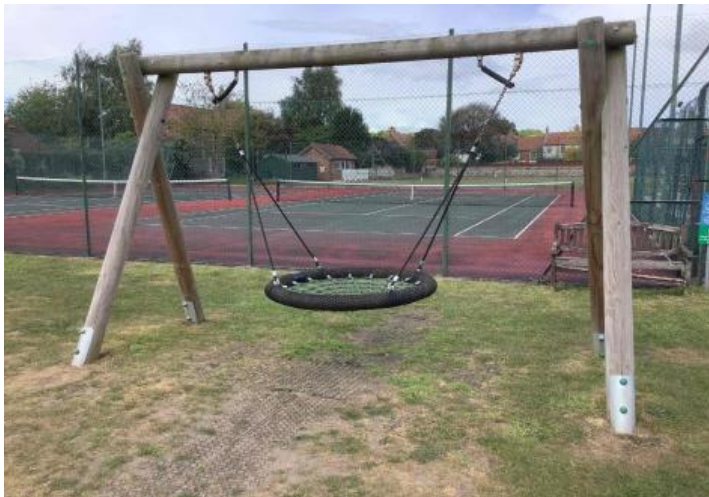
**Finding:** There is some wear to the suspension bolts

**Action:** Monitor and replace when 40% worn

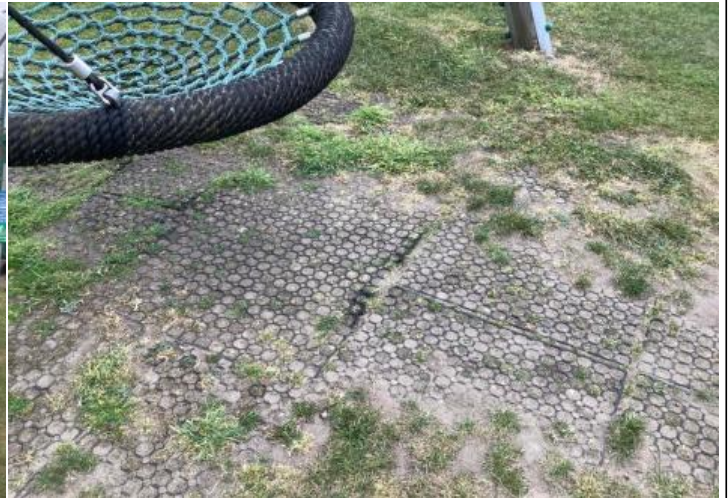
**Finding:** There is some minor damage to the surface

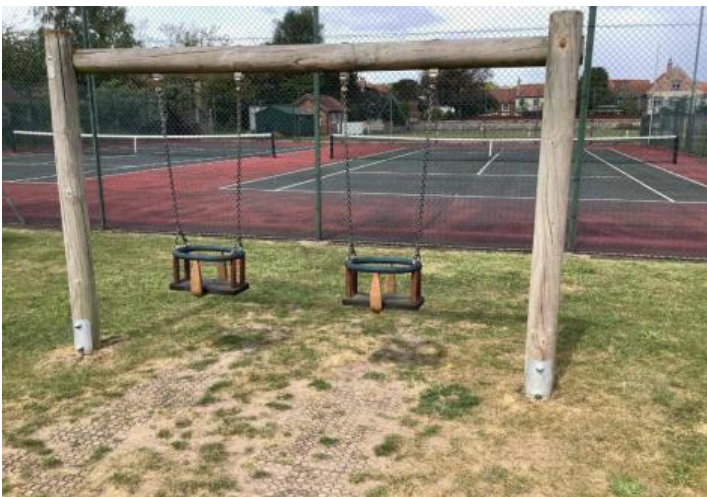
**Finding:** There is some wear to the shackles.

**Action:** Monitor for any further deterioration and replace when 40% worn

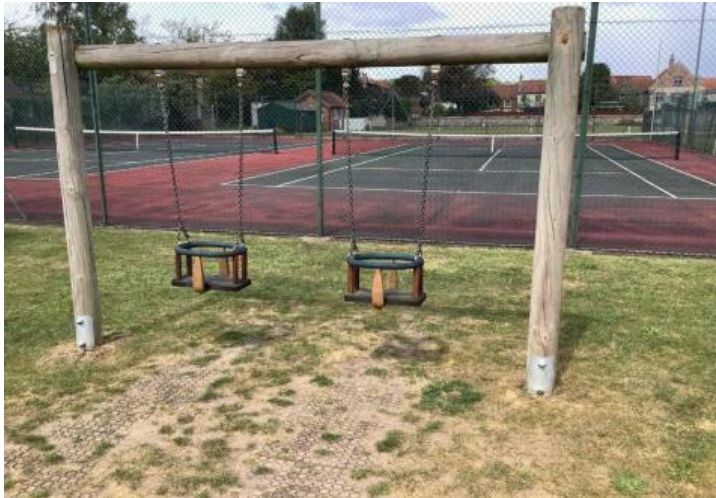
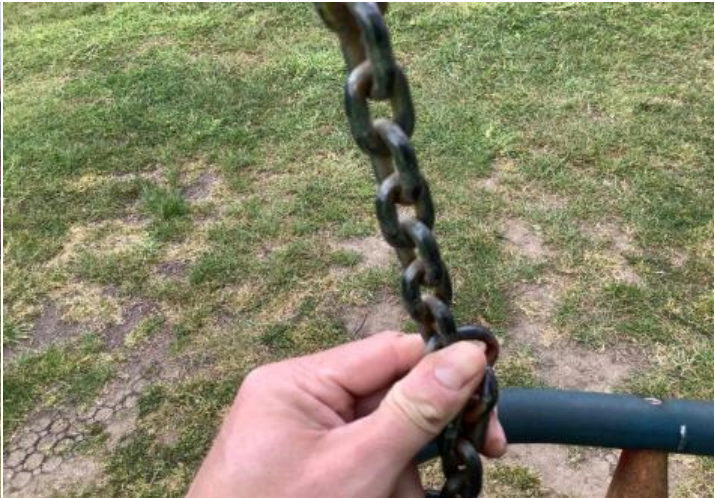
| <b>Finding:</b> There is some notable evidence of chain wear | | <b>Action:</b> Monitor for any further deterioration and replace when 40% worn | |

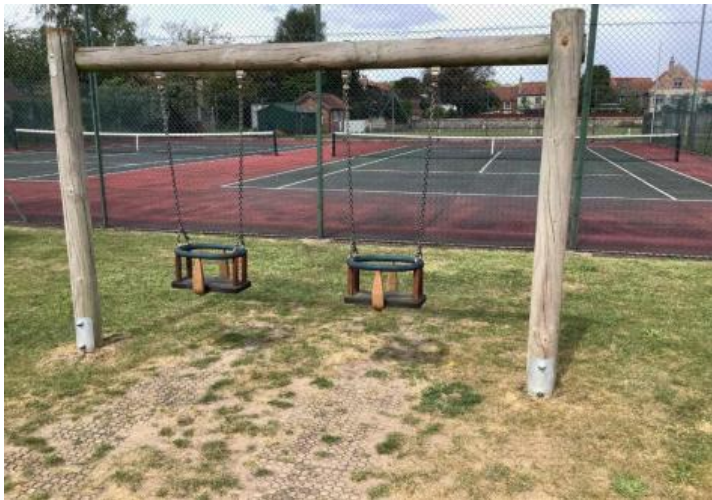
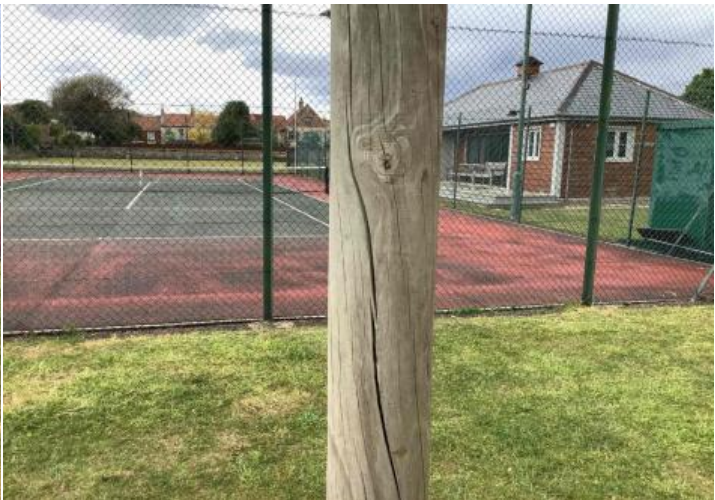
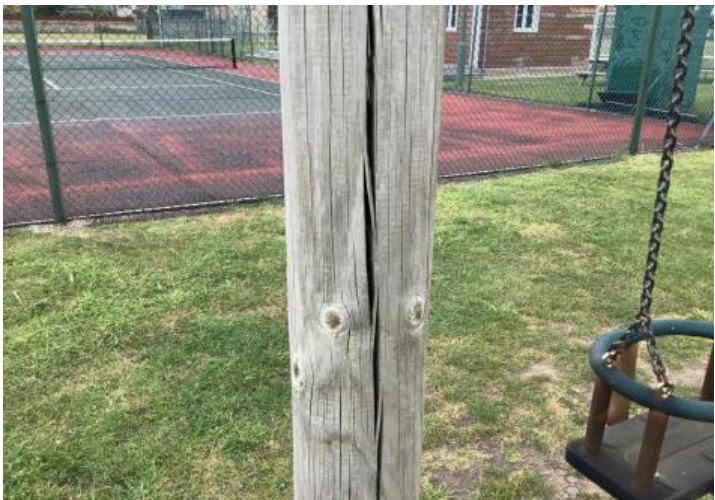
| <div> <div></div> <div>6 - Low Risk (Finding 3)</div> </div> | | | |
|---|--|---|--|
| <div> <div>Finding:</div> <div>The timber has a number of splits/shakes or air cracks and this may affect the stability or allow water ingress which will accelerate the rotting process. Timber splits may also create rough / splintering edges.</div> </div> | | <div> <div>Action:</div> <div>Monitor, sand down any rough edges and ensure the splits do not cross through fixing points of the structure and/or cause any instability</div> </div> | |

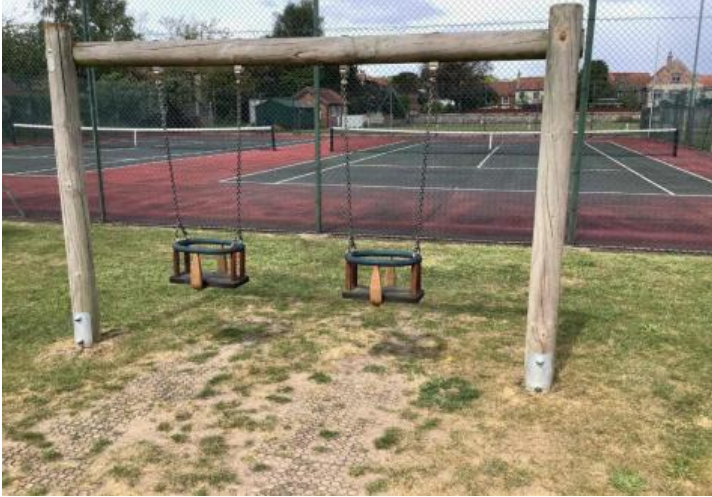
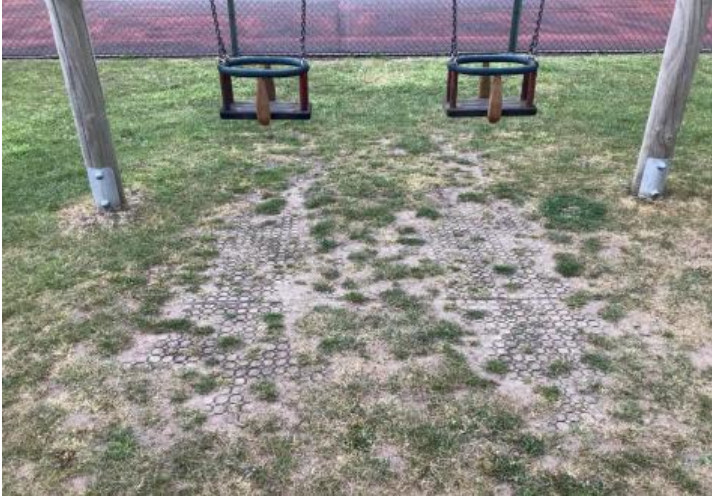
Finding:

The surface has eroded in some areas and may be slippery in wet conditions

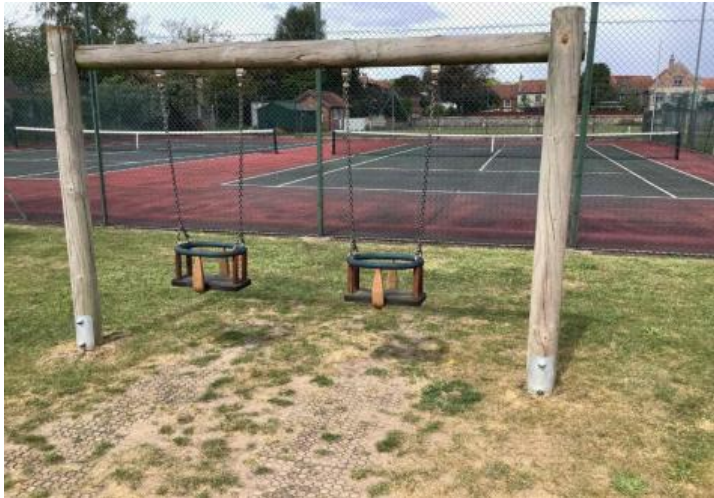
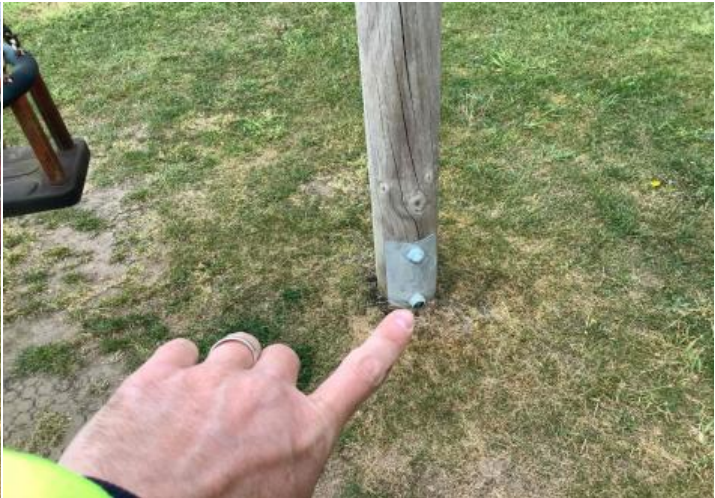
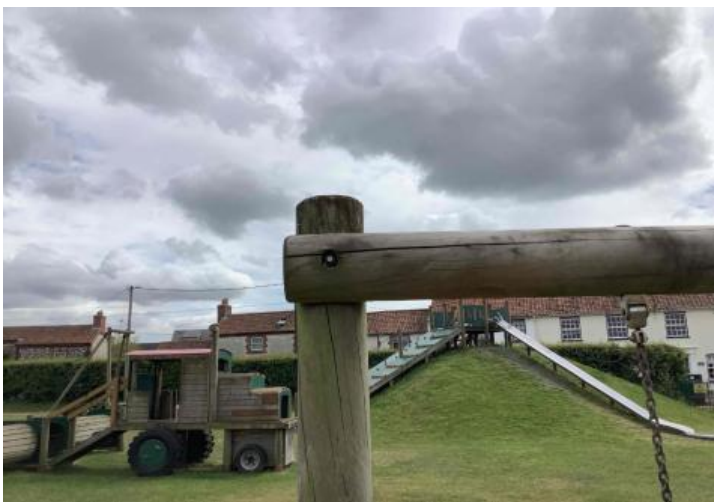
| <div> 4 - Very Low Risk (Finding 5) </div> | | | |

| <div> 4 - Very Low Risk (Finding 5) </div> | | | |
|---|--|---|--|
| <b>Finding:</b> Bolt cap cover/s missing or damaged | | <b>Action:</b> Replace | |

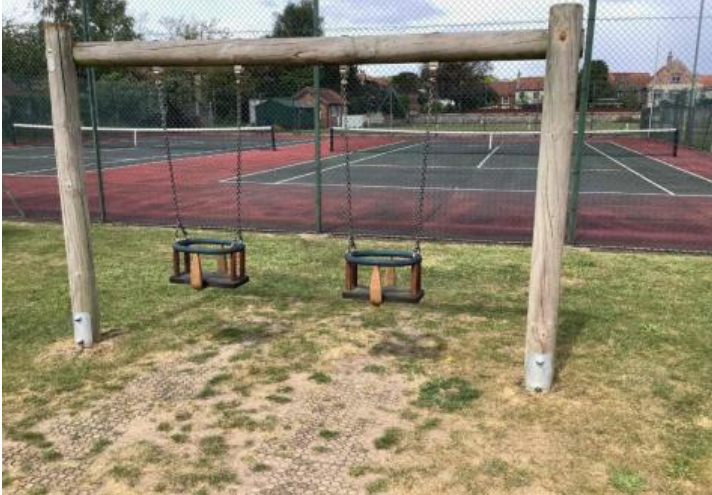
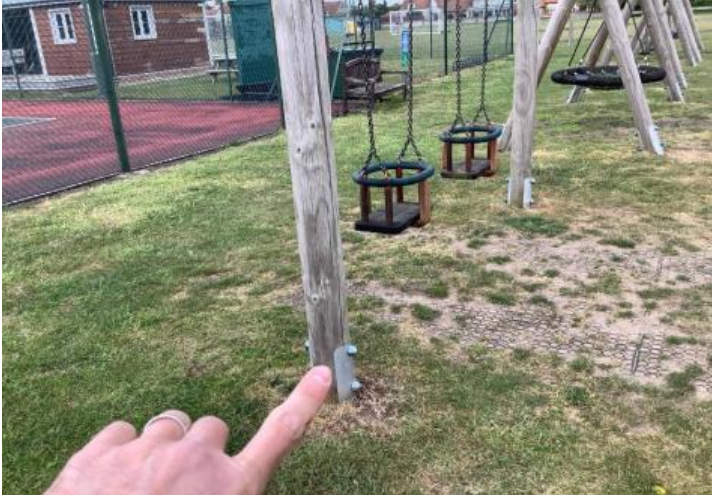
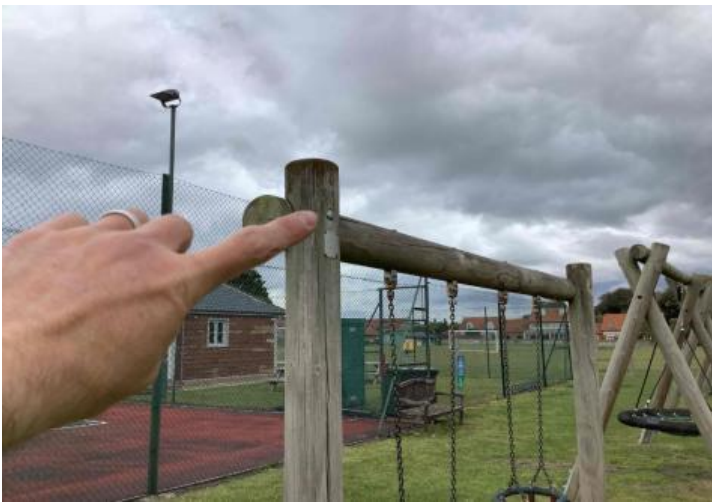
Finding: A number of fixing(s) have worked loose

Action: Secure all loose fixings

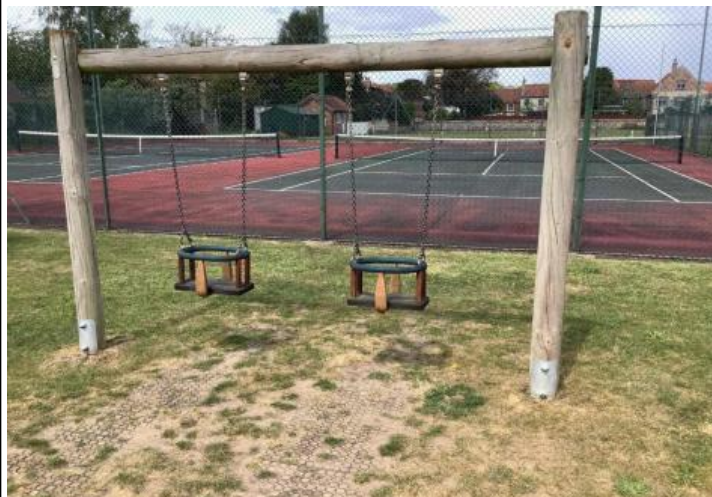
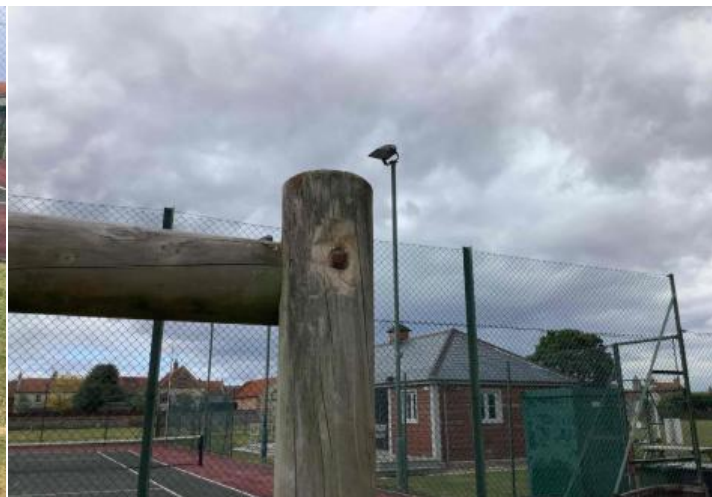
**Item:** Swings - 1 Bay 2 Seat (Cradle)  
**Manufacturer:** Adventure Playgrounds

**Finding:** The item has been damaged

**Action:** Monitor for any further deterioration and replace as required

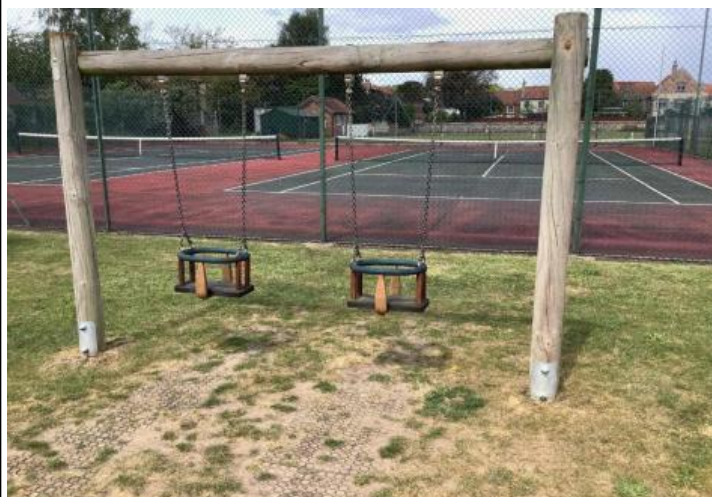
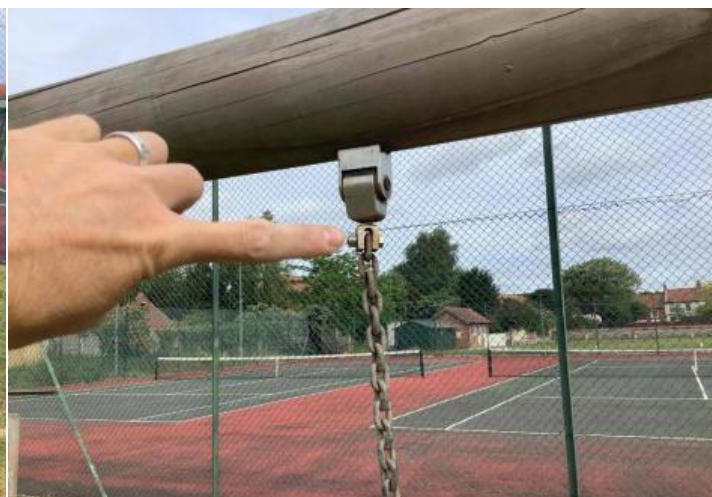
**Item:** Swings - 1 Bay 2 Seat (Cradle)  
**Manufacturer:** Adventure Playgrounds

**Finding:** There is some wear to the suspension bolts

**Action:** Monitor and replace when 40% worn

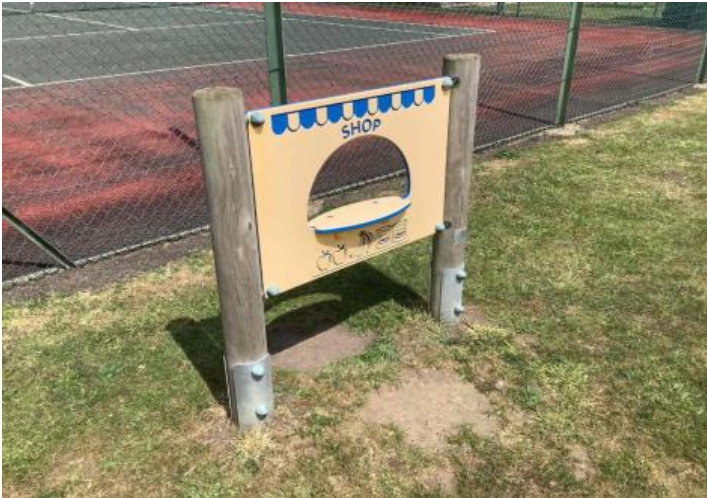
**Item:** Activity Equipment - Play Panel  
**Manufacturer:** Action Play and Leisure

**Finding:** The timber has a number of splits/shakes or air cracks and this may affect the stability or allow water ingress which will accelerate the rotting process. Timber splits may also create rough / splintering edges.

**Action:** Monitor, sand down any rough edges and ensure the splits do not cross through fixing points of the structure and/or cause any instability

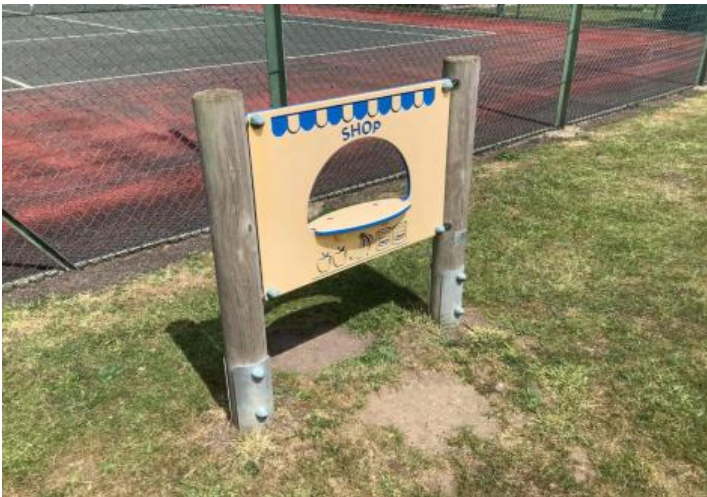
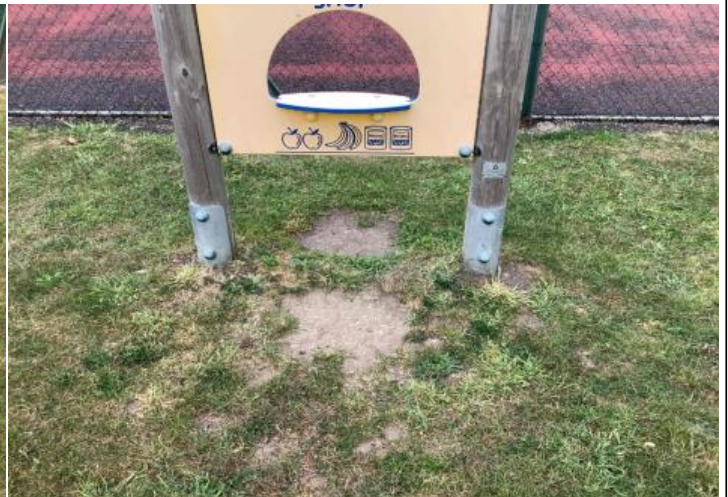
**Item:** Activity Equipment - Play Panel  
**Manufacturer:** Action Play and Leisure

**Finding:** The surface has eroded in some areas and may be slippery in wet conditions

**Action:** Reinstate the surface

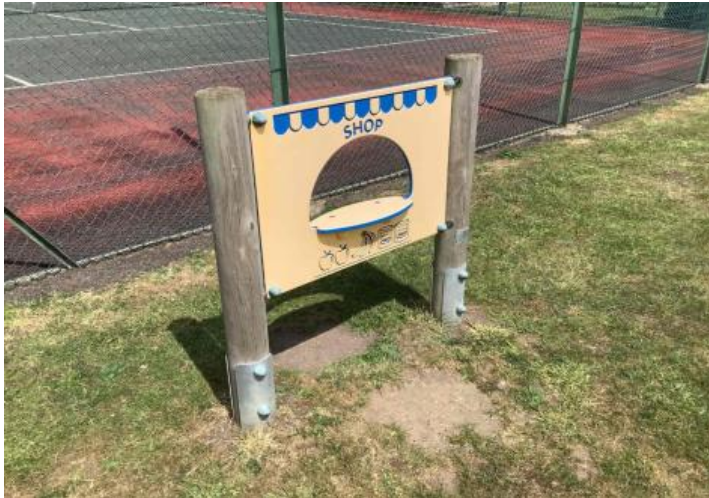
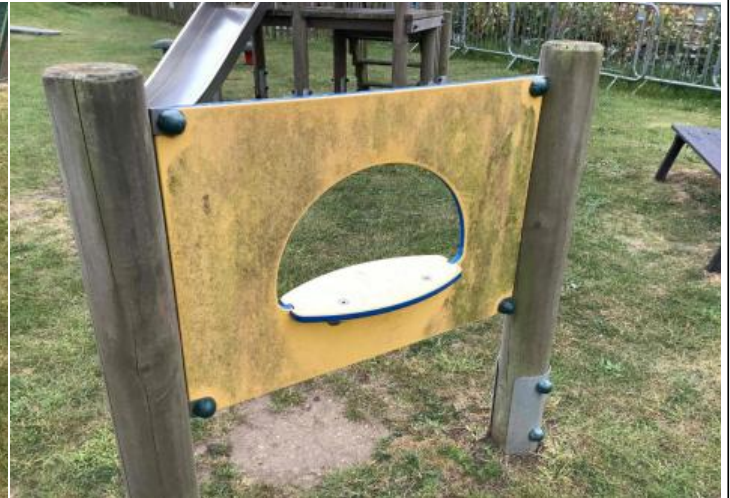
**Item:** Activity Equipment - Play Panel  
**Manufacturer:** Action Play and Leisure

**Finding:** There is algae or moss on the surface of the equipment

**Action:** Clean and treat appropriately

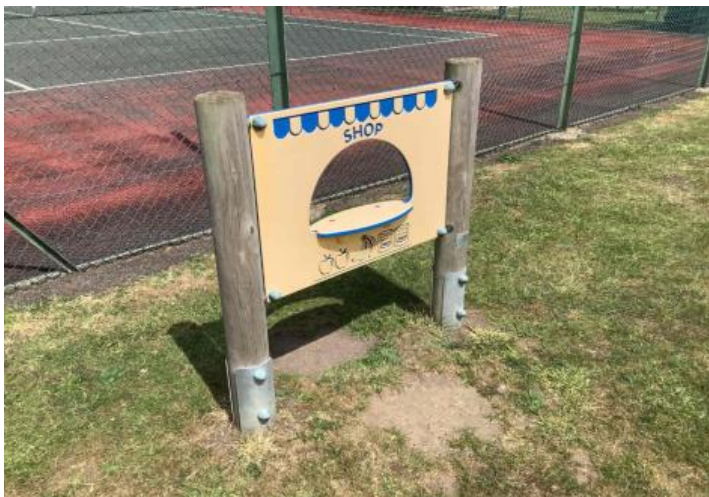
**Item:** Activity Equipment - Play Panel  
**Manufacturer:** Action Play and Leisure

**Finding:** A number of fixing(s) have worked loose

**Action:** Secure all loose fixings

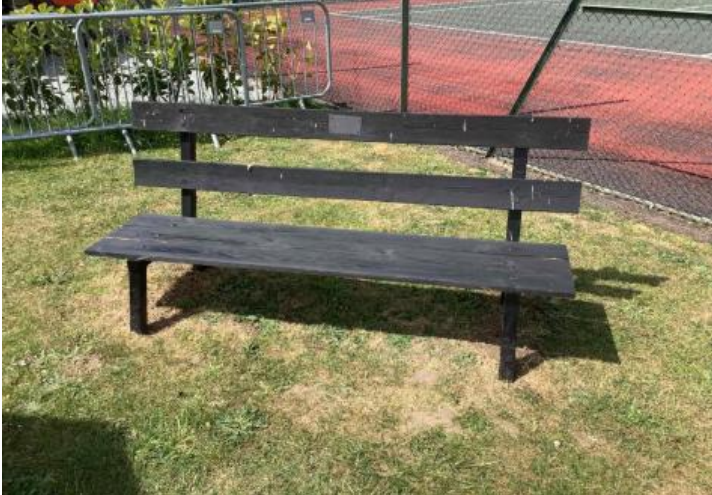
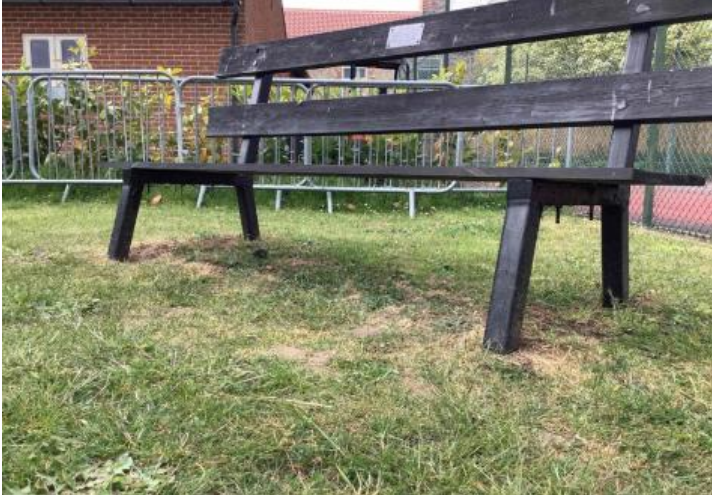
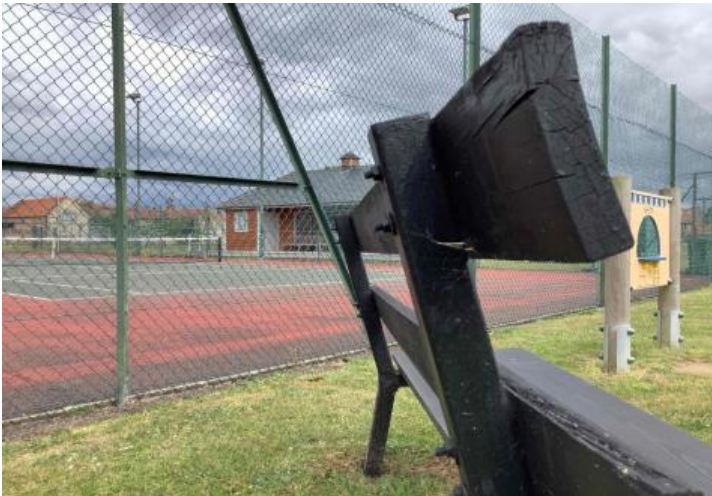
| <div> <div>Item:</div> <div>Ancillary Items - Bench</div> </div> | | <div> <div>Risk Level:</div> <div>L - Low Risk</div> </div> | |
| <div> <div>Finding:</div> <div>There are projecting bolt thread(s) present</div> </div> | | <div> <div>Action:</div> <div>Remove excess thread length and deburr or provide cap</div> </div> | |

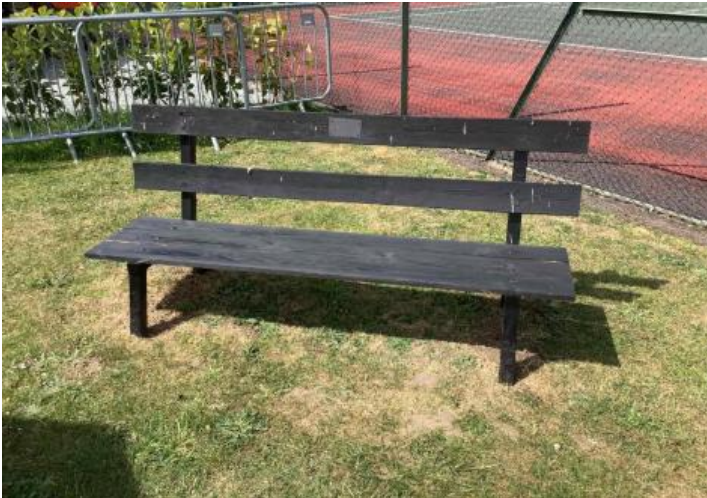
**Item:** Ancillary Items - Bench  
**Manufacturer:** Not Identified

**Finding:** There is some evidence of rot in the timber

**Action:** Monitor for any further deterioration and replace as required

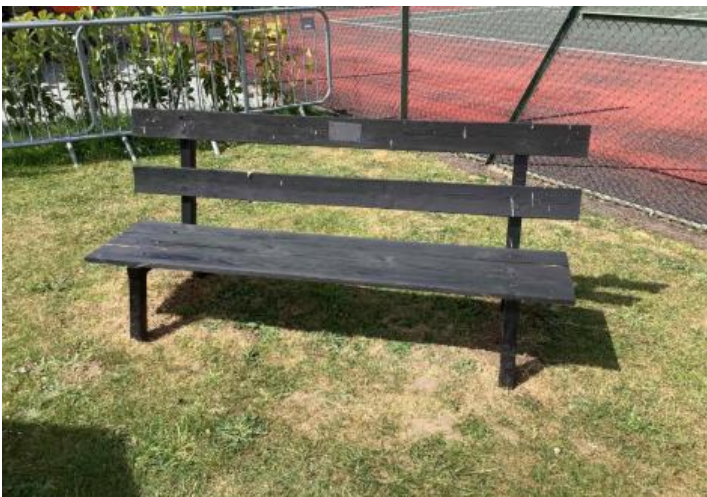
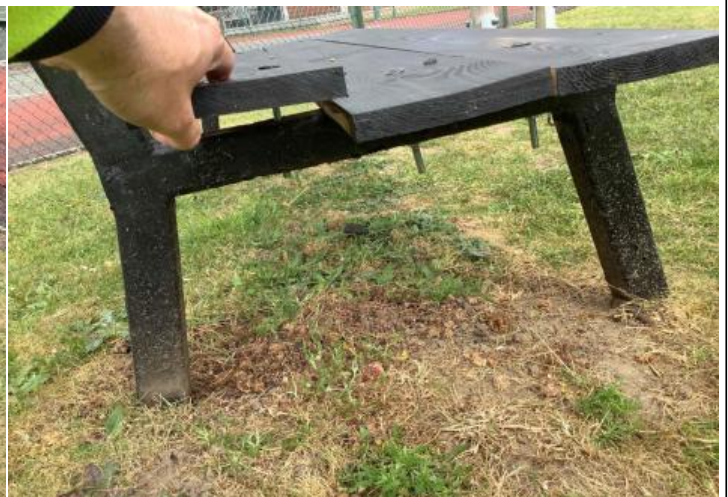
**Item:** Ancillary Items - Bench  
**Manufacturer:** Not Identified

**Finding:** A number of fixing(s) have worked loose

**Action:** Secure all loose fixings

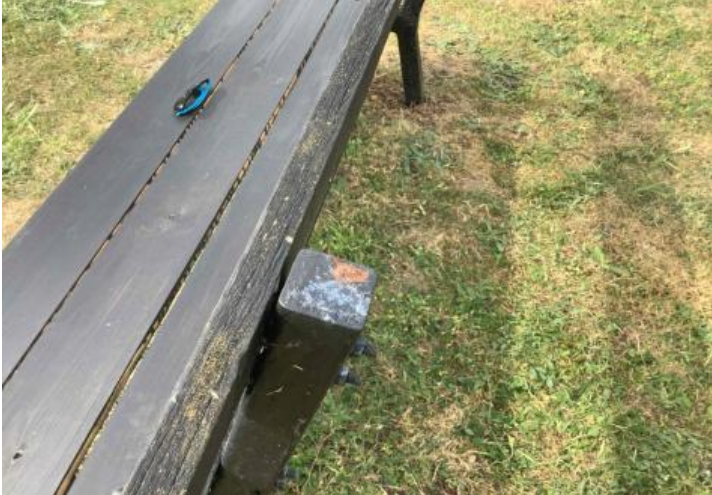
| <div> 4 - Very Low Risk (Finding 4) </div> | | | |
|---|--|---|--|
| <b>Item:</b> Ancillary Items - Bench | | <b>Risk Level:</b> V - Very Low Risk | |
| <b>Finding:</b> The paintwork on this item has been damaged or worn exposing the metal underneath which is rusting / corroding | | <b>Action:</b> Treat affected areas and repaint | |

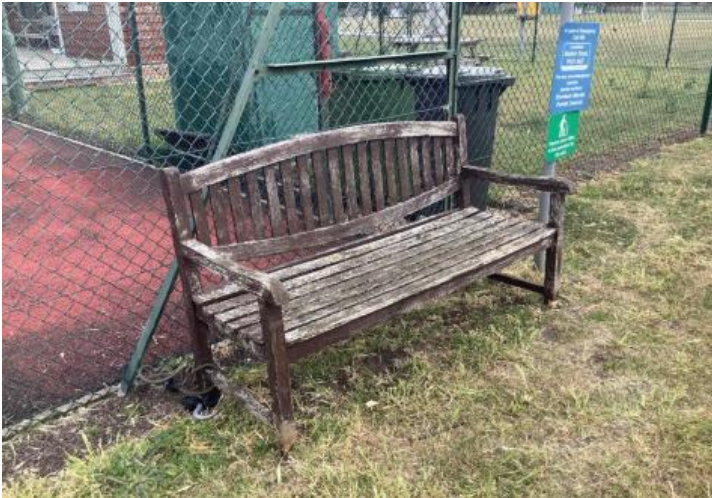
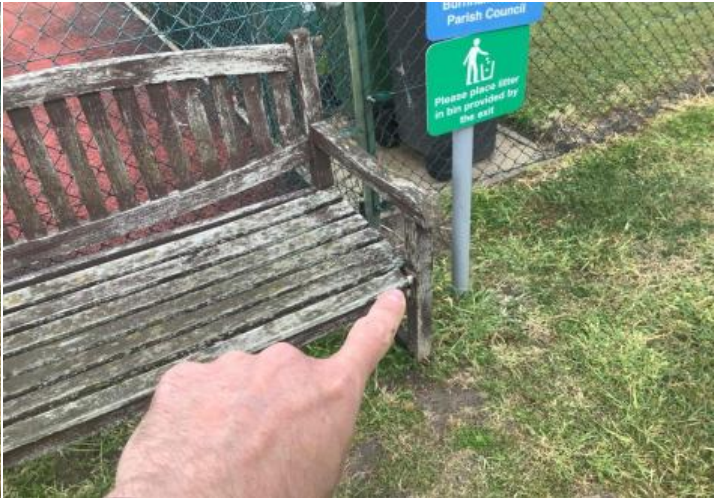
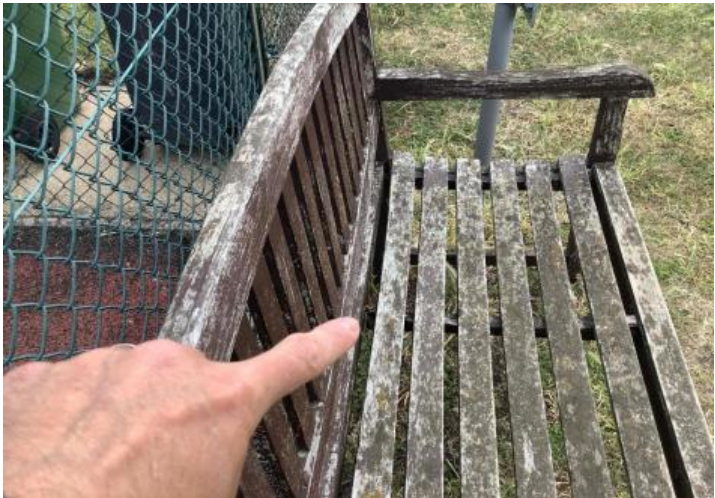
**Item:** Ancillary Items - Bench  
**Manufacturer:** Not Identified

**Finding:** The item has been damaged

**Action:** Repair or replace the item / affected part

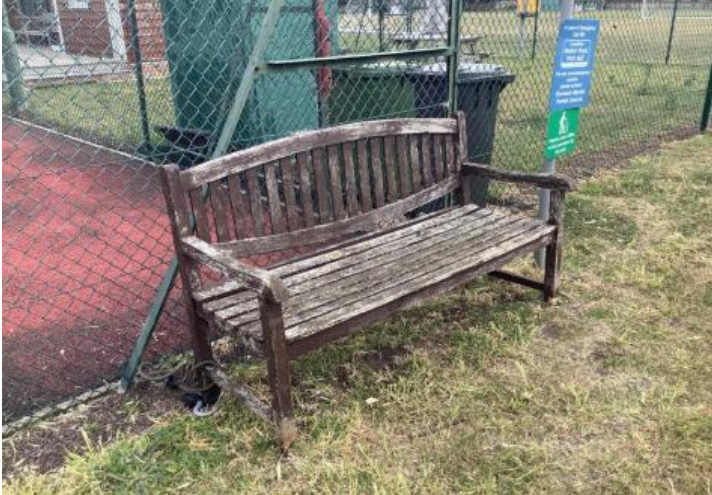
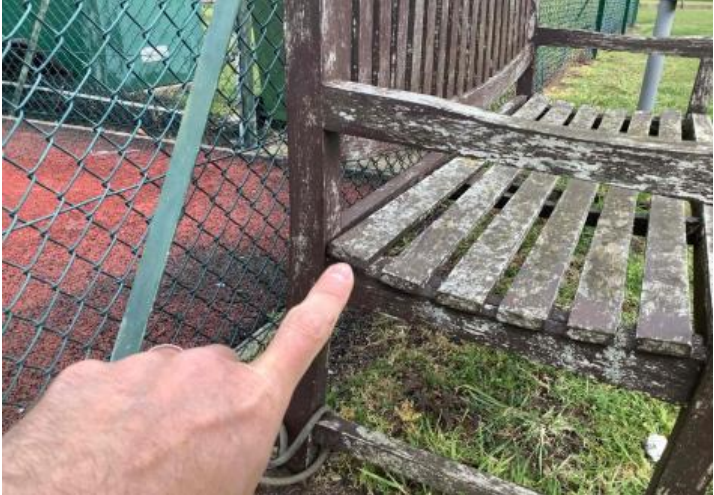
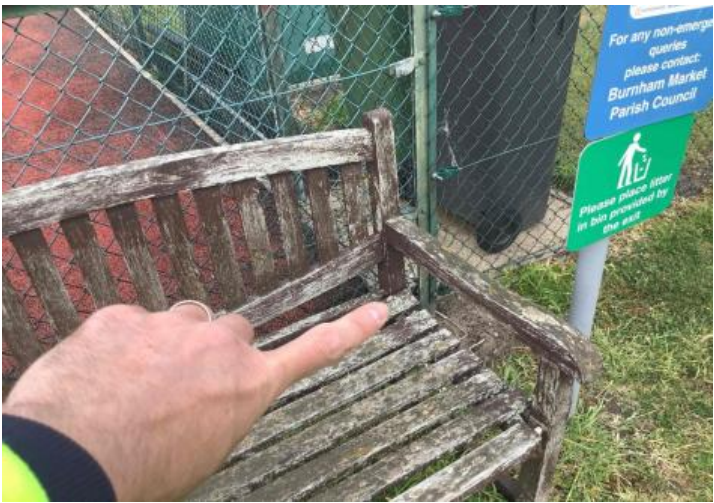
| Item: | Ancillary Items - Bench | Risk Level: | L - Low Risk |
| <b>Finding:</b> A number of fixing(s) have worked loose | | <b>Action:</b> Secure all loose fixings | |

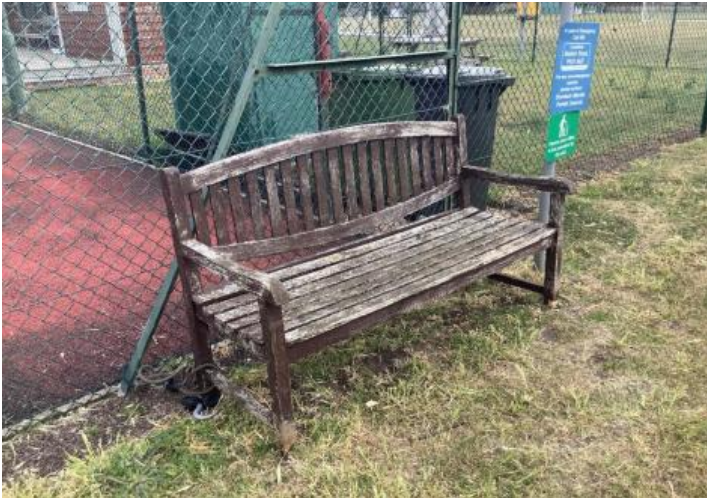
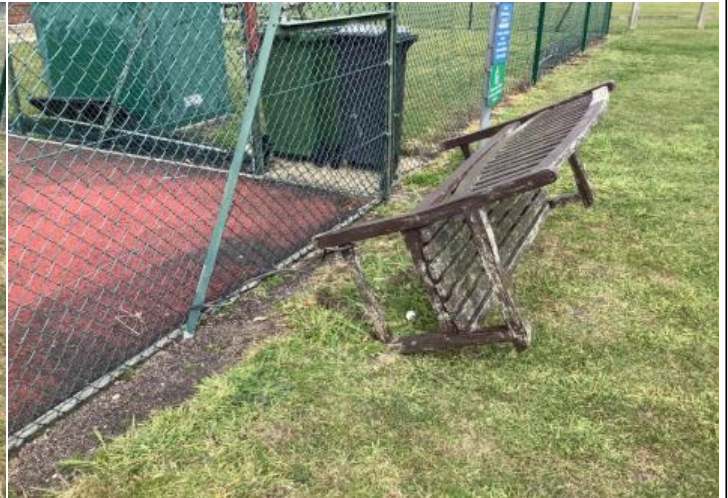
**Item:** Ancillary Items - Bench  
**Manufacturer:** Not Identified

**Finding:** The bench/es is/are not securely fixed to the surface and there is some possibility of the item/s tipping or rolling over

**Action:** Secure to the ground

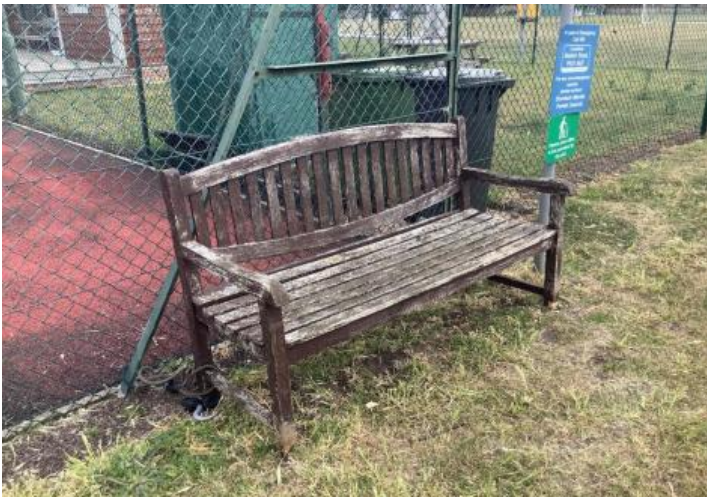
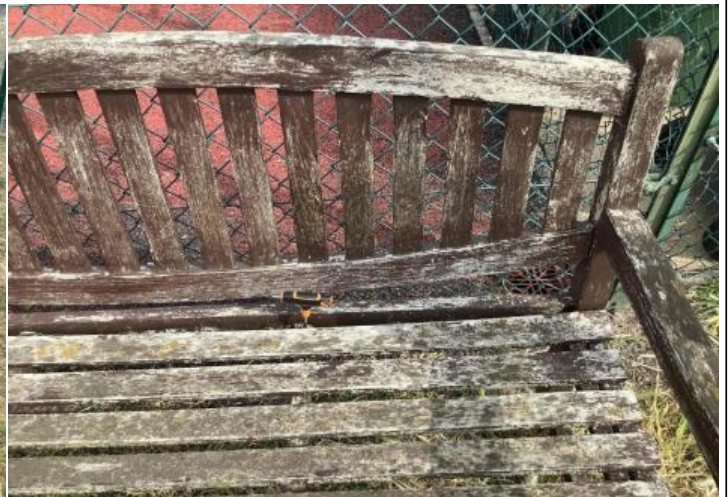
**Item:** Ancillary Items - Bench  
**Manufacturer:** Not Identified

**Finding:** There are areas or parts of the timber on the structure that have rotted

**Action:** Replace all affected timbers

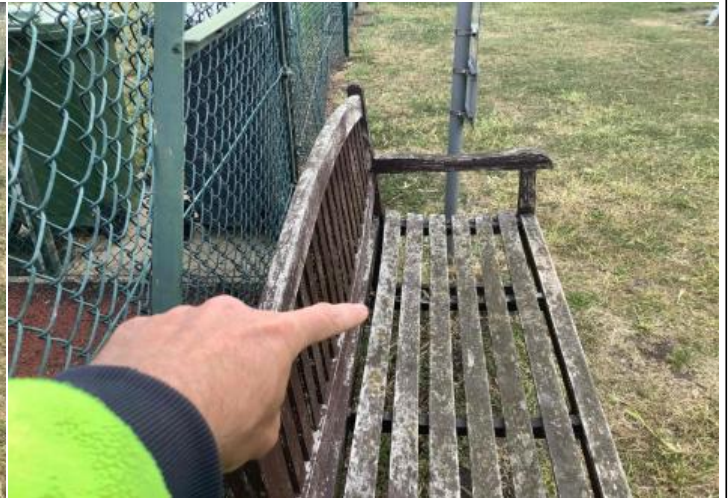
**Finding:** There is or are fixings missing on the item

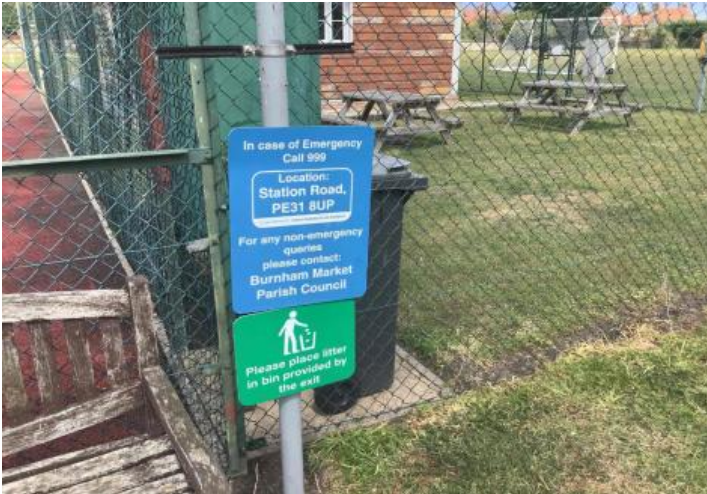
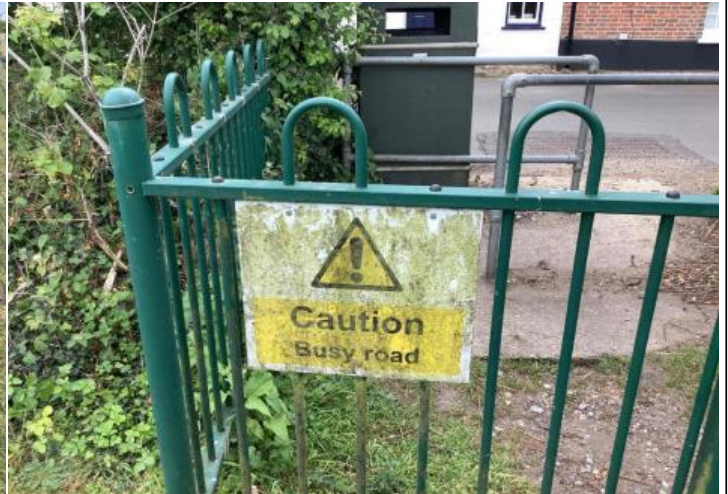
**Item:** Signs - Playground Sign  
**Manufacturer:** Not Identified

**Finding:** There is algae or moss on the surface of the equipment

**Action:** Clean and treat appropriately

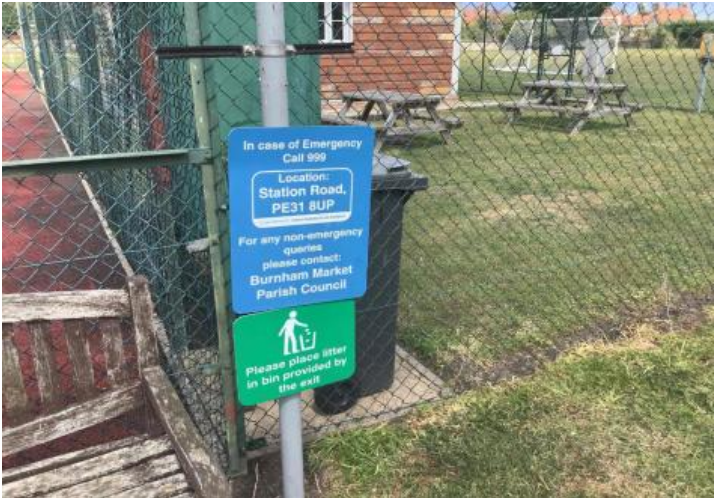
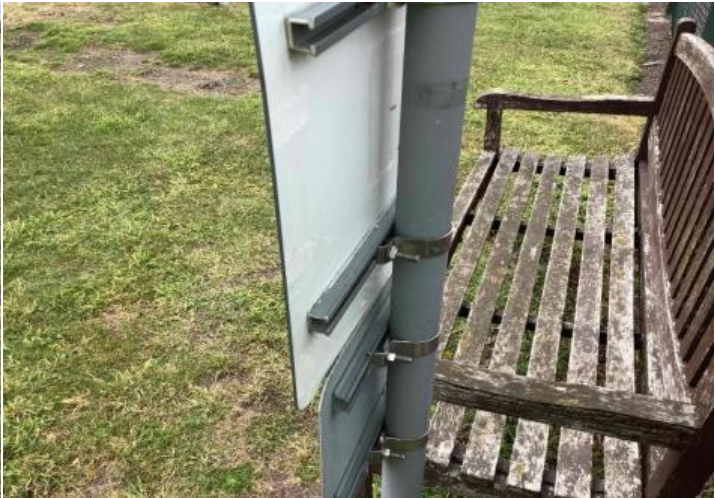
| 8 - Low Risk (Finding 2) | | | |
|---|---|---|---|
| <b>Item:</b> | Signs - Playground Sign | <b>Risk Level:</b> | L - Low Risk |
| <b>Finding:</b> There are projecting bolt thread(s) present | | <b>Action:</b> Remove excess thread length and deburr or provide cap | |

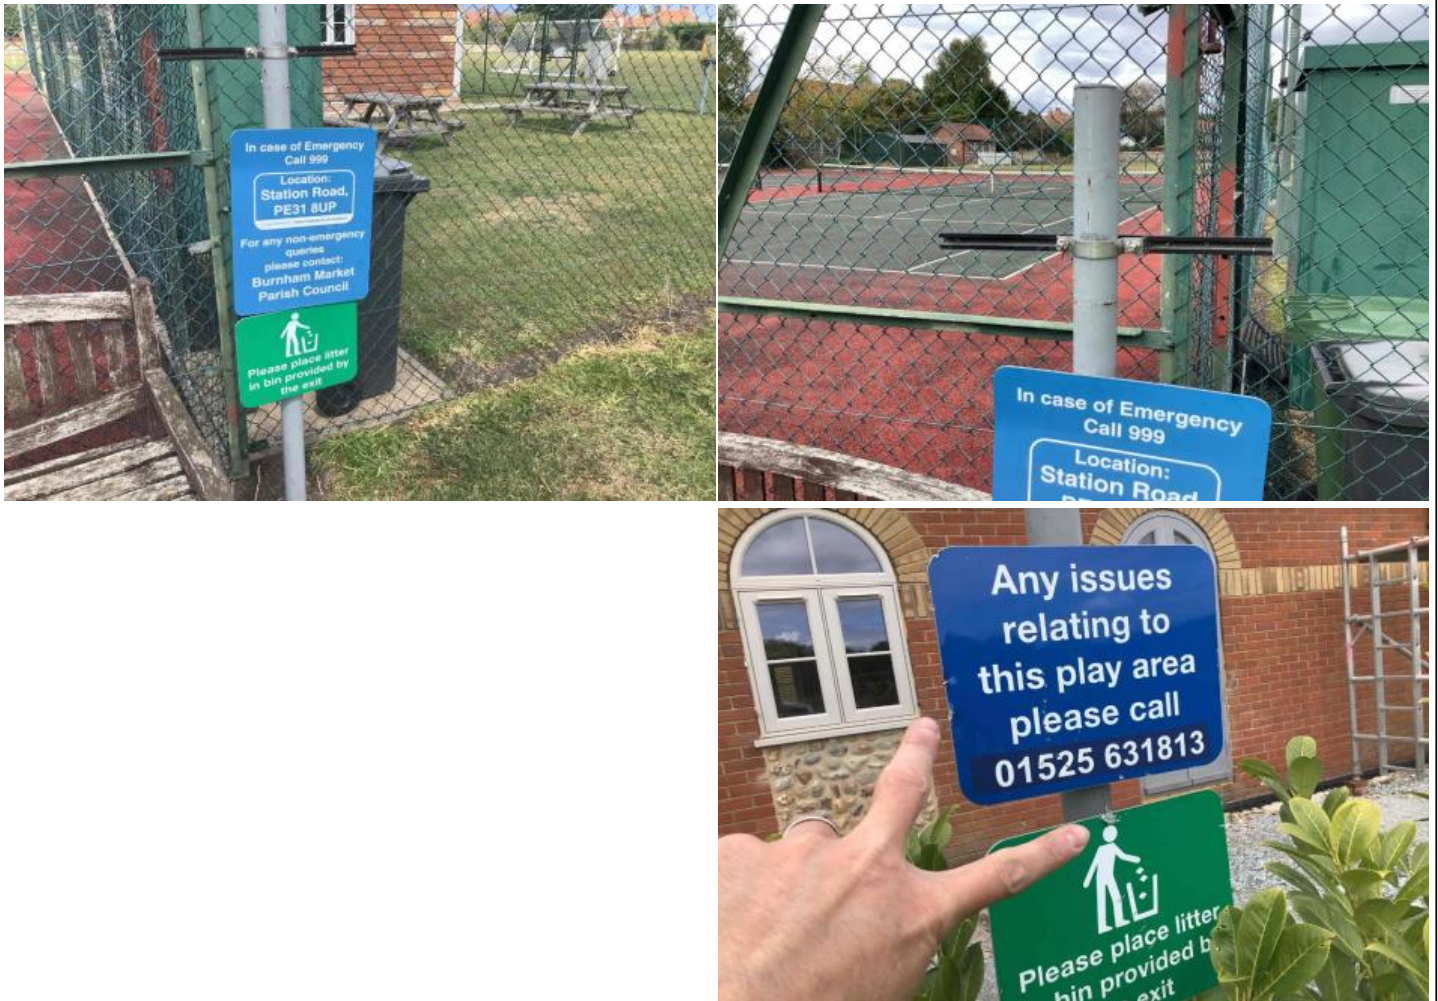
**Finding:** The signage is damaged or missing

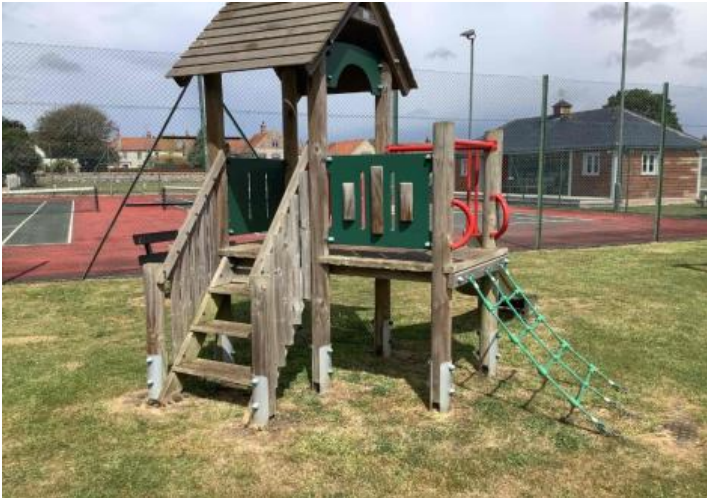
**Item:** Activity Equipment - Multi Play (Junior)  
**Manufacturer:** Action Play and Leisure

**Finding:** The timber has a number of splits/shakes or air cracks and this may affect the stability or allow water ingress which will accelerate the rotting process. Timber splits may also create rough / splintering edges.

**Action:** Monitor, sand down any rough edges and ensure the splits do not cross through fixing points of the structure and/or cause any instability

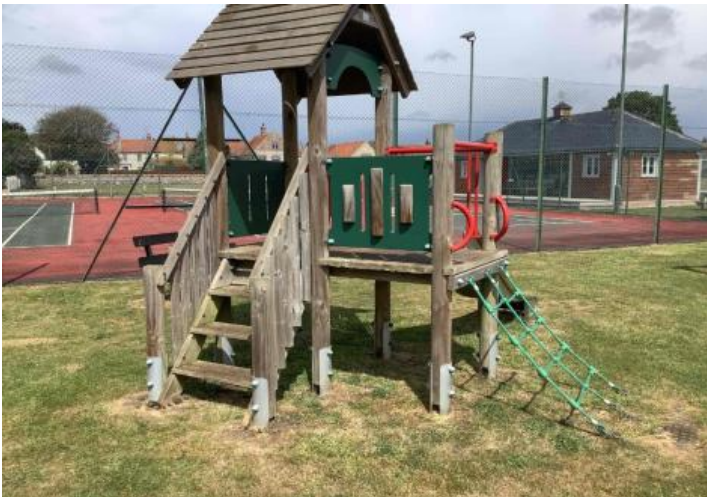
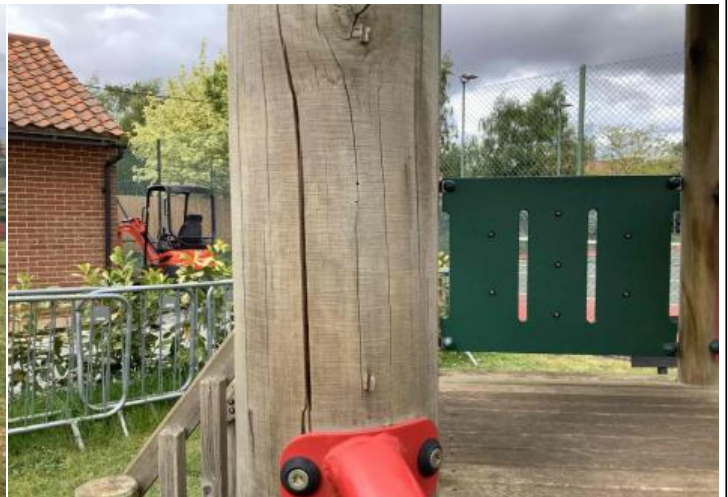
**Item:** Activity Equipment - Multi Play (Junior)  
**Manufacturer:** Action Play and Leisure

**Finding:** There are sharp protruding staples on the item

**Action:** Remove staples

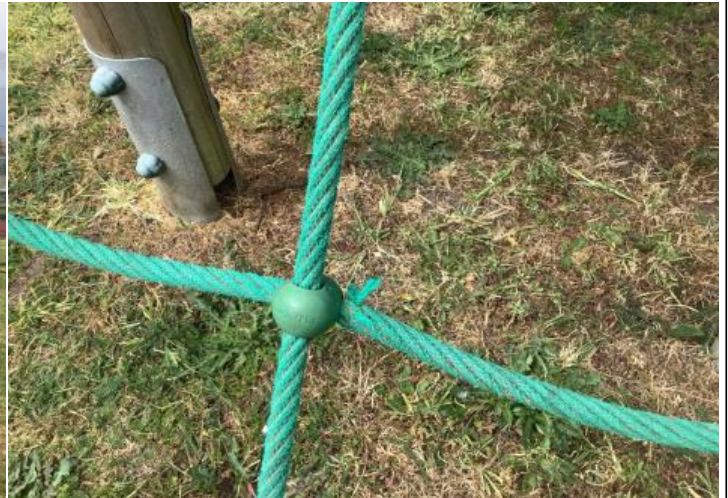
**Finding:** The ropes/nets are worn/damaged in places
