## BURNHAM MARKET PARISH COUNCIL ANNUAL GENERAL MEETING Minutes

Date: Wednesday 6<sup>th</sup> May 2026 at 6.30pm |

## Burnham Market Play Area

# Safety Inspection Report

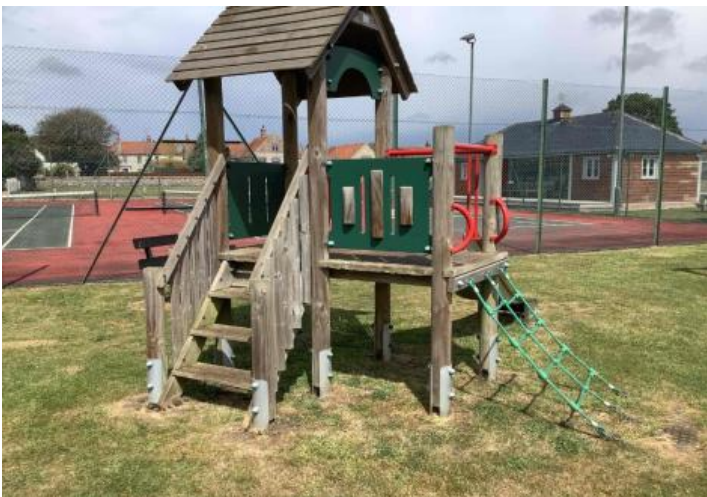
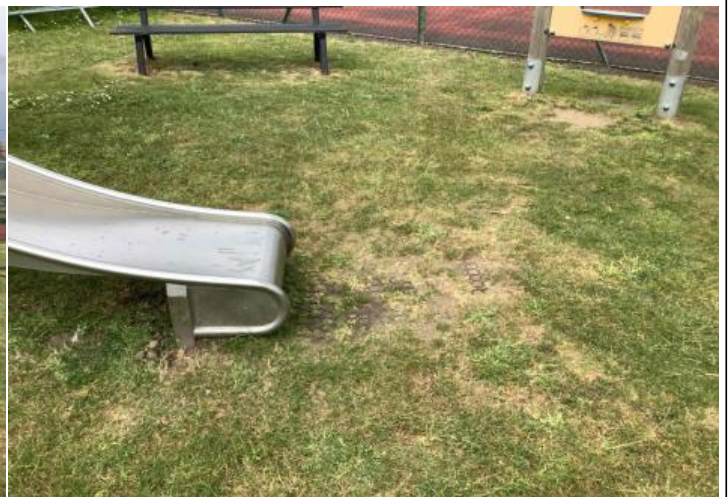
**Item:** Activity Equipment - Multi Play (Junior)  
**Manufacturer:** Action Play and Leisure

**Finding:** The surface has eroded in some areas and may be slippery in wet conditions

**Action:** Reinstate the surface

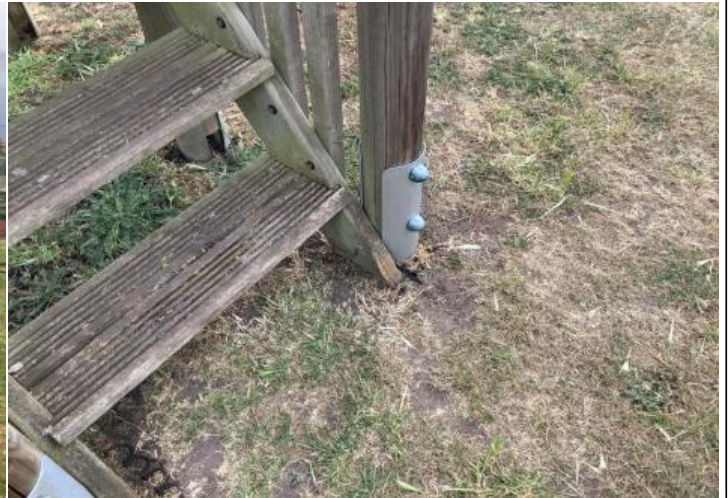
**Finding:** There is some strimmer / machinery damage apparent on the posts, this can penetrate the preservative applied to the timber and accelerate the rotting process

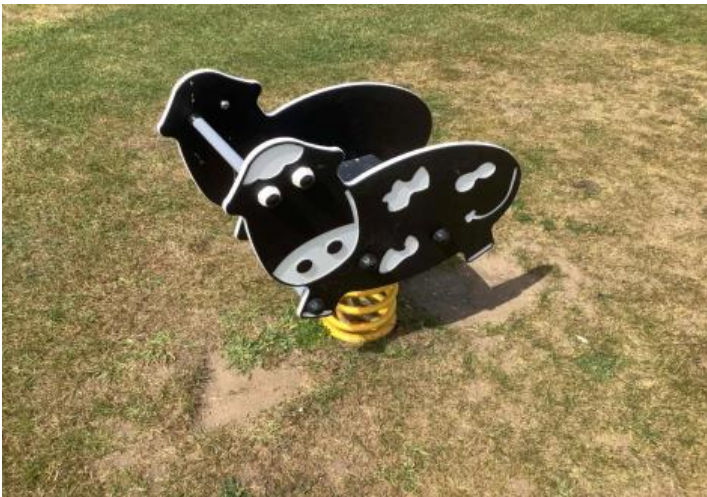
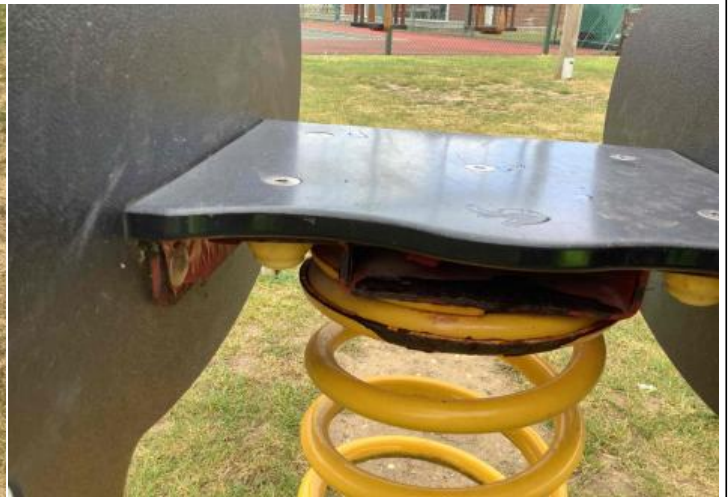
**Item:** Rocking Equipment - Spring Cow  
**Manufacturer:** Fahr Industries

**Finding:** The paintwork on this item has been damaged or worn exposing the metal underneath which is rusting / corroding

**Action:** Treat affected areas and repaint

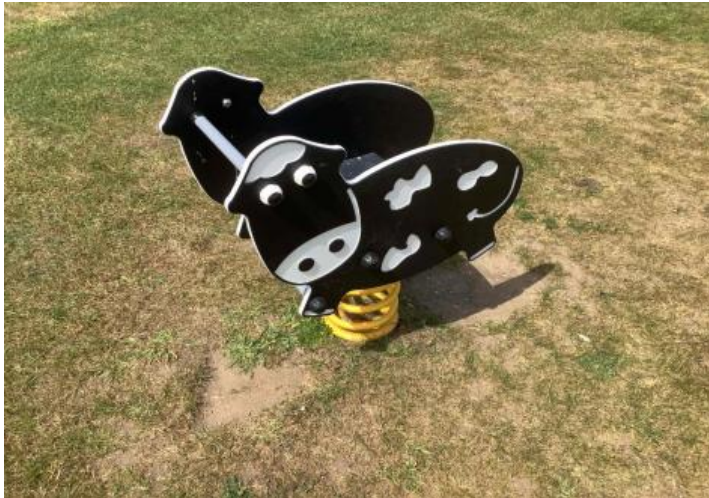
**Item:** Rocking Equipment - Spring Cow  
**Manufacturer:** Fahr Industries

**Finding:** The Handgrips/Footrests rotate and may cause an unexpected movement for the user  
**Action:** Secure Handgrips/Footrests to prevent rotation.

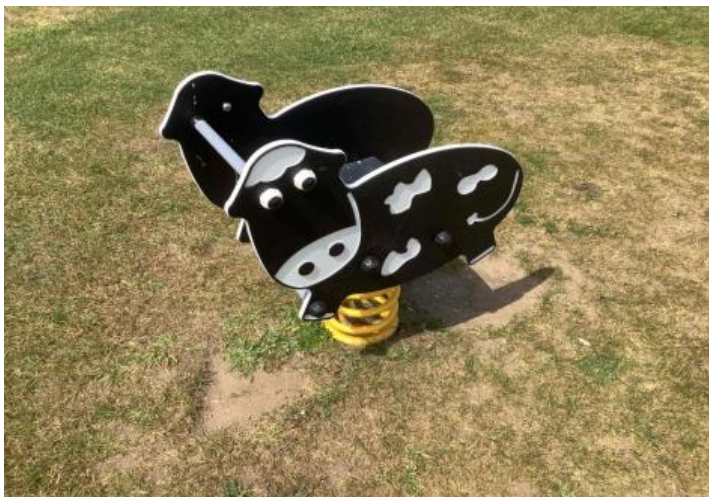
**Item:** Rocking Equipment - Spring Cow  
**Manufacturer:** Fahr Industries

**Finding:** A number of fixing(s) have worked loose on the baseplate  
**Action:** Secure all loose fixings

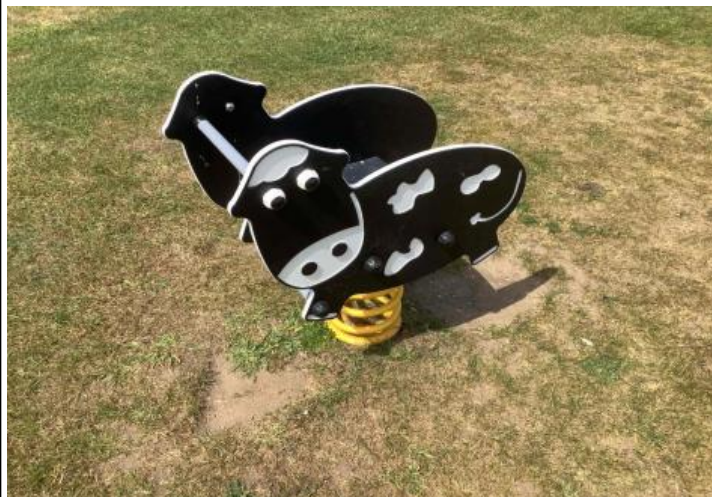
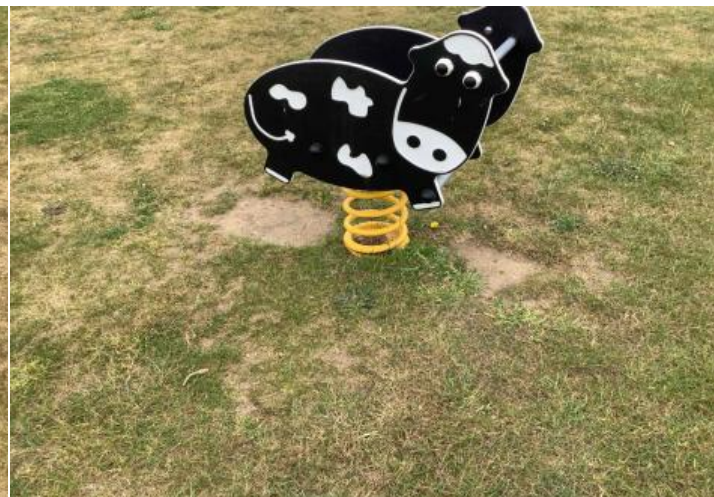
**Item:** Rocking Equipment - Spring Cow  
**Manufacturer:** Fahr Industries

**Finding:** The surface has eroded in some areas and may be slippery in wet conditions  
**Action:** Reinstate the surface

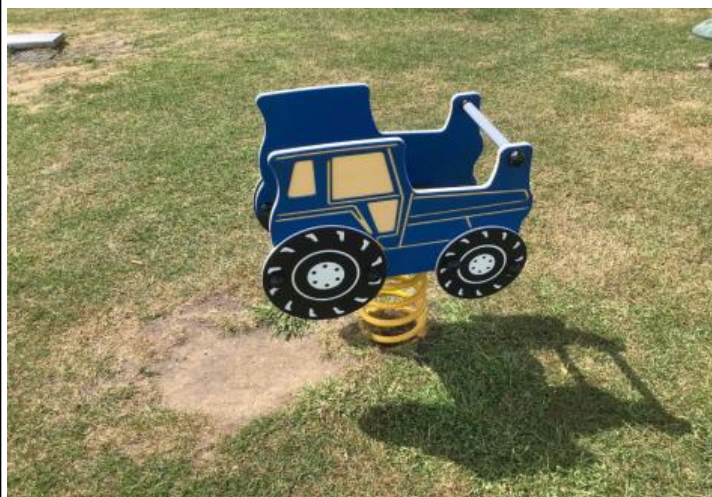
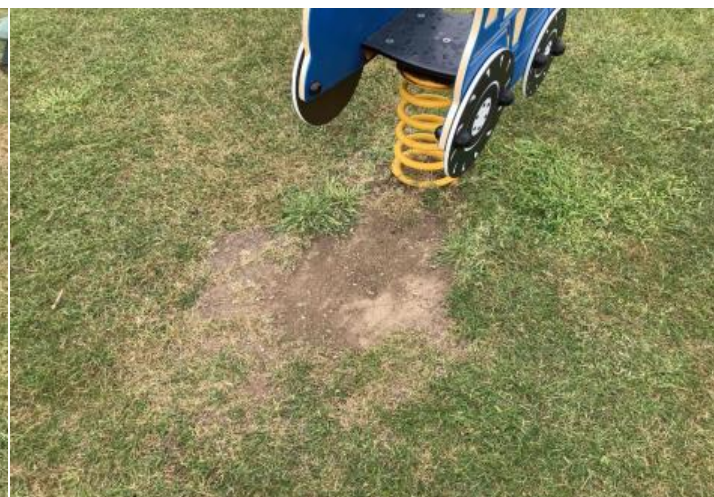
**Item:** Rocking Equipment - Spring Tractor  
**Manufacturer:** Fahr Industries

**Finding:** The surface has eroded in some areas and may be slippery in wet conditions  
**Action:** Reinstate the surface

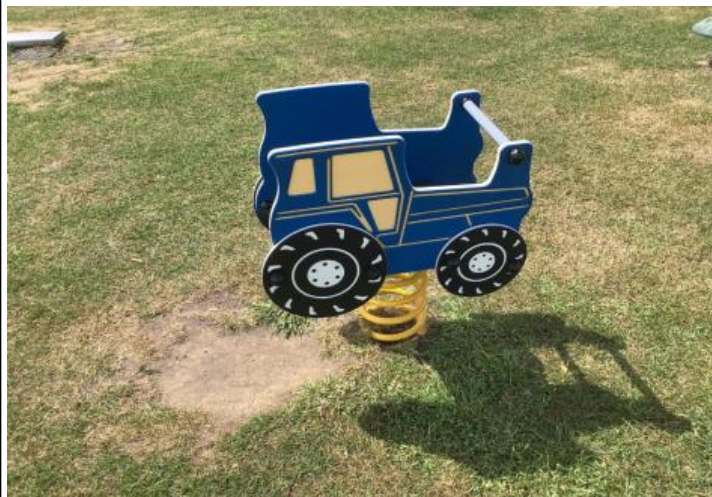
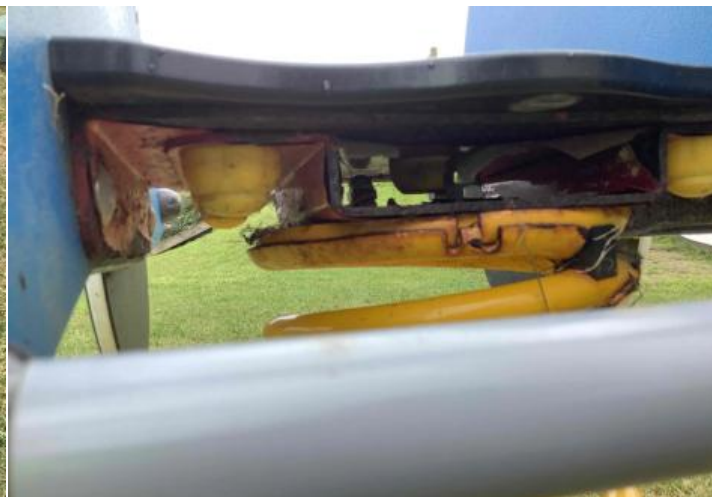
**Item:** Rocking Equipment - Spring Tractor  
**Manufacturer:** Fahr Industries

**Finding:** Bolt cap cover/s missing or damaged

**Action:** Replace

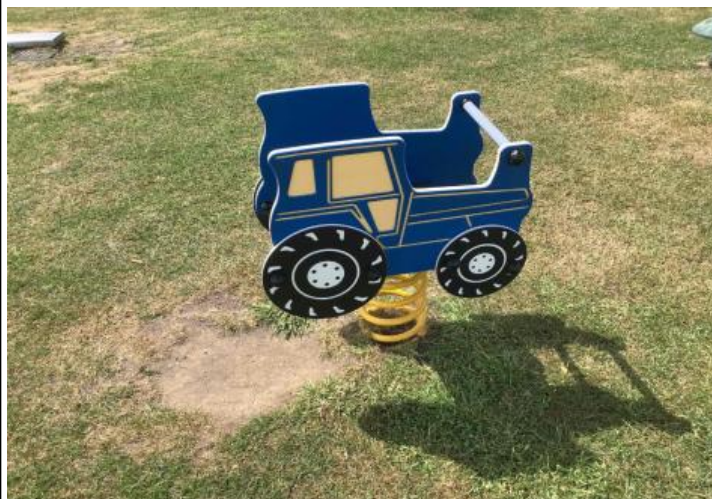
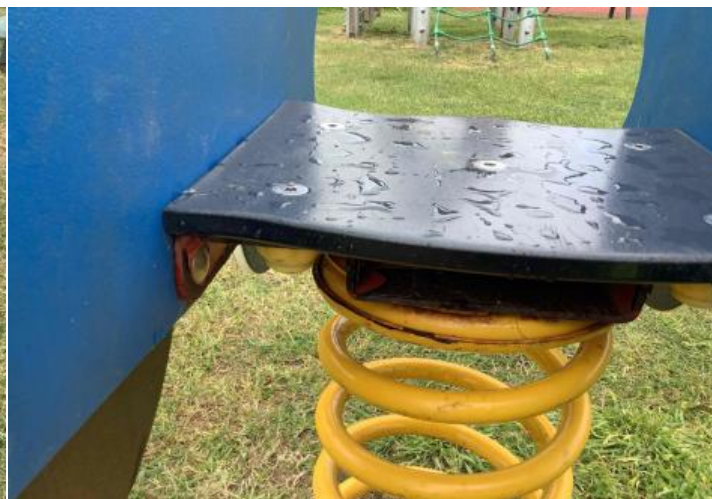
**Item:** Rocking Equipment - Spring Tractor  
**Manufacturer:** Fahr Industries

**Finding:** The paintwork on this item has been damaged or worn exposing the metal underneath which is rusting / corroding

**Action:** Treat affected areas and repaint

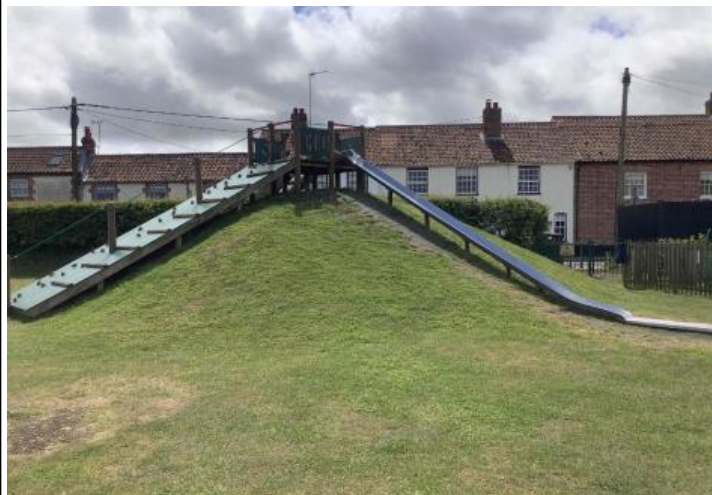
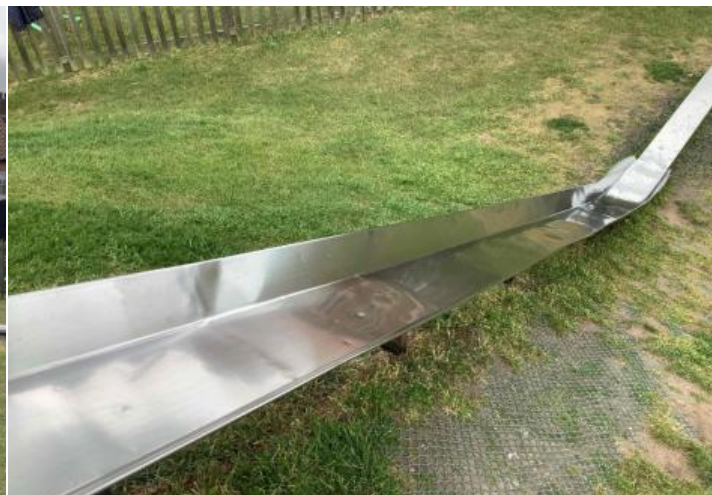
**Item:** Other - Embankment Slide  
**Manufacturer:** Adventure Playgrounds

**Finding:** There are a number of dents in the slide surface

**Action:** Monitor for any further deterioration and repair as required

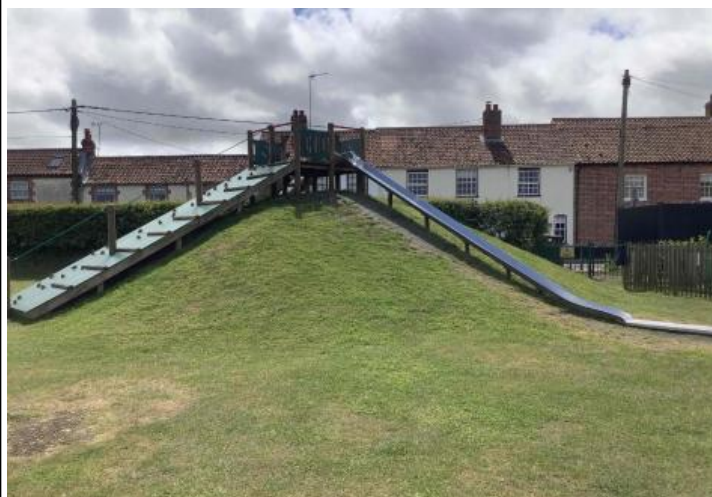
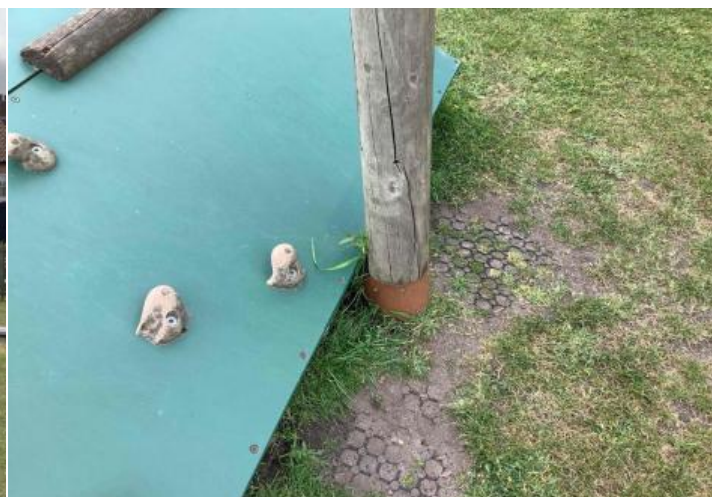
**Item:** Other - Embankment Slide  
**Manufacturer:** Adventure Playgrounds

**Finding:** There are post protectors around the timber posts that are preventing the inspector from thoroughly testing for signs of decay and we are unable to verify the condition of the posts in these locations. NOTE - timber rot / decay is possible even with the post protectors in place

**Action:** Refer to manufacturer inspection / maintenance recommendations

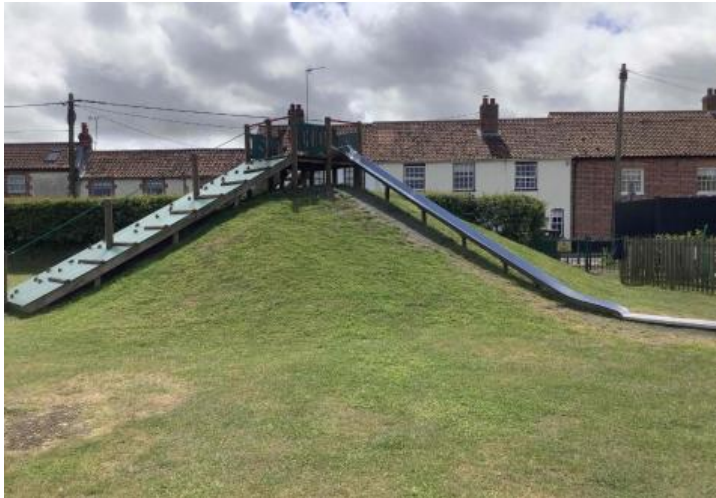
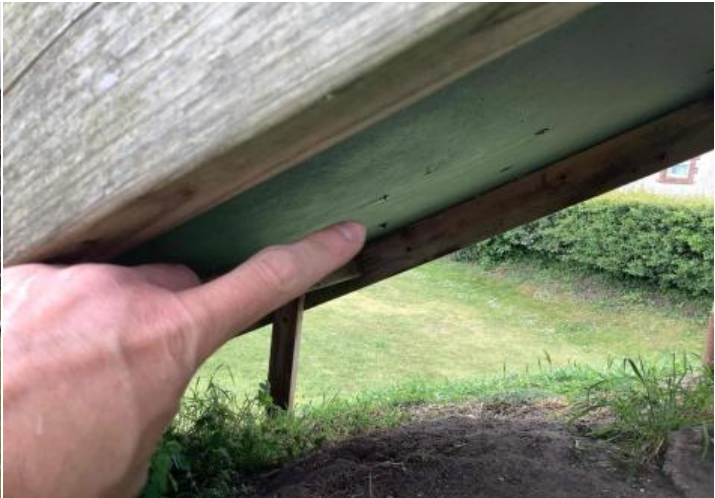
| <div> <div>Item:</div> <div>Other - Embankment Slide</div> </div> | | <div> <div>Risk Level:</div> <div>L - Low Risk</div> </div> | |

| <div> <div>Finding:</div> <div>There are projecting bolt thread(s) present</div> </div> | | <div> <div>Action:</div> <div>Remove excess thread length and deburr or provide cap</div> </div> | |

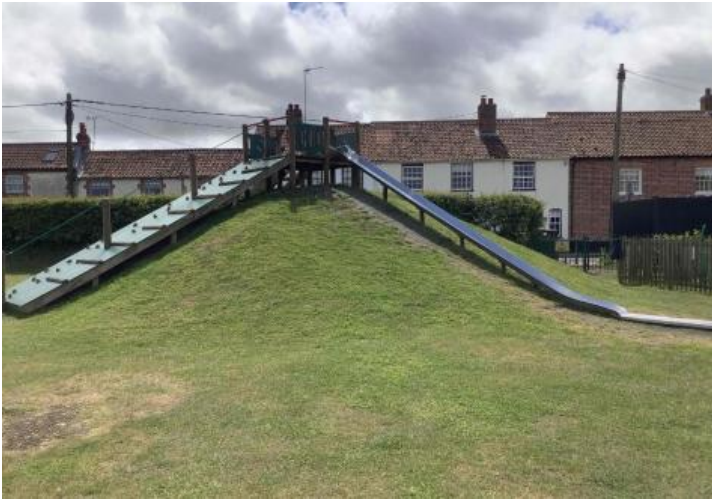
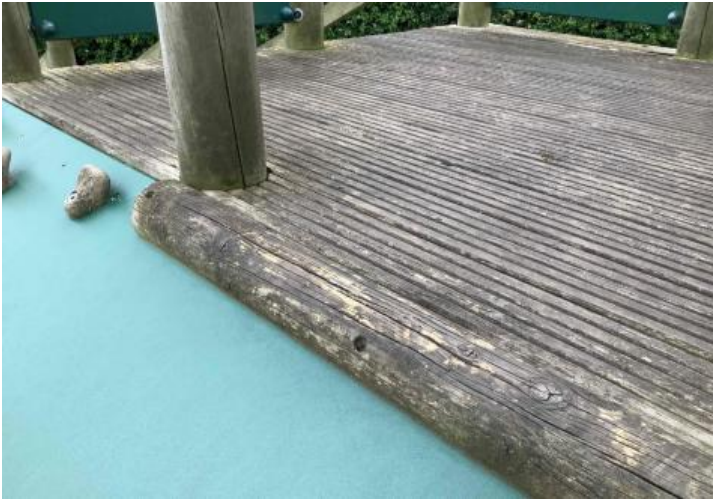
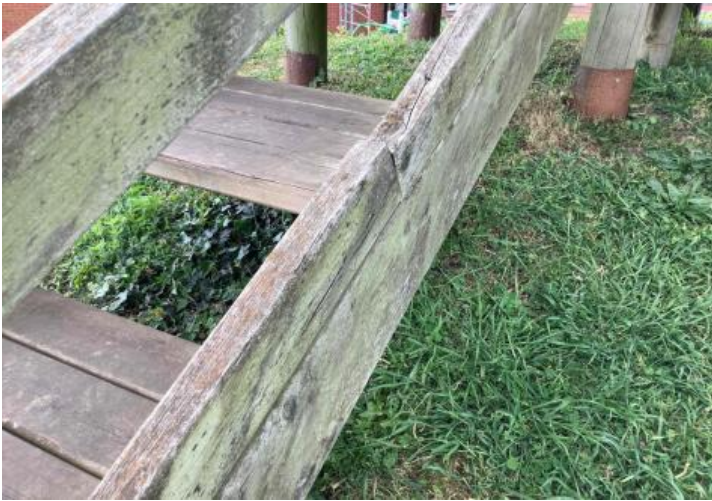
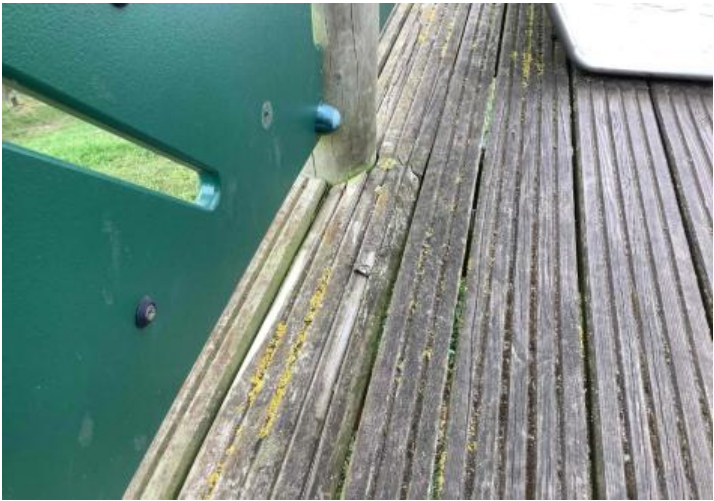
| <div> <div></div> <div>6 - Low Risk (Finding 4)</div> </div> | | | |
|---|--|---|--|
| <div> <div>Item:</div> <div>Other - Embankment Slide</div> </div> | | <div> <div>Risk Level:</div> <div>L - Low Risk</div> </div> | |

| <div> <div></div> <div>6 - Low Risk (Finding 4)</div> </div> | | | |
|---|--|---|--|
| <div>Finding: Parts of the timber are rough or splintered</div> | | <div>Action: Remove all rough or sharp edges</div> | |

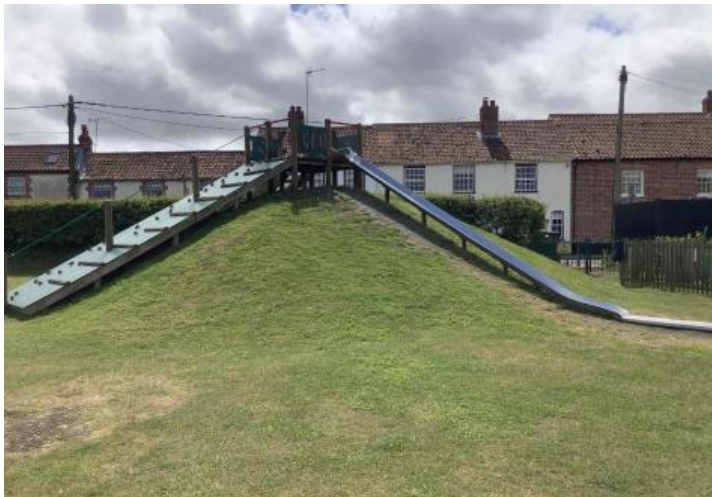
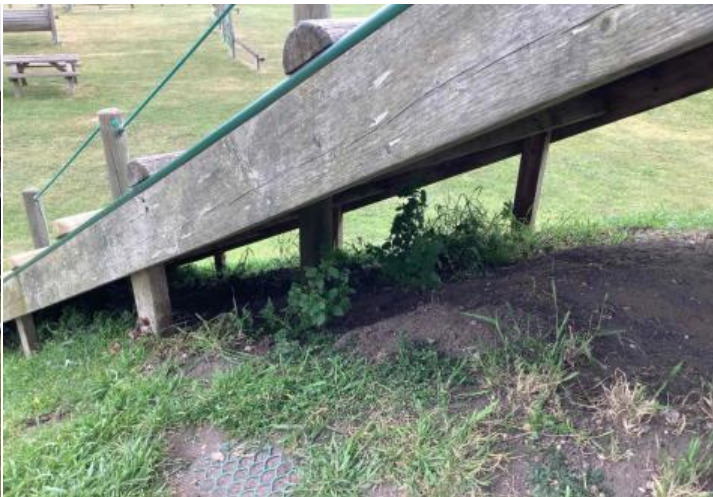
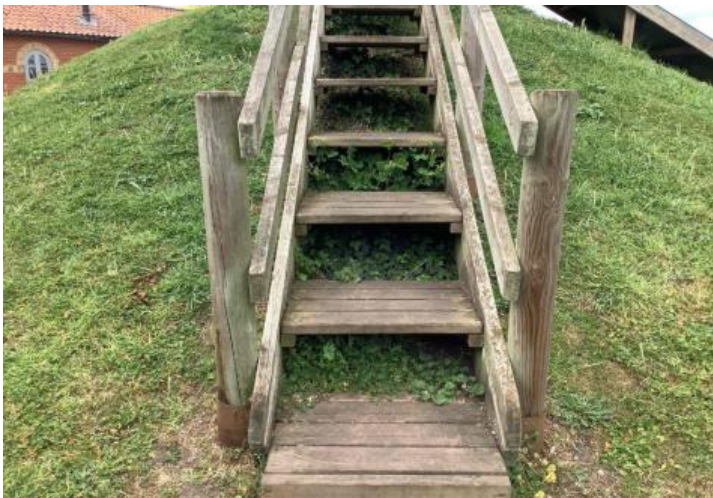
| <div><div>Item:</div><div>Other - Embankment Slide</div></div> | | <div><div>Risk Level:</div><div>L - Low Risk</div></div> | |

| <div><div>Finding:</div><div>There is weed / vegetation and nettle growth within the surface</div></div> | | | |

| <div><div>Action:</div><div>Remove weed / vegetation growth</div></div> | | | |

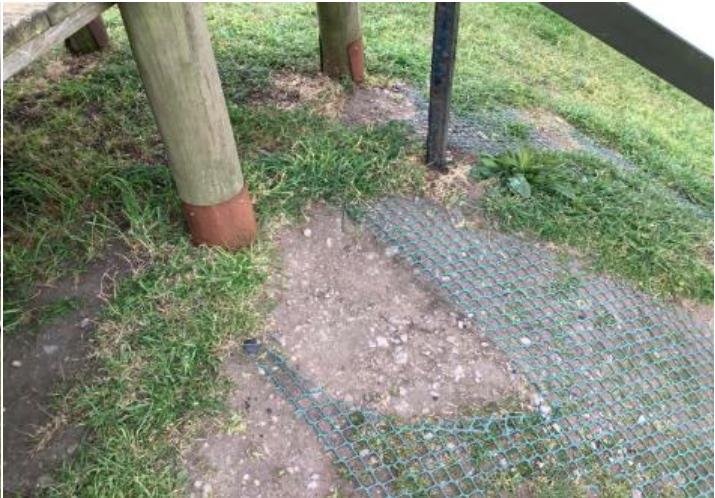
| <div> 8 - Low Risk (Finding 6) </div> | | | |
|---|--|---|--|
| <b>Item:</b> Other - Embankment Slide<br><b>Manufacturer:</b> Adventure Playgrounds | | <b>Risk Level:</b> L - Low Risk<br><b>Surface:</b> Grass Matrix Tiles | |

| <div> 8 - Low Risk (Finding 6) </div> | | | |
|---|--|---|--|
| <b>Finding:</b> There is moderate damage to the surface | | <b>Action:</b> Repair the damaged areas of surfacing | |

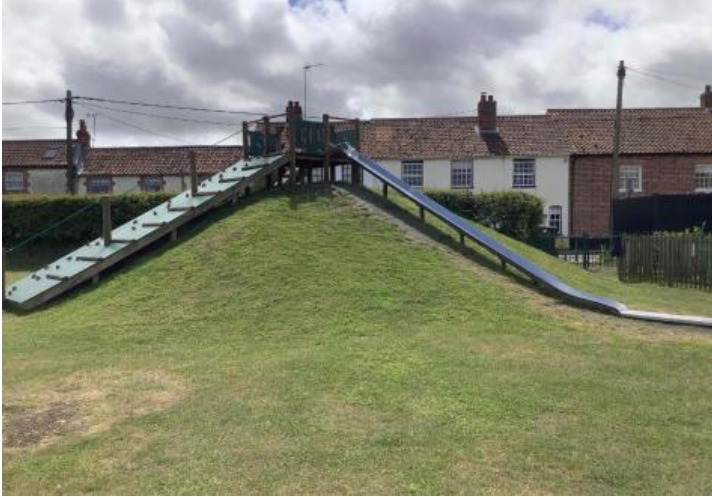
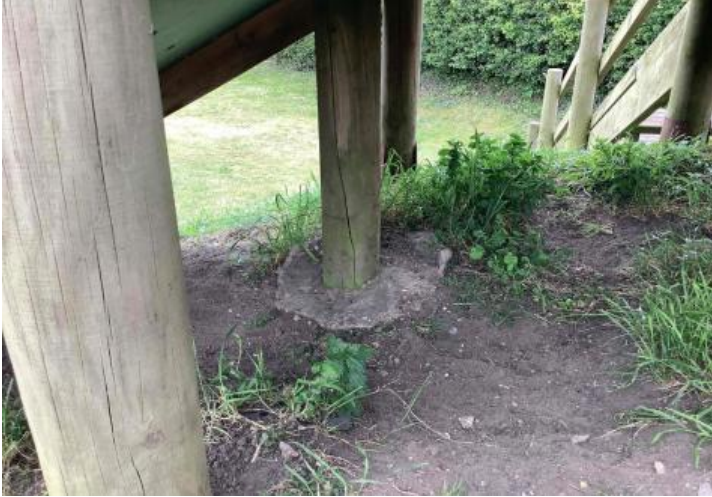
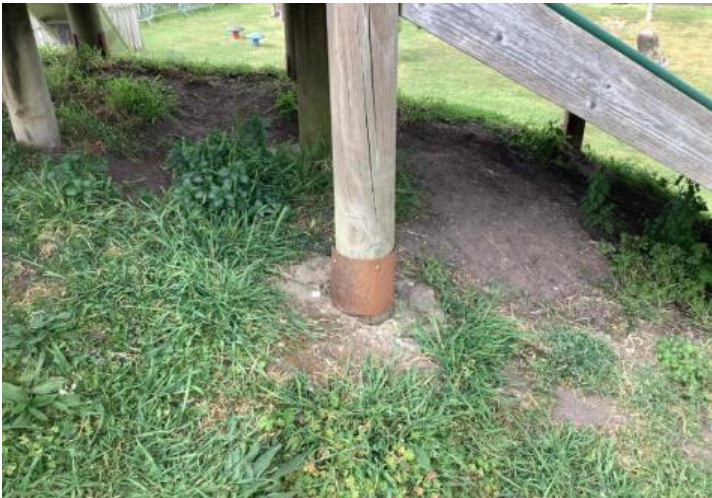
| <div> <div></div> <div>8 - Low Risk (Finding 7)</div> </div> | | | |
|---|--|---|--|
| | | <div> <div>Finding:</div> <div>The surface has eroded and the foundations are exposed</div> </div> <div> <div>Action:</div> <div>Reinstate surrounding surfaces to cover the foundations</div> </div> | |

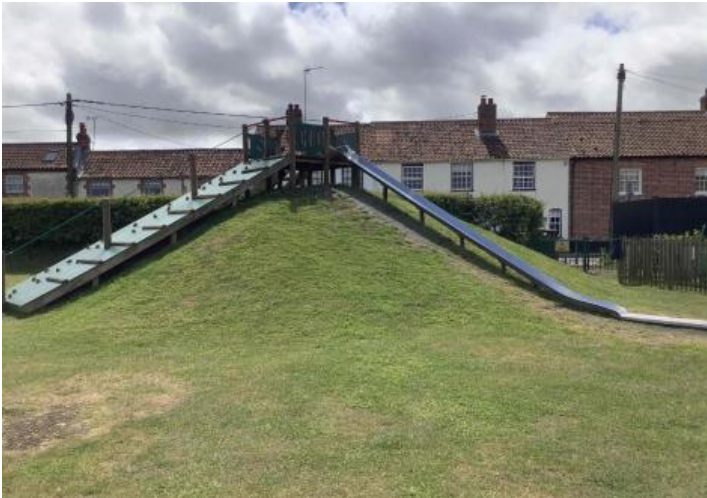
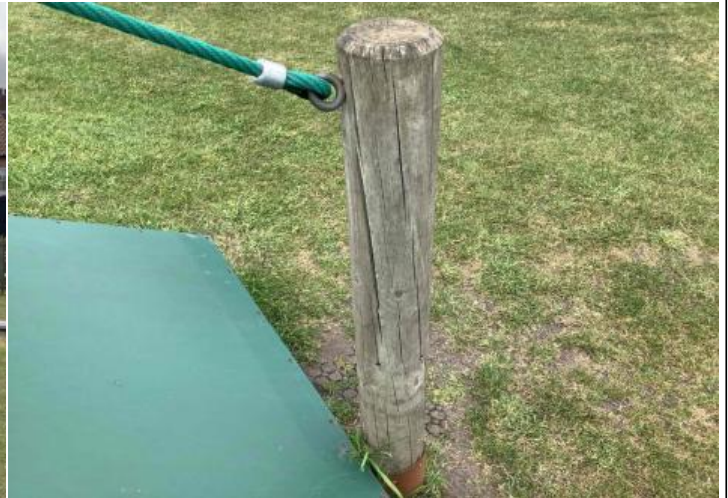
**Item:** Other - Embankment Slide  
**Manufacturer:** Adventure Playgrounds

**Finding:** The timber has a number of splits/shakes or air cracks and this may affect the stability or allow water ingress which will accelerate the rotting process. Timber splits may also create rough / splintering edges.

**Action:** Monitor, sand down any rough edges and ensure the splits do not cross through fixing points of the structure and/or cause any instability

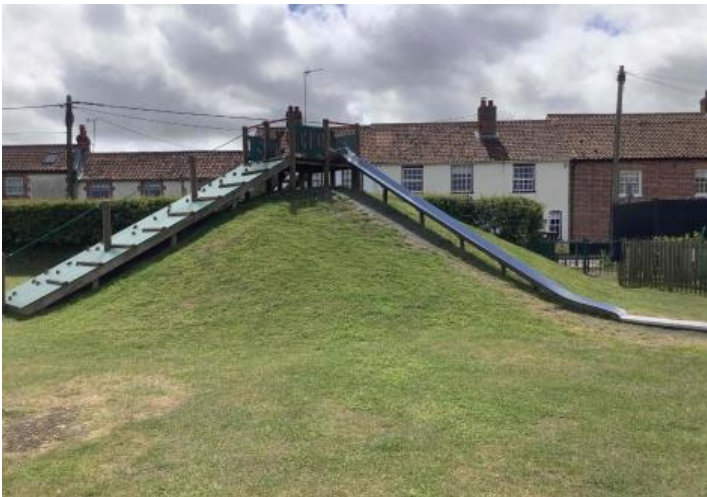
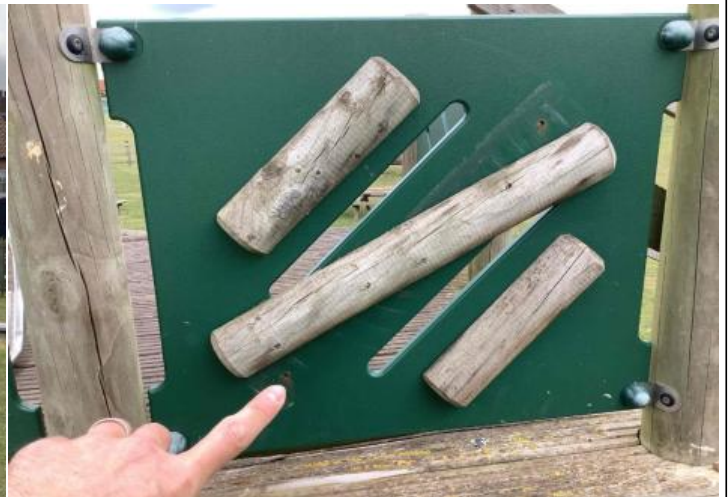
**Item:** Other - Embankment Slide  
**Manufacturer:** Adventure Playgrounds

**Finding:** There is or are fixings missing on the item and the component is not secure

**Action:** Replace all missing fixings

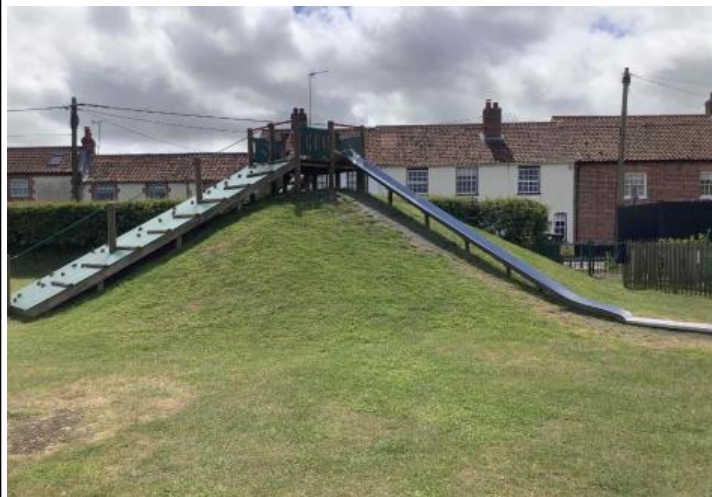
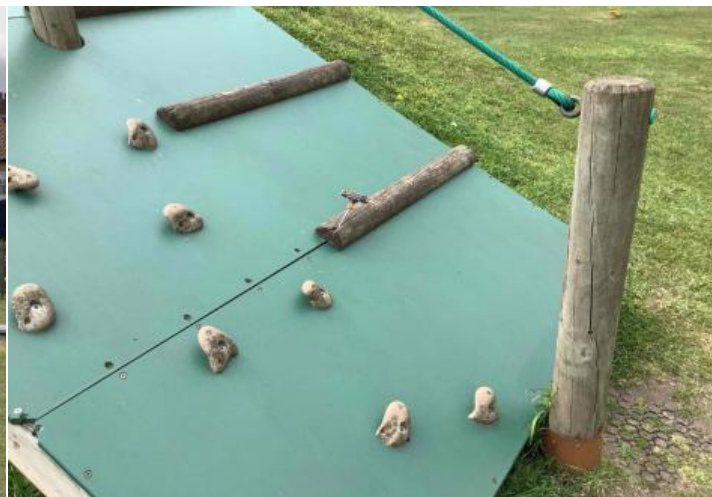
**Item:** Other - Embankment Slide  
**Manufacturer:** Adventure Playgrounds

**Finding:** There is some evidence of rot in the timbers

**Action:** Monitor for any further deterioration and replace as required

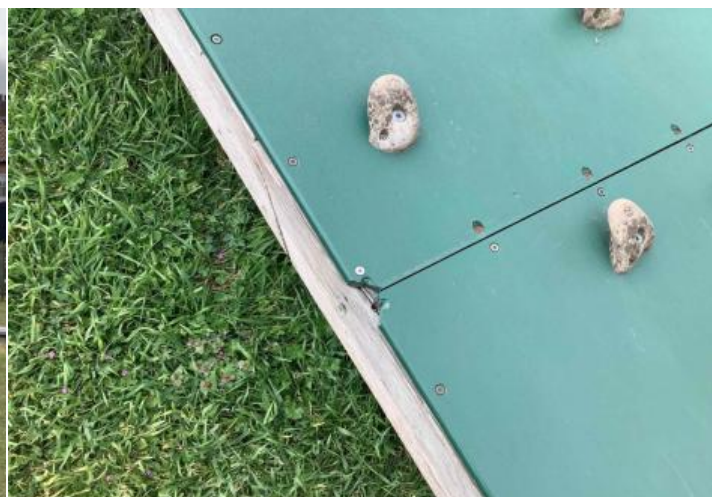
**Item:** Other - Embankment Slide  
**Manufacturer:** Adventure Playgrounds

**Finding:** There is or are fixings missing on the item

**Action:** Replace all missing fixings

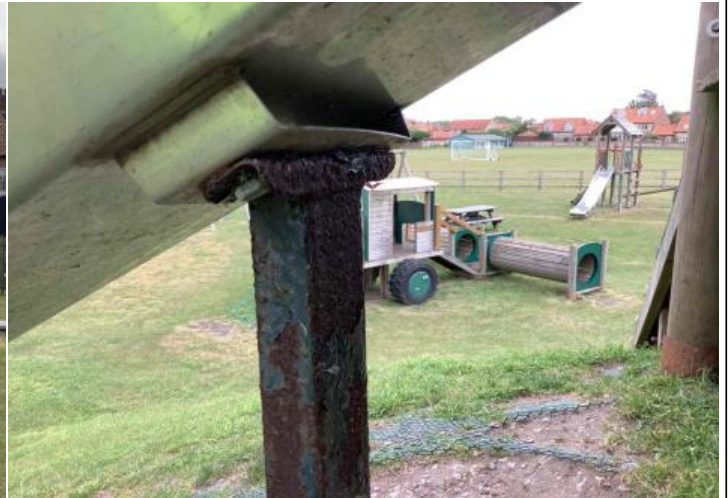
**Item:** Other - Embankment Slide  
**Manufacturer:** Adventure Playgrounds

**Finding:** The paintwork on this item has been damaged or worn exposing the metal underneath which is rusting / corroding

**Action:** Treat affected areas and repaint

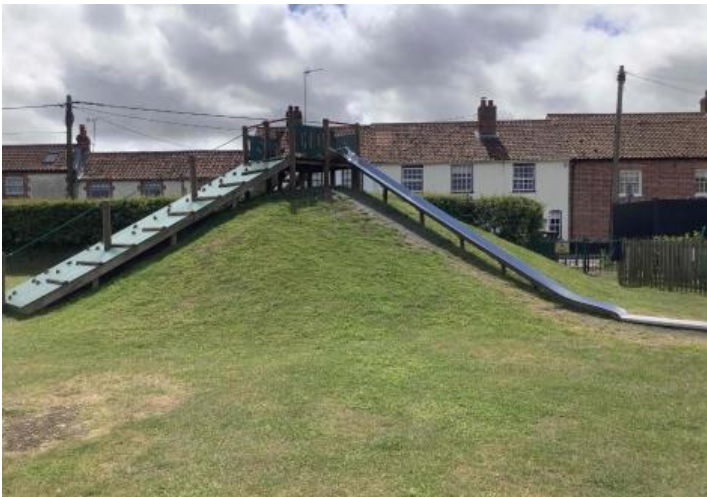
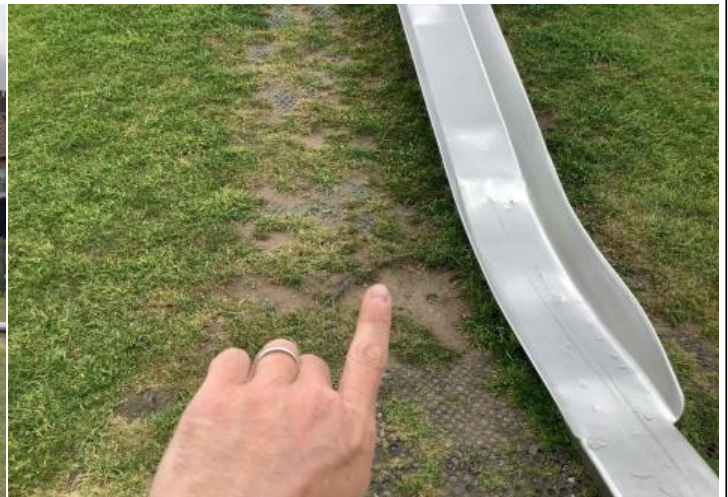
**Item:** Other - Embankment Slide  
**Manufacturer:** Adventure Playgrounds

**Finding:** There are trip hazards present

**Action:** Remove trip hazard

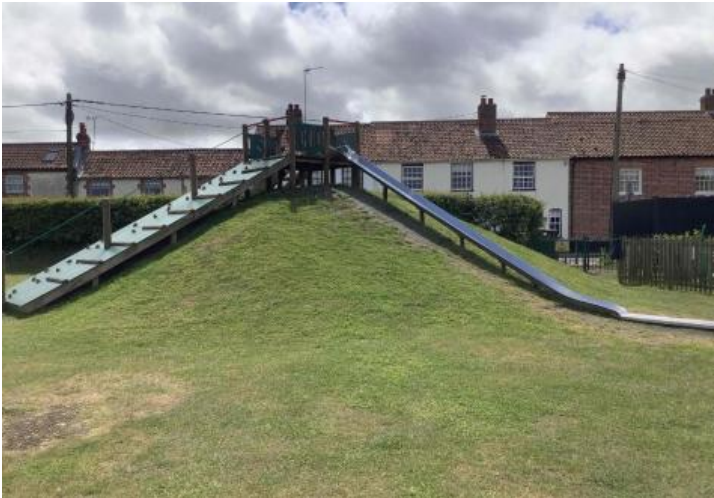
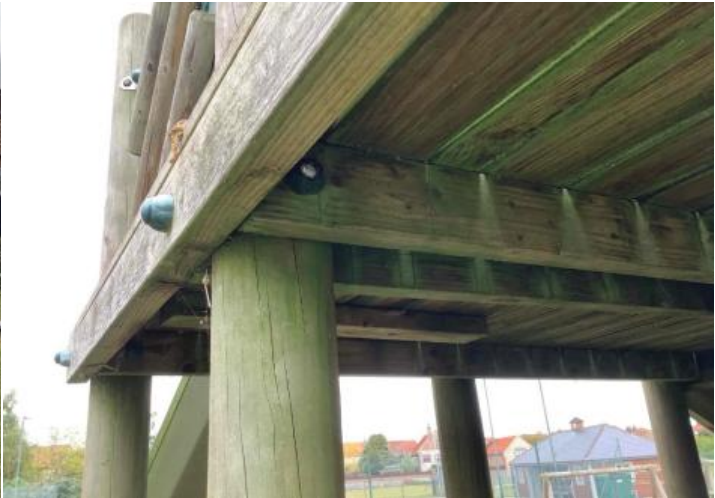
| <b>Item:</b> Other - Embankment Slide | | <b>Risk Level:</b> V - Very Low Risk | |

| <b>Finding:</b> Bolt cap cover/s missing or damaged | | <b>Action:</b> Replace | |

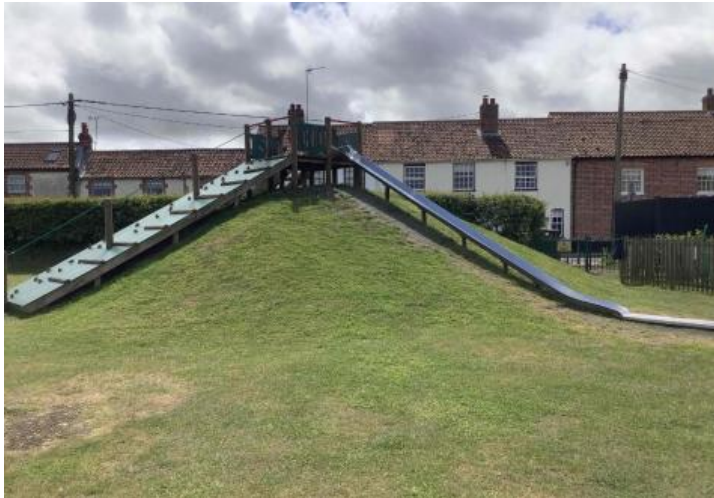
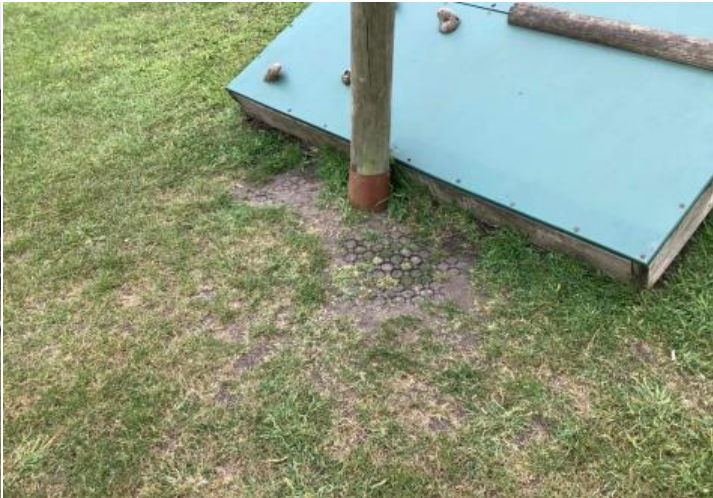
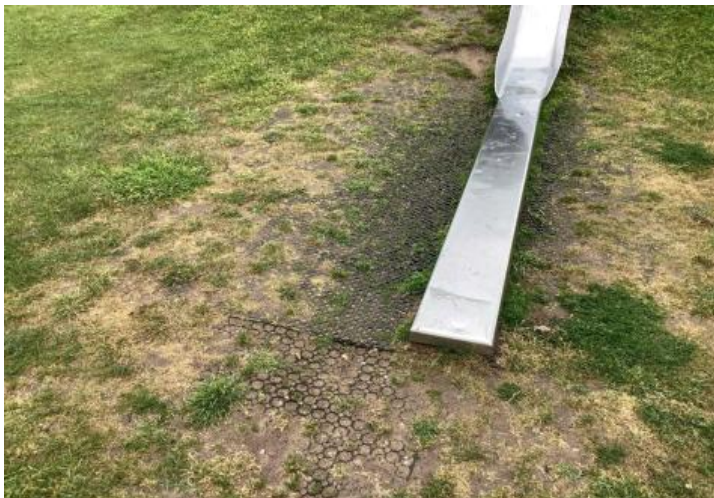
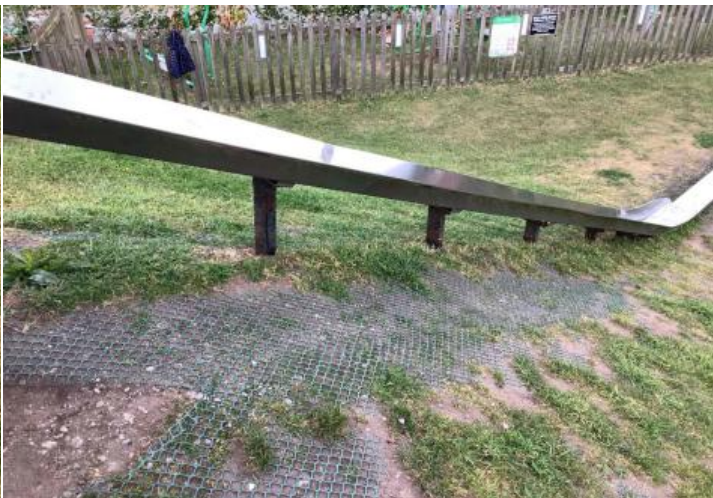
| <div><div>Finding:</div><div>The surface has eroded in some areas and may be slippery in wet conditions</div></div> | | <div><div>Action:</div><div>Reinstate the surface</div></div> | |

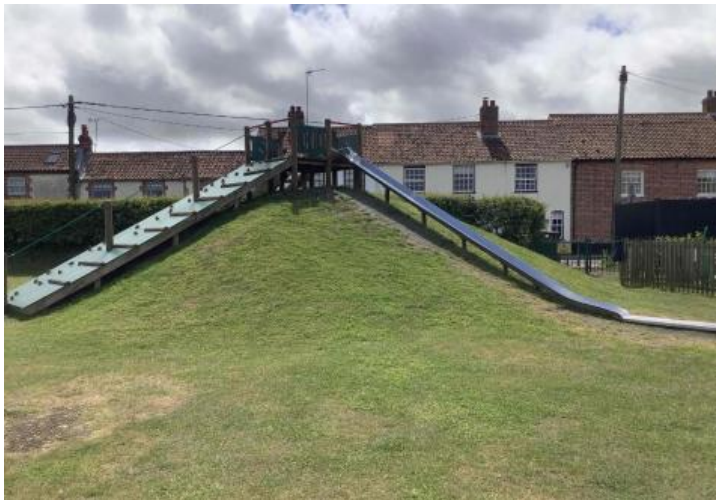
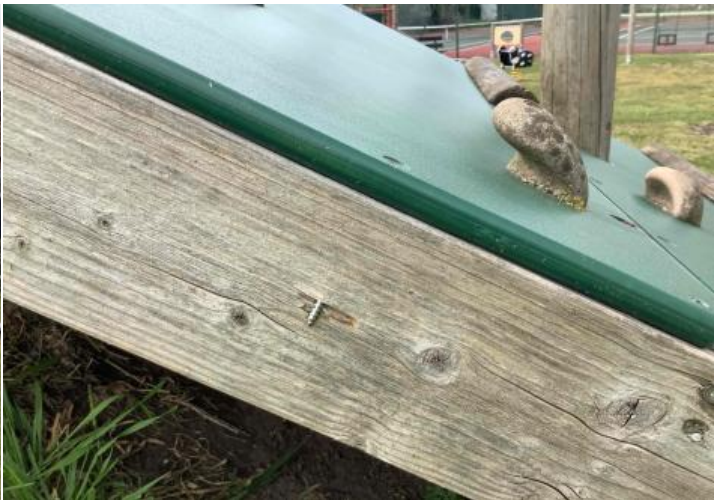
| <div> <div>Finding:</div> <div>The item has been damaged</div> </div> | | <div> <div>Action:</div> <div>Monitor for any further deterioration and replace as required</div> </div> | |

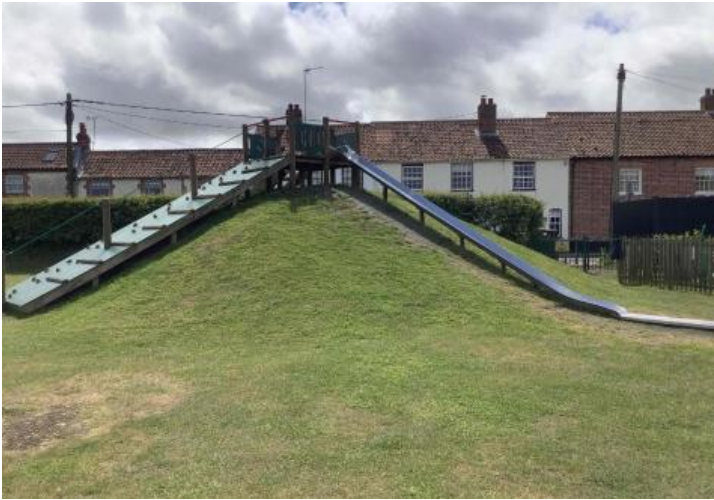
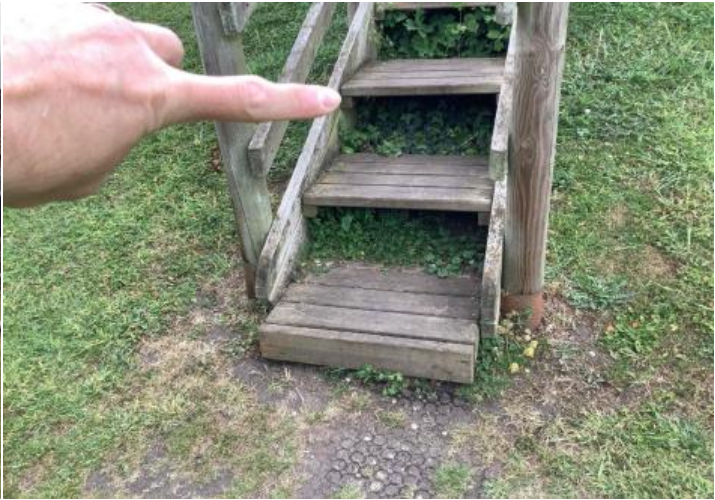
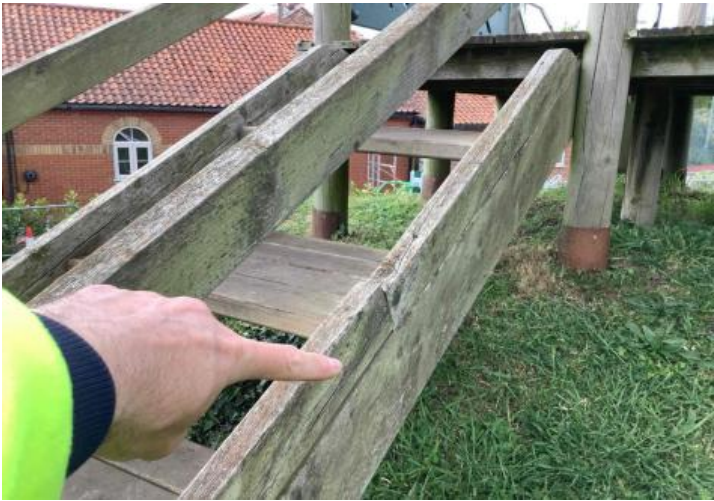
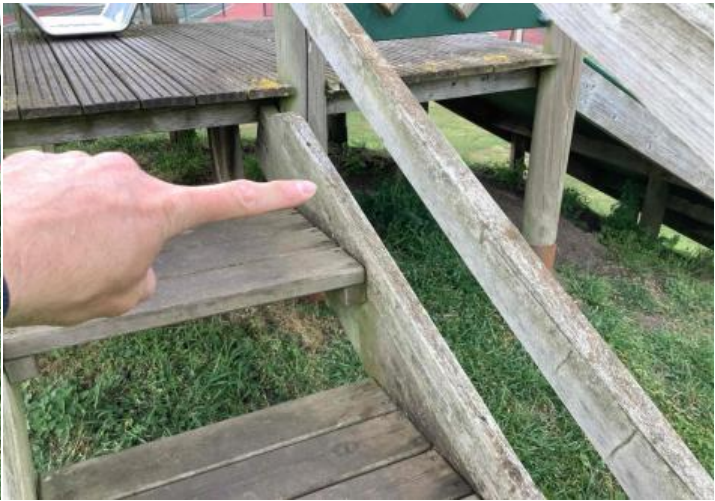
Finding: A number of fixing(s) have worked loose

Action: Secure all loose fixings

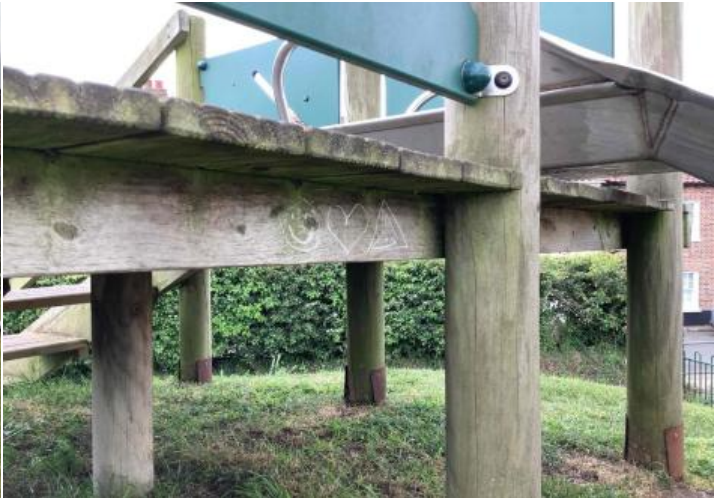
| <div> <div></div> <div>0 - Risk Assessment not Undertaken (Finding 18)</div> </div> | | | |
|---|--|---|--|
| <div>Finding: There is some graffiti present</div> | | <div>Action: Remove the graffiti</div> | |

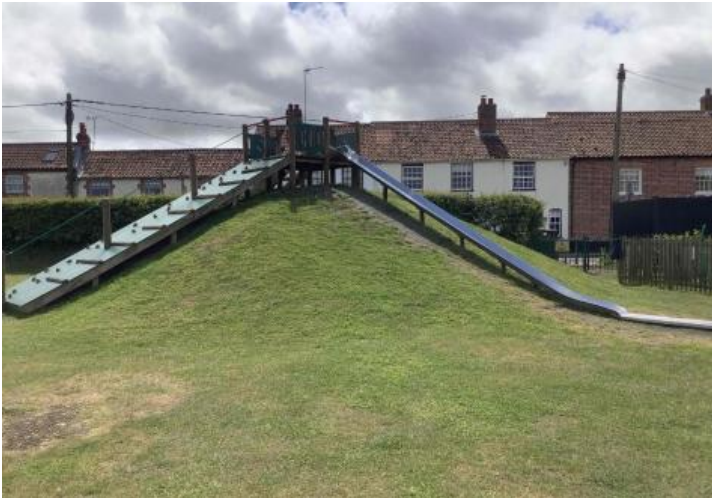
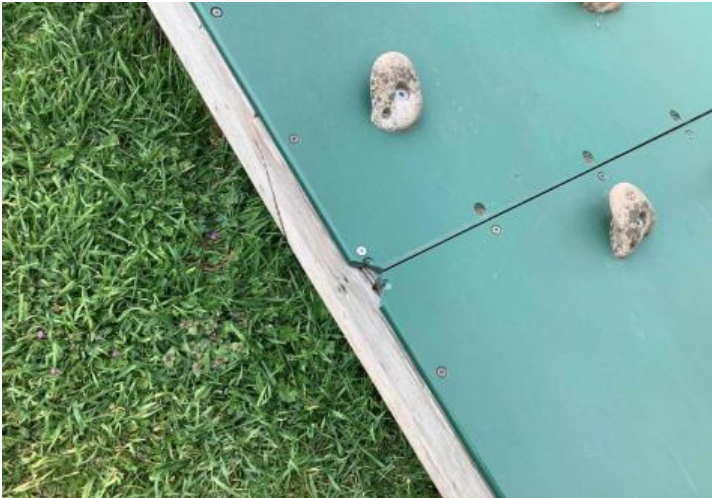
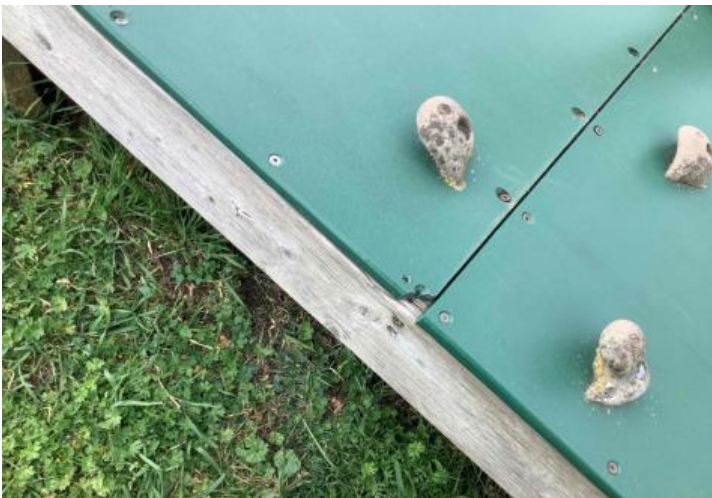
| <div> <div></div> <div>6 - Low Risk (Finding 19)</div> </div> | | | |
|---|--|---|--|
| <div> <div>Finding:</div> <div>The item has been damaged</div> </div> | | <div> <div>Action:</div> <div>Monitor for any further deterioration and replace as required</div> </div> | |
