## BURNHAM MARKET PARISH COUNCIL ANNUAL GENERAL MEETING Minutes

Date: Wednesday 6<sup>th</sup> May 2026 at 6.30pm |

## Burnham Market Play Area

# Safety Inspection Report

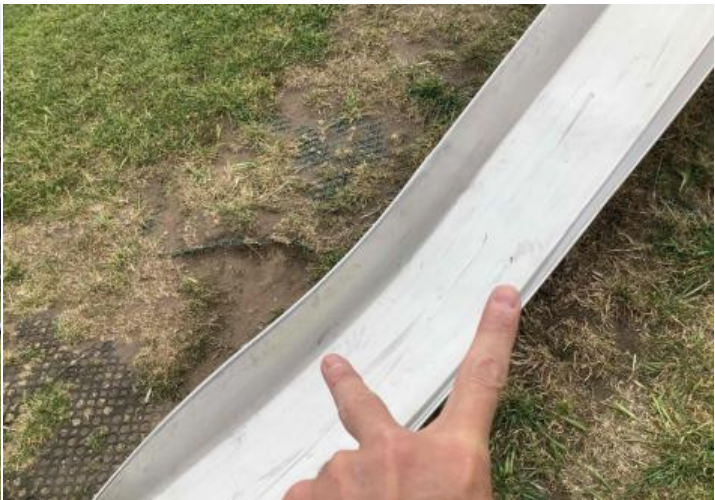
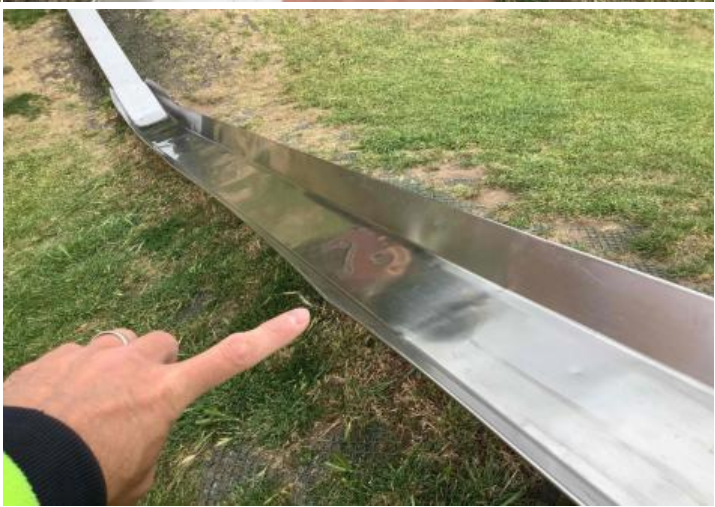
Finding: The slide chute has some minor damage

Action: Monitor and file down any sharp burrs

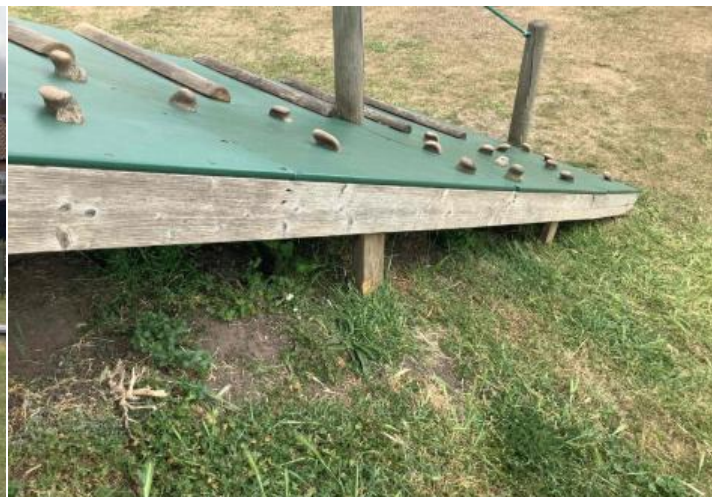
**Finding:** There is some strimmer / machinery damage apparent on the posts, this can penetrate the preservative applied to the timber and accelerate the rotting process

**Action:** Monitor for any deterioration (rot) and replace as required

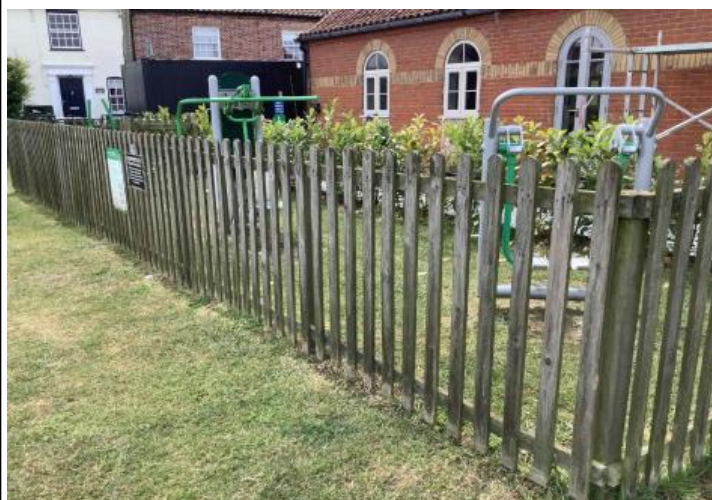
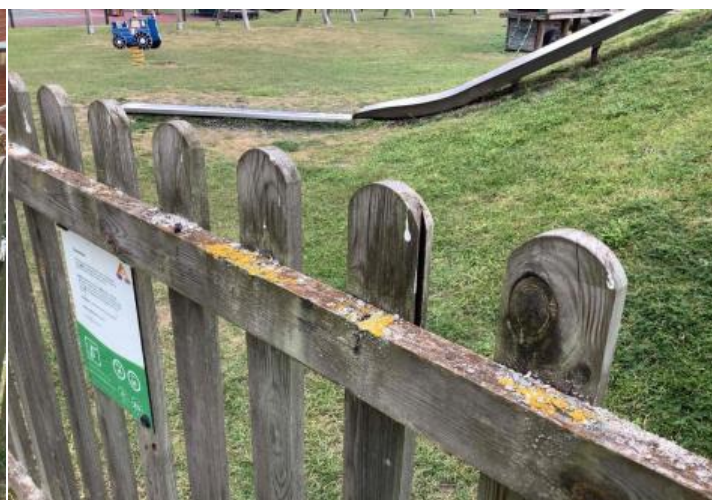
**Finding:** The timber has a number of splits/shakes or air cracks and this may affect the stability or allow water ingress which will accelerate the rotting process. Timber splits may also create rough / splintering edges.

**Action:** Monitor, sand down any rough edges and ensure the splits do not cross through fixing points of the structure and/or cause any instability

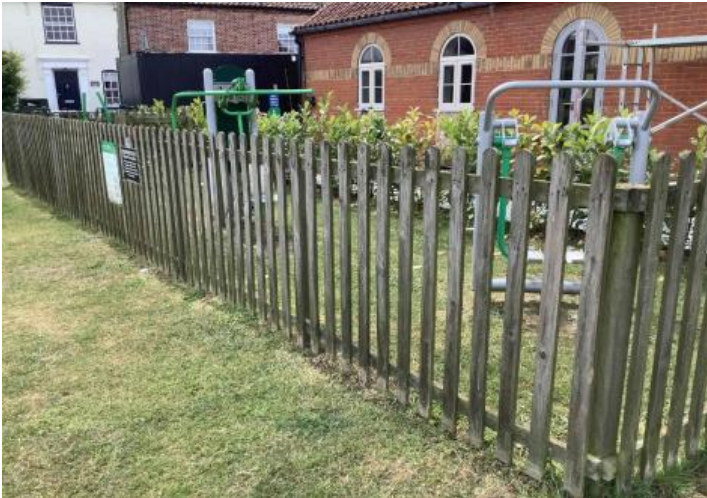
**Finding:** There are a number of loose posts around the fence

**Action:** Monitor for any further deterioration and reset as required

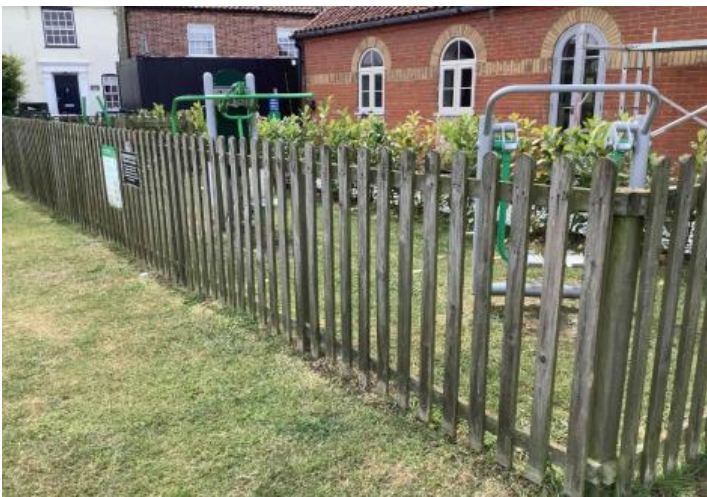
**Finding:** There is some strimmer / machinery damage apparent on the posts, this can penetrate the preservative applied to the timber and accelerate the rotting process

**Action:** Monitor for any deterioration (rot) and replace as required

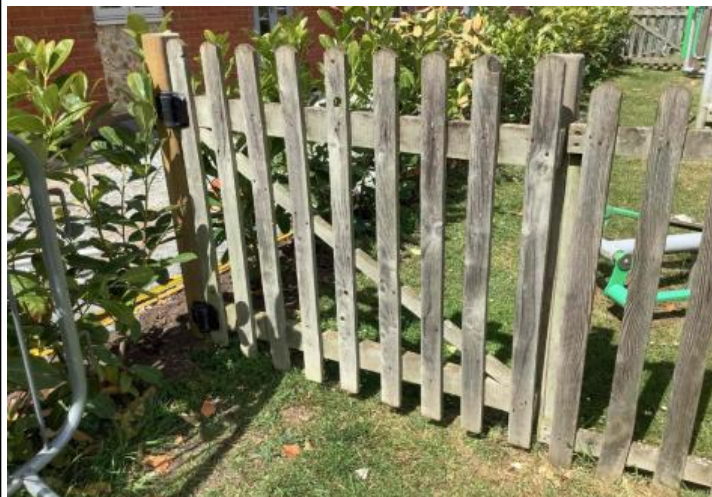
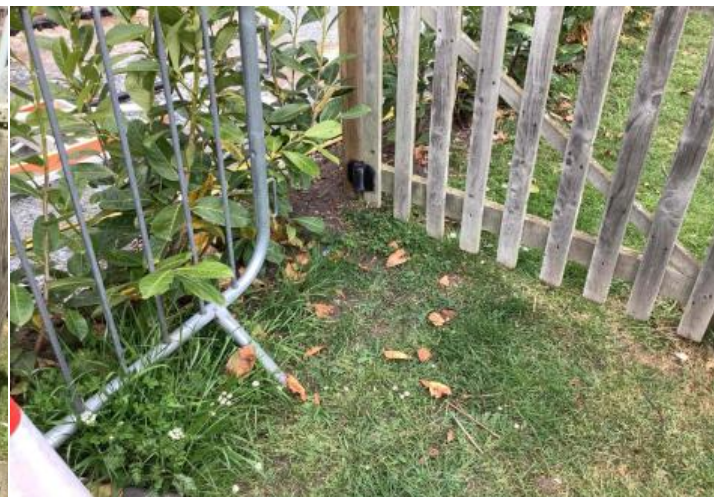
**Finding:** The gate is snagging on the surrounding surface preventing it from opening fully

**Action:** Carry out remedial works to ensure the gate operates correctly

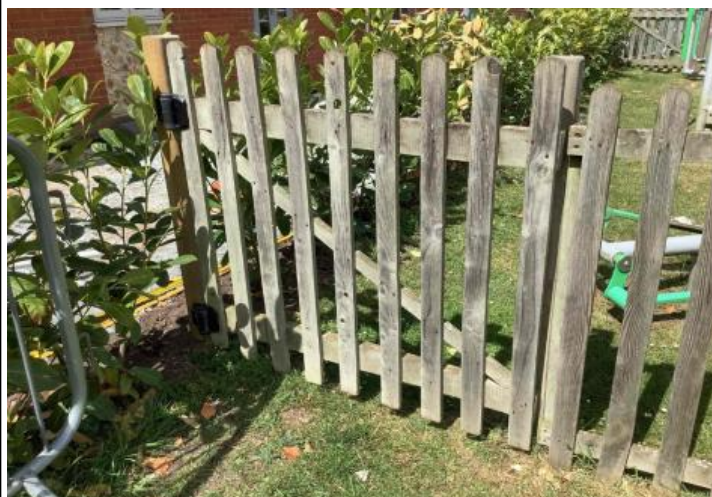
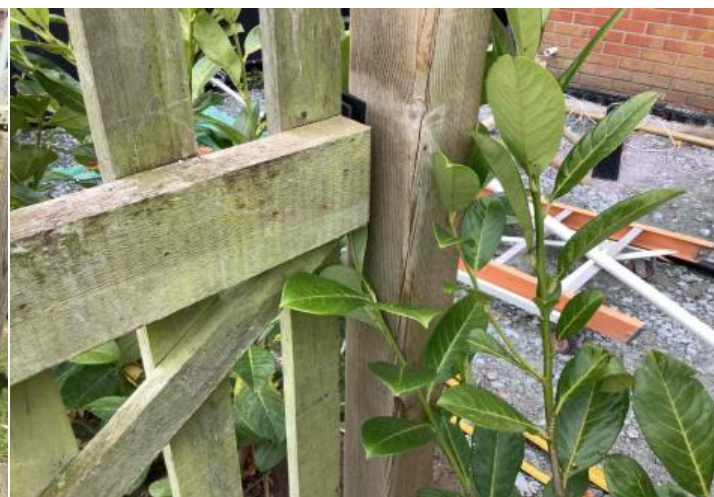
**Finding:** The timber has a number of splits/shakes or air cracks and this may affect the stability or allow water ingress which will accelerate the rotting process. Timber splits may also create rough / splintering edges.

**Action:** Monitor, sand down any rough edges and ensure the splits do not cross through fixing points of the structure and/or cause any instability

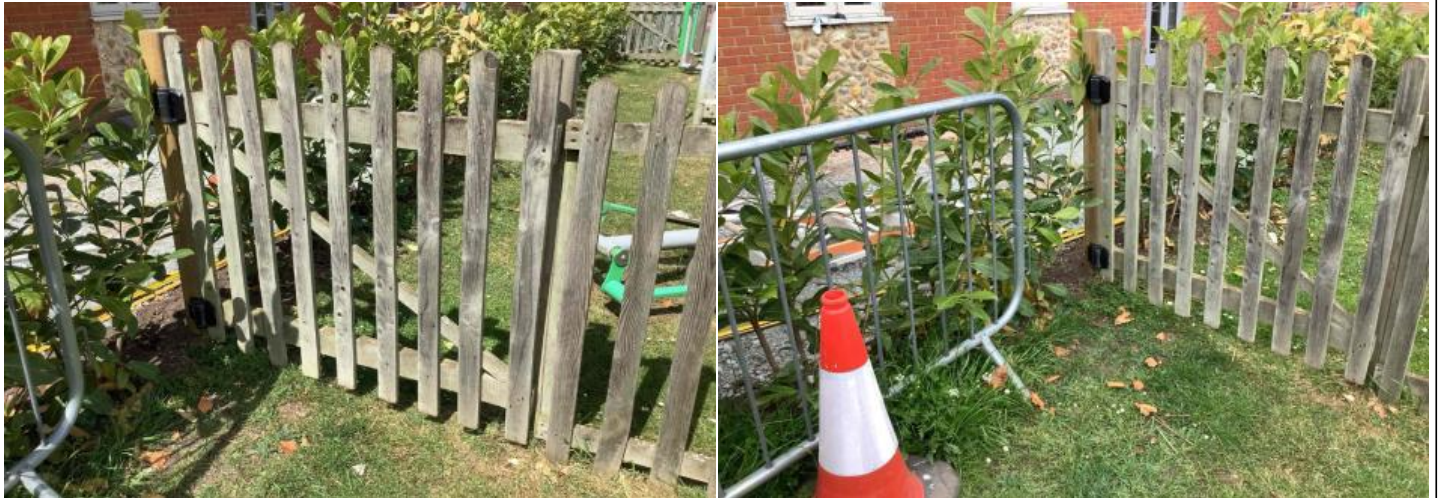
**Finding:** The crowd barrier fencing is impeding the gates

**Action:** Monitor and move / remove asap

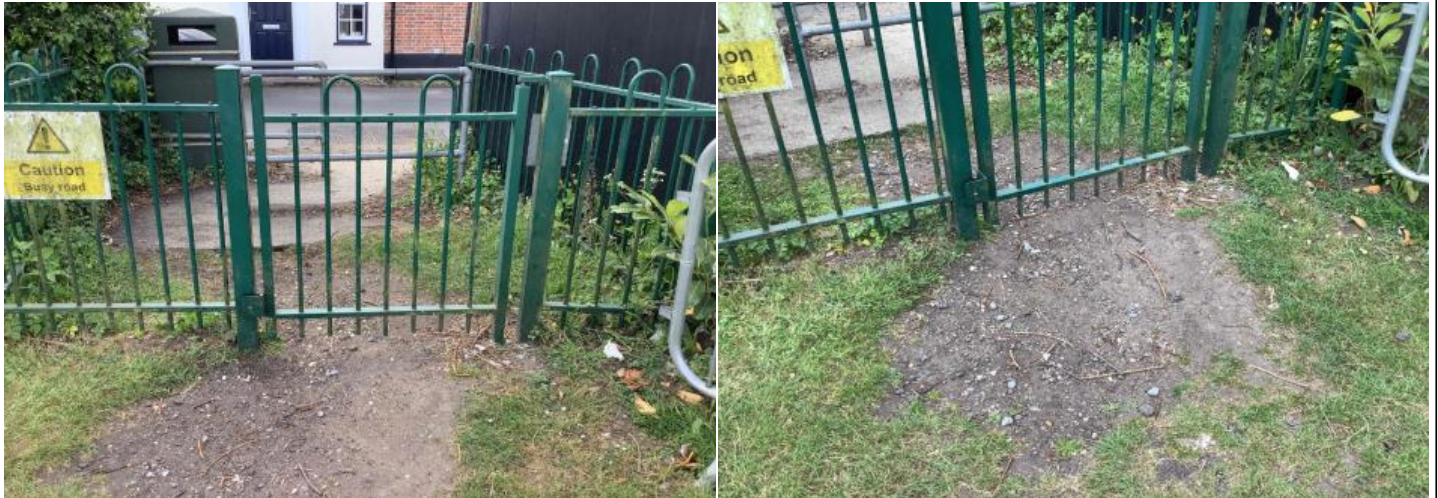
**Finding:** The surface has eroded in some areas and may be slippery in wet conditions  
**Action:** Reinstate the surface

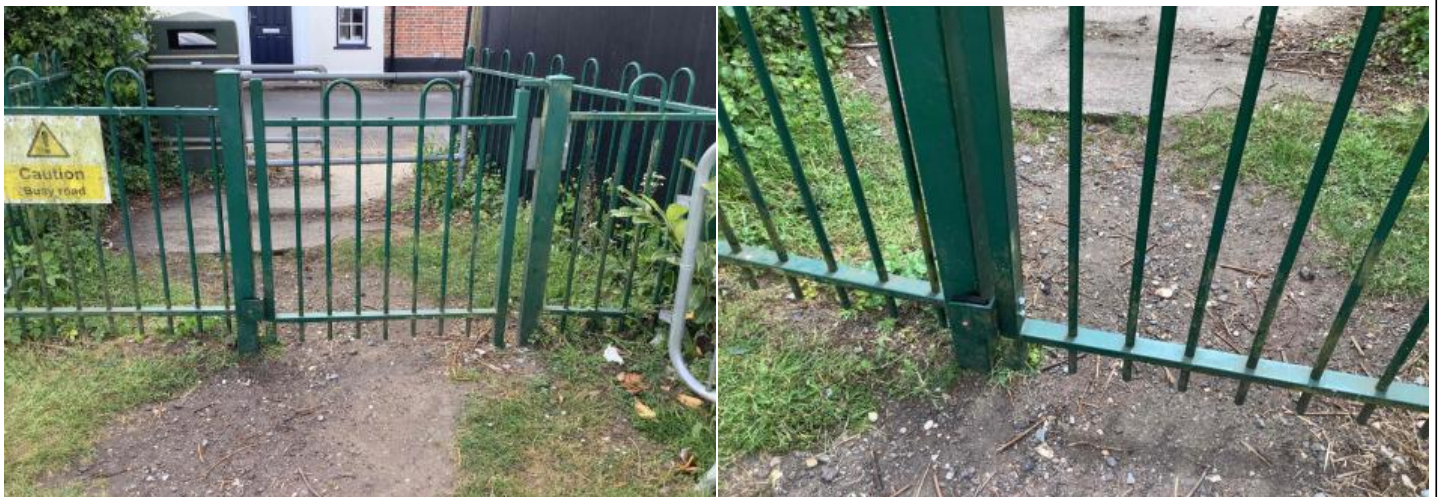
**Finding:** There is algae or moss on the surface of the equipment  
**Action:** Clean and treat appropriately

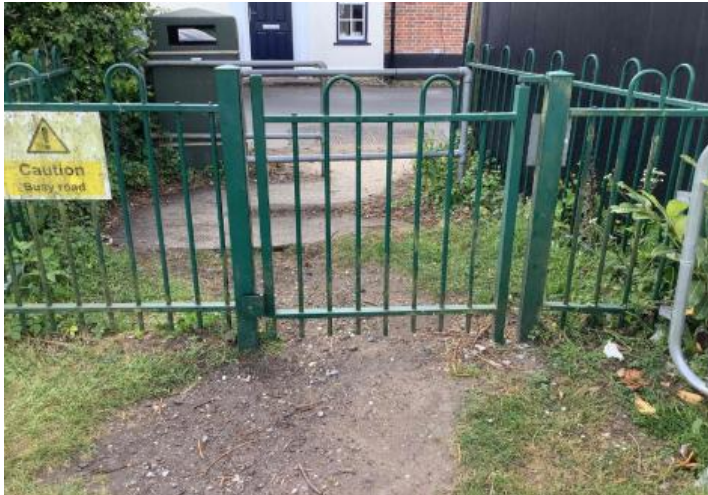
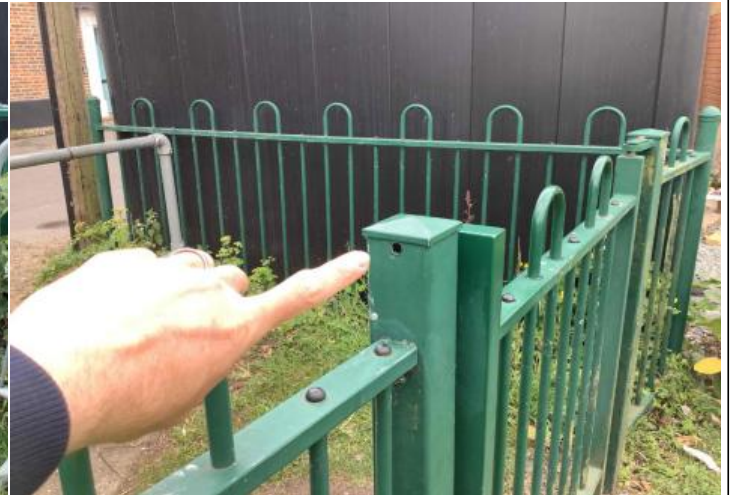
**Finding:** Insert/s missing or damaged

**Action:** Replace

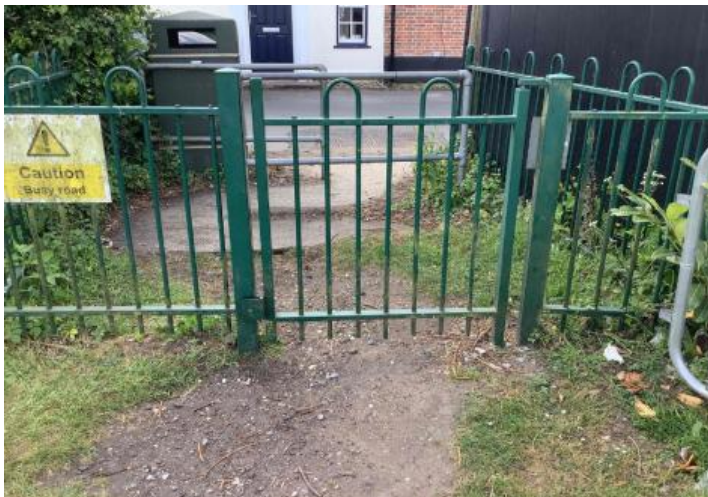
**Finding:** There are trip hazards present

**Action:** Remove trip hazard

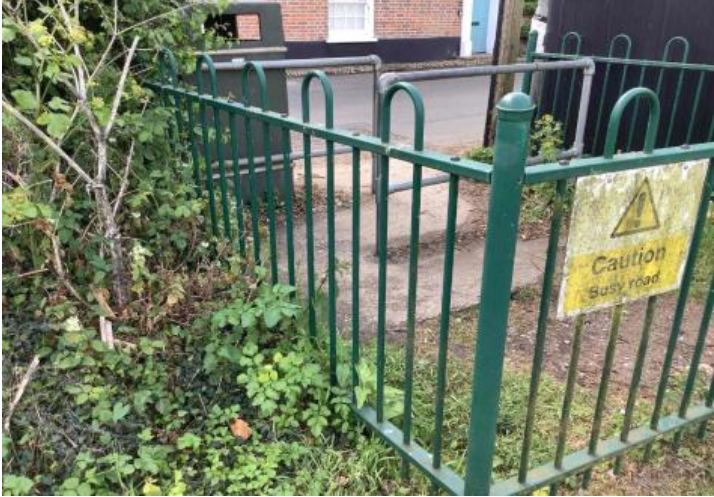
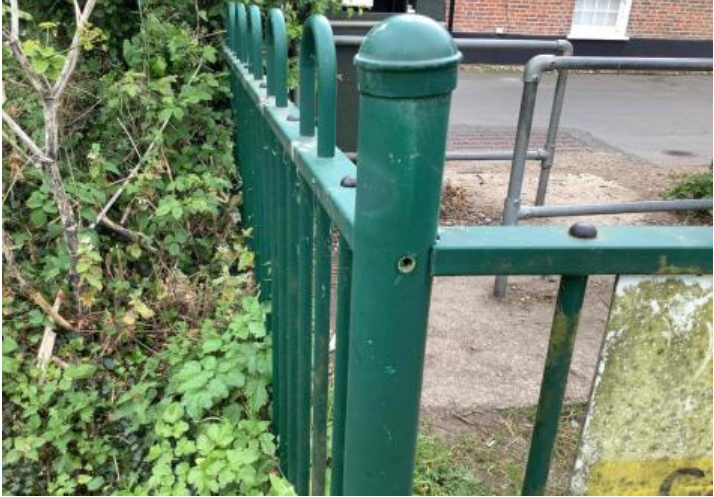
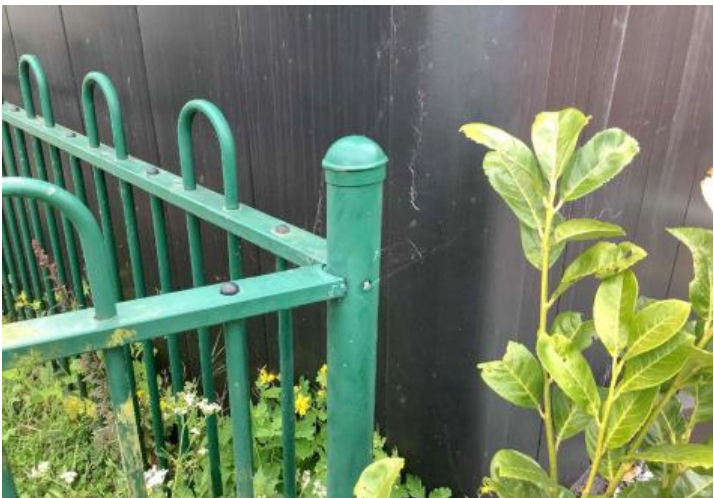
| <div> <div></div> <div>8 - Low Risk (Finding 2)</div> </div> | | | |
|---|--|---|--|
| <div> <div>Finding:</div> <div>There is or are fixings missing on the item</div> </div> | | <div> <div>Action:</div> <div>Replace all missing fixings</div> </div> | |

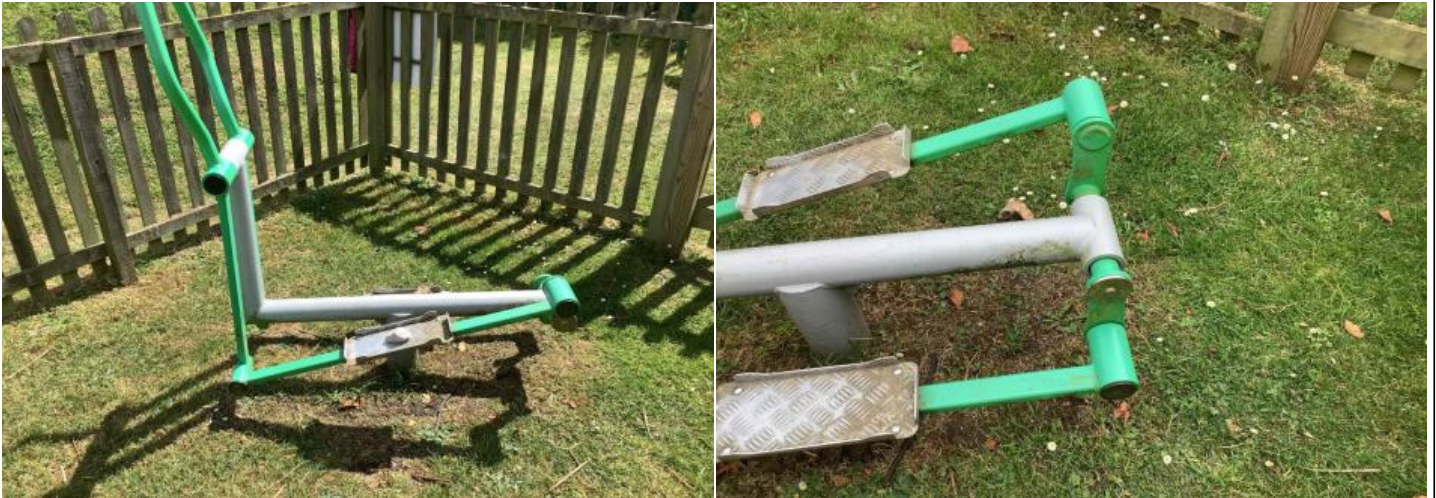
**Finding:** There is algae or moss on the surface of the equipment

**Action:** Clean and treat appropriately

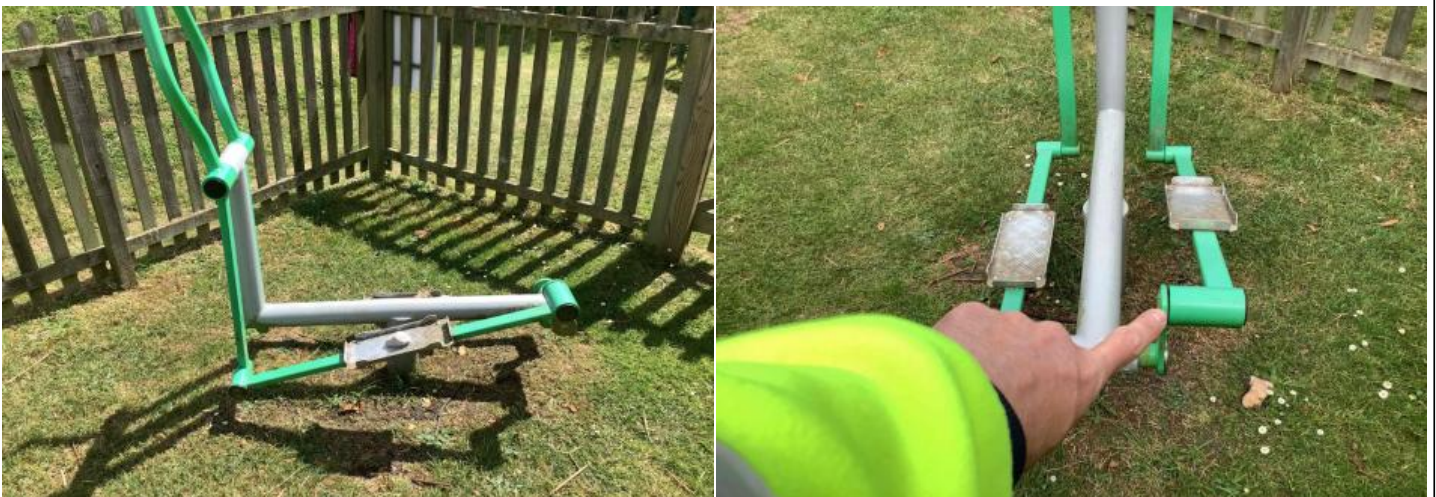
**Item:** Outdoor Fitness Equipment - Cross Trainer **Risk Level:** L - Low Risk  
**Manufacturer:** Action Play and Leisure **Surface:** Grass Matrix Tiles

**Finding:** The bearing is showing signs of wear

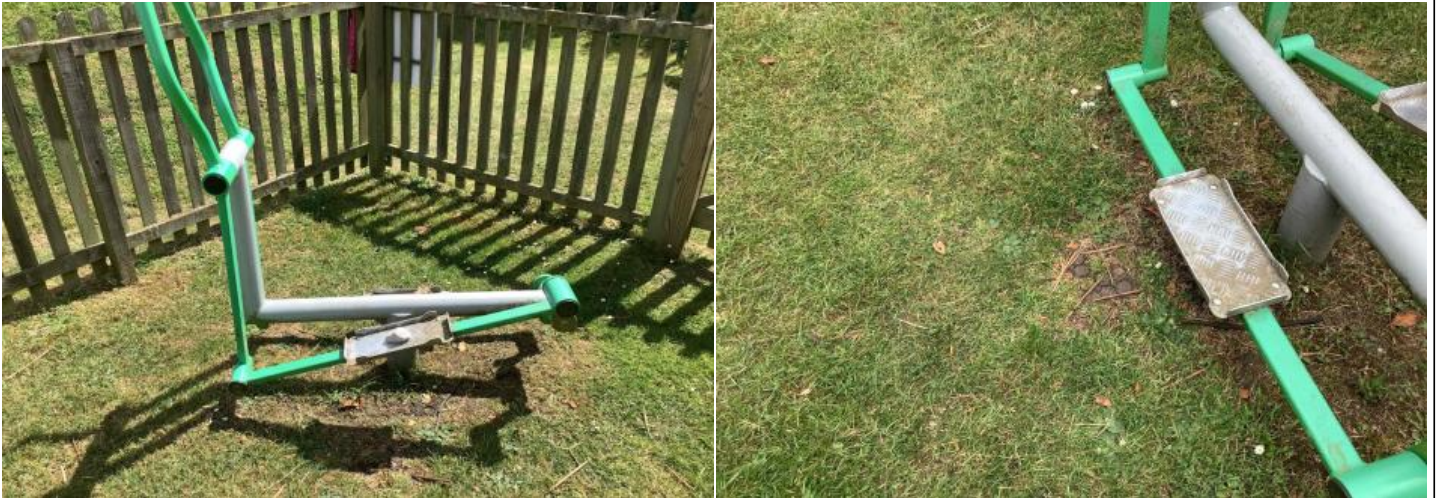
**Finding:** The surface has eroded in some areas and may be slippery in wet conditions  
**Action:** Reinstate the surface

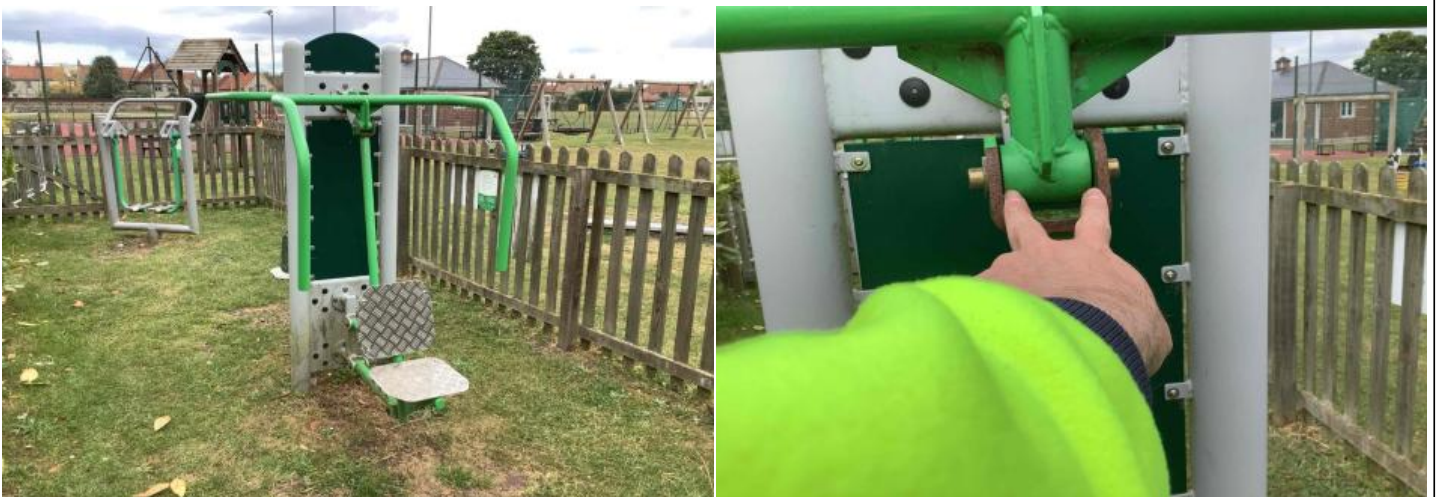
**Item:** Outdoor Fitness Equipment - Chest Press  
**Manufacturer:** Action Play and Leisure  
**Risk Level:** L - Low Risk  
**Surface:** Grass Matrix Tiles

**Finding:** The bearing is showing signs of wear  
**Action:** Monitor for any further deterioration and replace as required

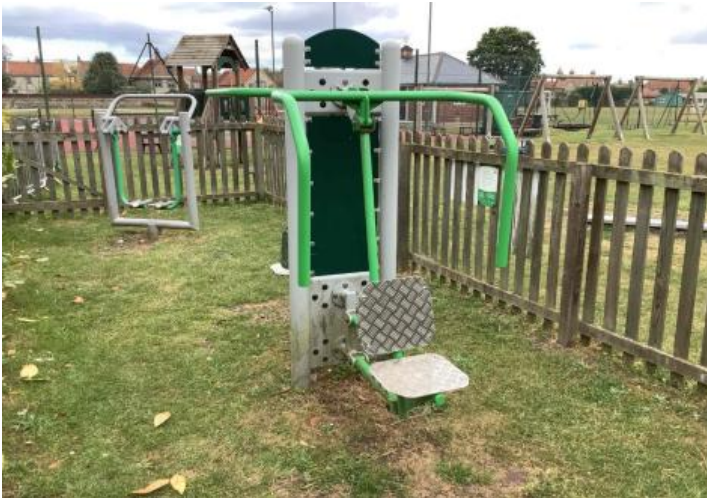
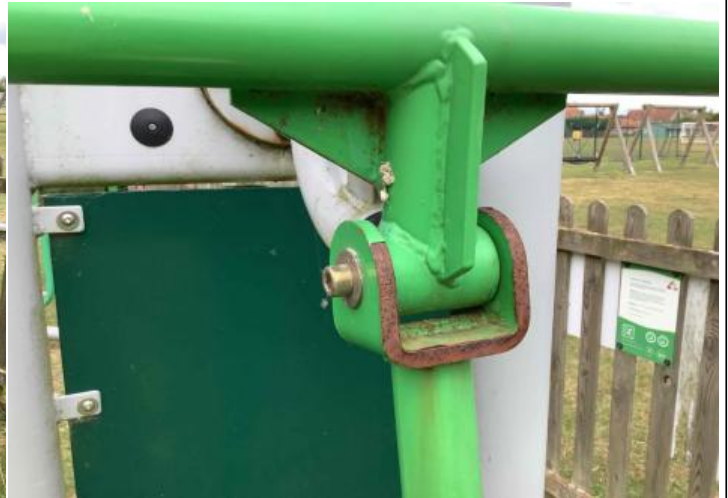
**Finding:** The paintwork on this item has been damaged or worn exposing the metal underneath which is rusting / corroding

**Action:** Treat affected areas and repaint

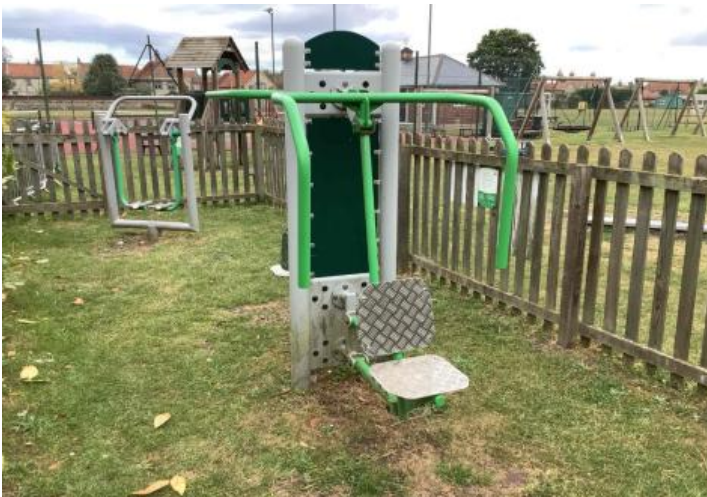
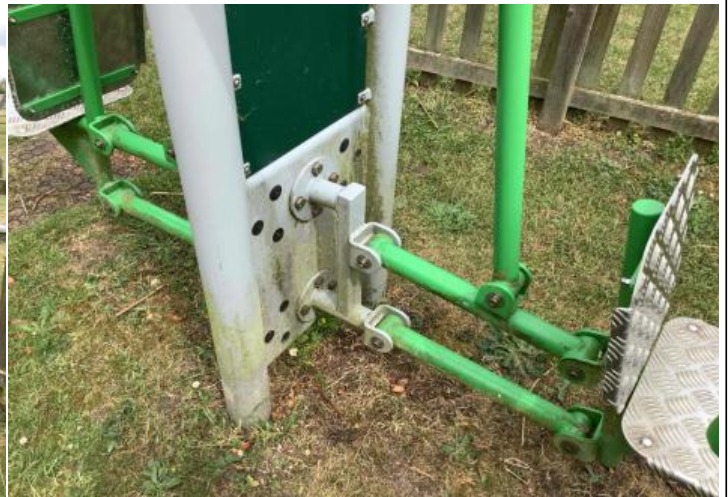
**Item:** Outdoor Fitness Equipment - Chest Press  
**Manufacturer:** Action Play and Leisure

**Finding:** There is algae or moss on the surface of the equipment

**Action:** Clean and treat appropriately

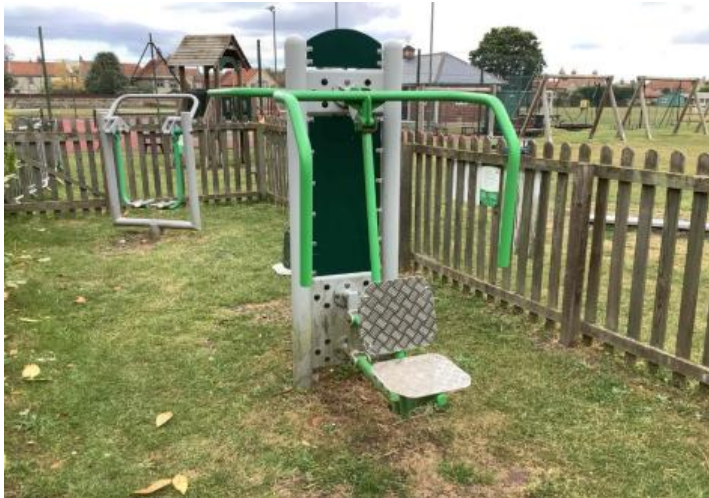
**Item:** Outdoor Fitness Equipment - Chest Press  
**Manufacturer:** Action Play and Leisure

**Finding:** The surface has eroded in some areas and may be slippery in wet conditions  
**Action:** Reinstate the surface

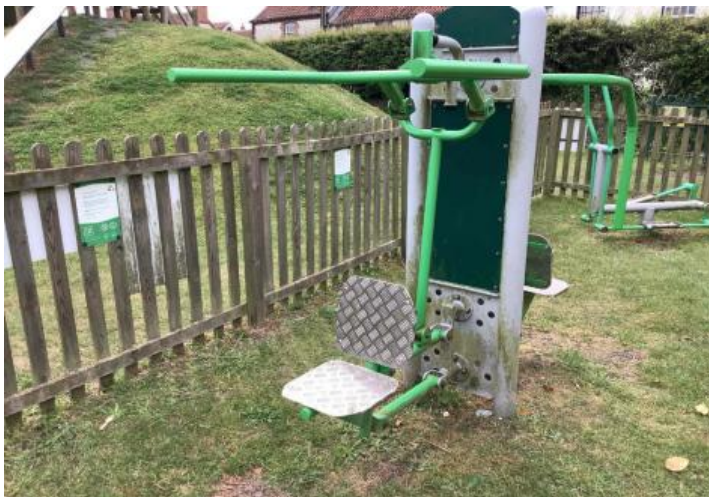
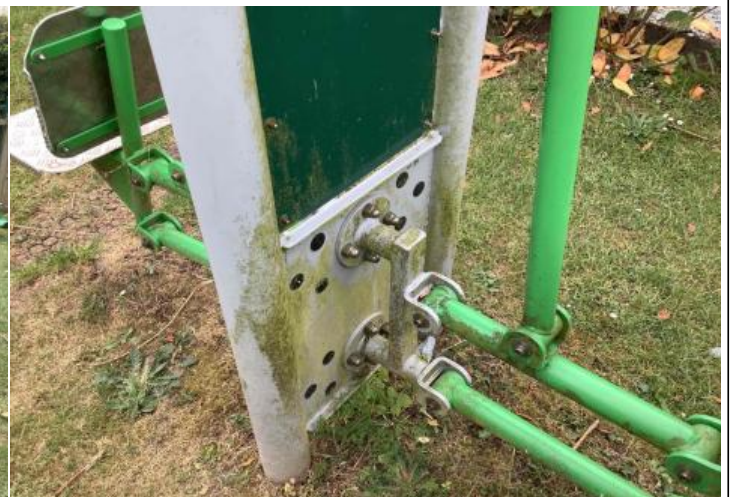
**Item:** Outdoor Fitness Equipment - Pull Down Challenger  
**Manufacturer:** Action Play and Leisure

**Finding:** There is algae or moss on the surface of the equipment  
**Action:** Clean and treat appropriately

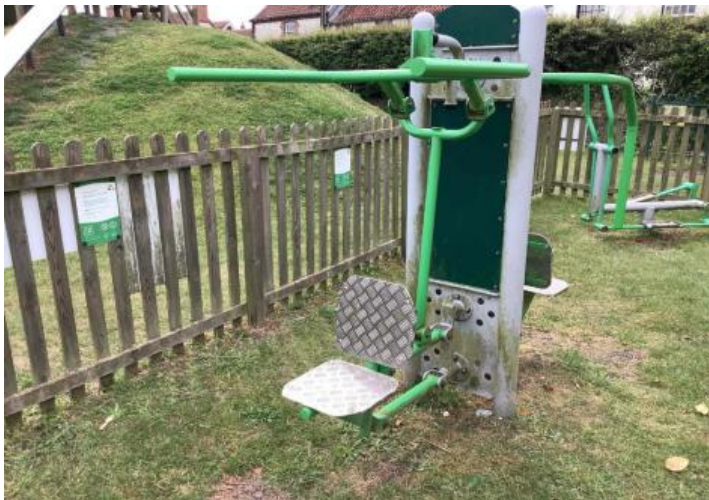
**Item:** Outdoor Fitness Equipment - Pull Down Challenger  
**Manufacturer:** Action Play and Leisure

**Finding:** The paintwork on this item has been damaged or worn exposing the metal underneath which is rusting / corroding

**Action:** Treat affected areas and repaint

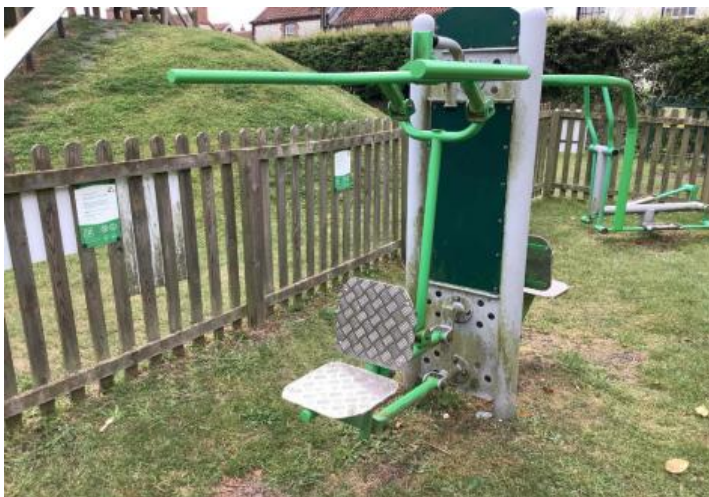
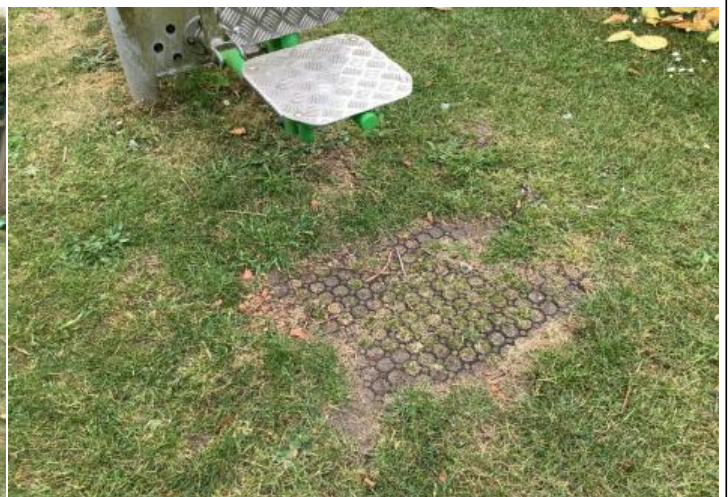
**Item:** Outdoor Fitness Equipment - Pull Down Challenger  
**Manufacturer:** Action Play and Leisure

**Finding:** The surface has eroded in some areas and may be slippery in wet conditions

**Action:** Reinstate the surface

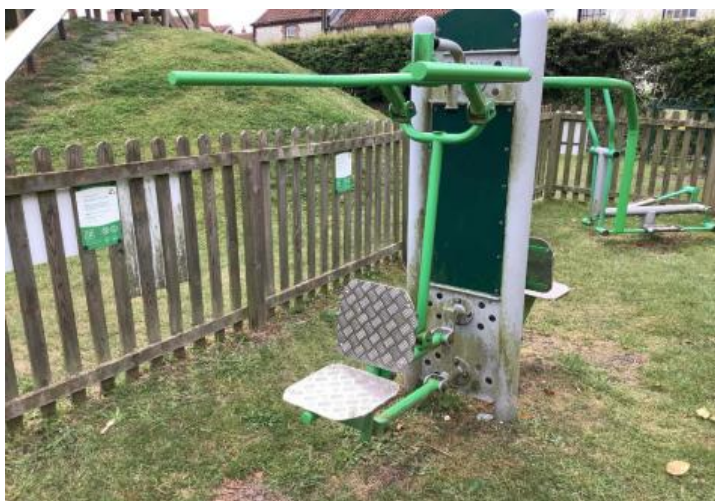
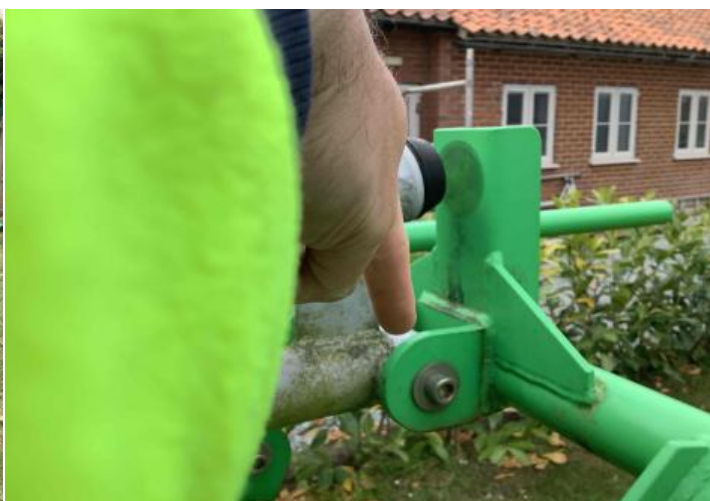
**Item:** Outdoor Fitness Equipment - Pull Down Challenger  
**Manufacturer:** Action Play and Leisure

**Finding:** The bearing is showing signs of wear

**Action:** Monitor for any further deterioration and replace as required

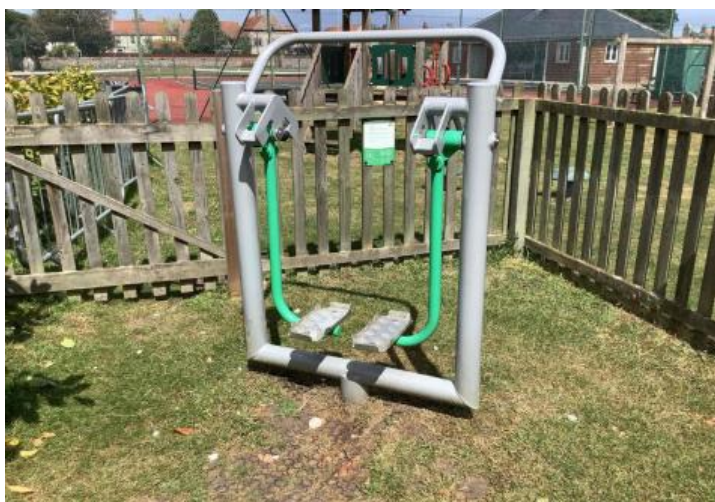
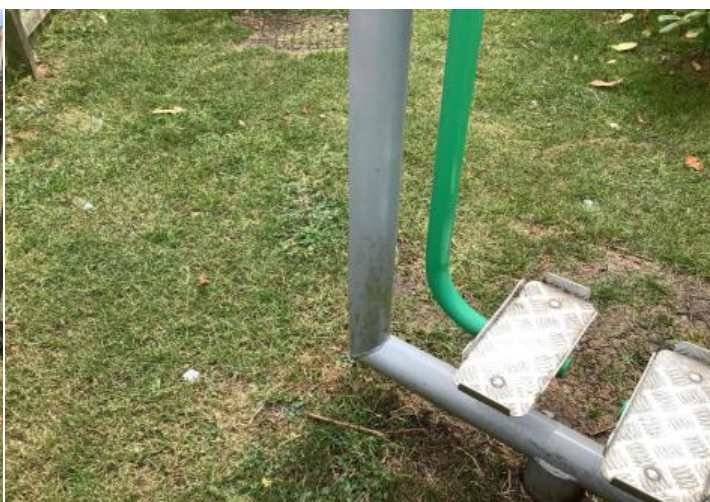
**Item:** Outdoor Fitness Equipment - Air Walker  
**Manufacturer:** Action Play and Leisure

**Finding:** There is algae or moss on the surface of the equipment

**Action:** Clean and treat appropriately

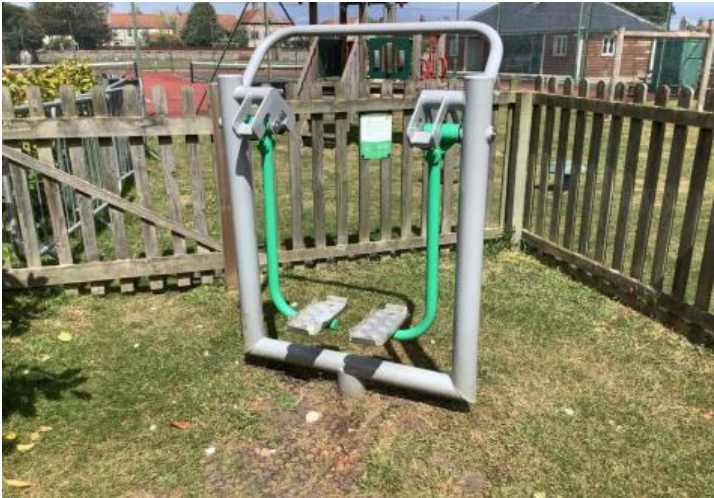
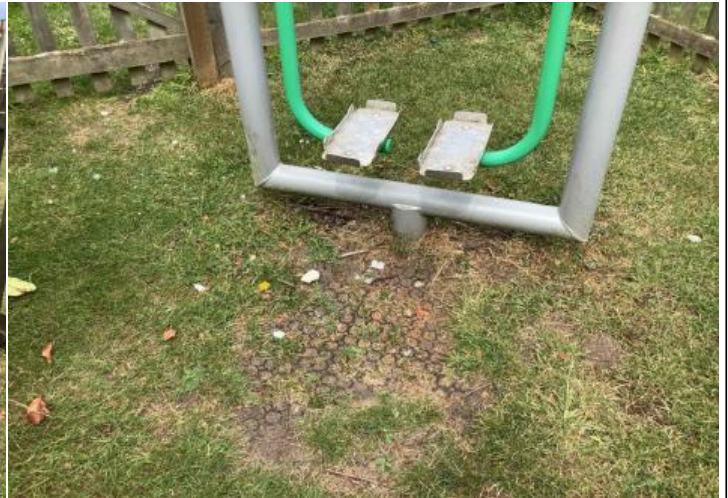
**Item:** Outdoor Fitness Equipment - Air Walker  
**Manufacturer:** Action Play and Leisure

**Finding:** The surface has eroded in some areas and may be slippery in wet conditions  
**Action:** Reinstate the surface

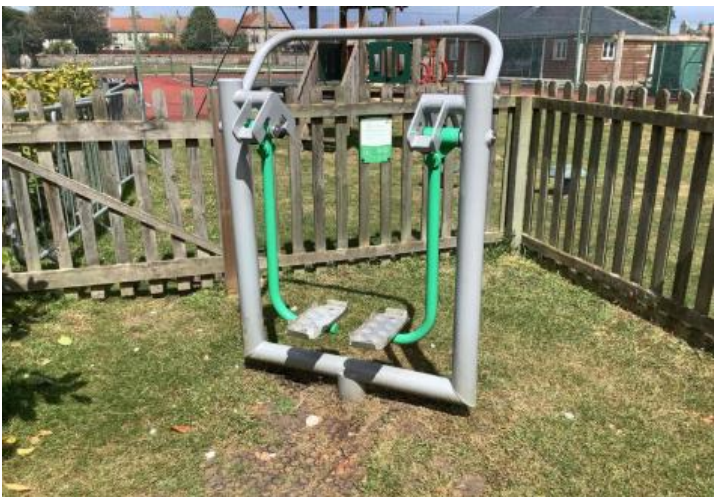
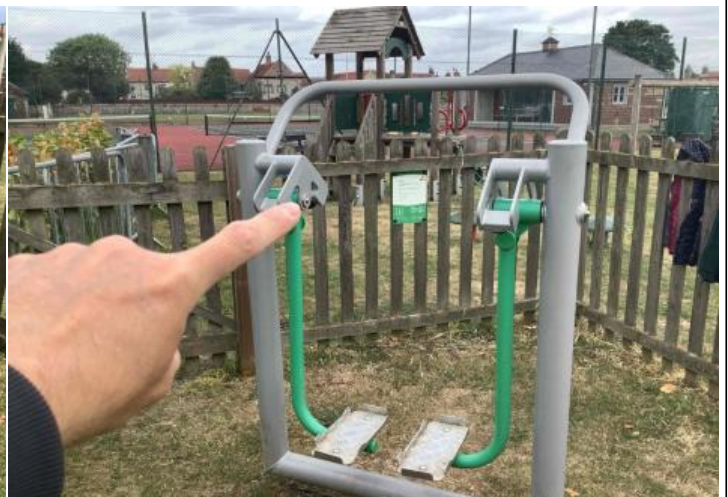
**Item:** Outdoor Fitness Equipment - Air Walker  
**Manufacturer:** Action Play and Leisure

**Finding:** The bearing is showing signs of wear

**Action:** Monitor for any further deterioration and replace as required

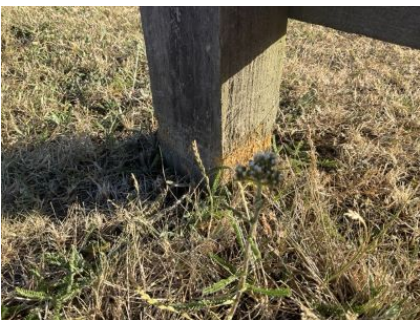
# Fencing - Wooden

Strimmer damage is present on posts, allowing water to enter and timbers to soften. It can also remove the protective envelope around the timber. Prevent further damage and check timbers for decay throughout the year.

Prevent further damage.

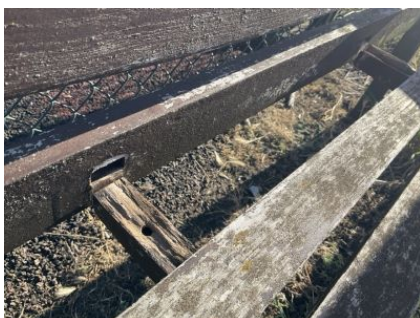
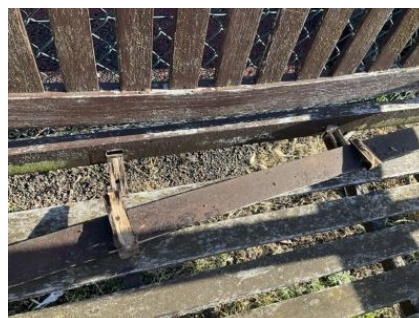
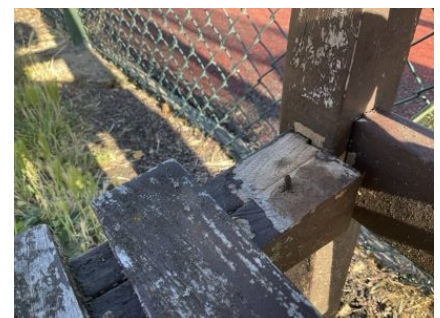
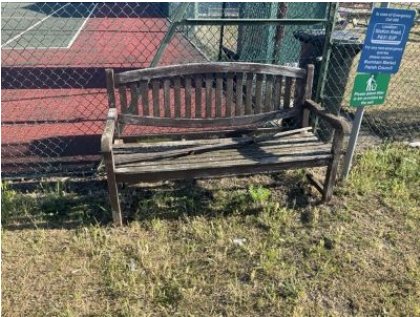
Item is damaged.

The seat frame is damaged and a slat has detached.

## Repair.

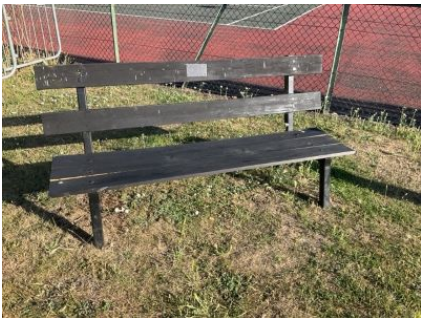
Additional comments are noted below.

Seat slats are bending when used. The replaced timber slats may be too thin for public use and could snap under load bearing. Replace with a more substantial timber slats.

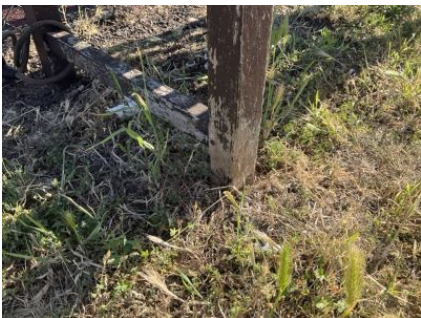
Strimmer damage is present on posts, allowing water to enter and timbers to soften. It can also remove the protective envelope around the timber. Prevent further damage and check timbers for decay throughout the year.

Table seat legs.

Prevent further damage.

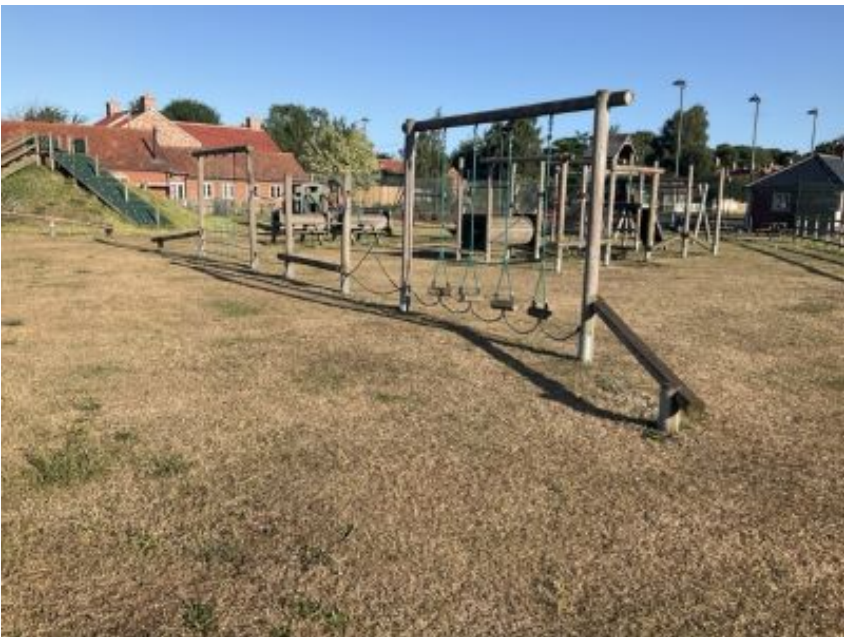
# Agility - Trim Trail - 7 Stations

Bolt(s) loose.

Posts loose in metal shoes. General tightening of all fittings is required.

This equipment relies on one post for its stability. Special attention should be paid to maintenance (e.g. by monitoring degradation) and if necessary decommissioning the item before the end of its operating life. This is a requirement of the British Standard.

Monitor for decay running through the shakes.

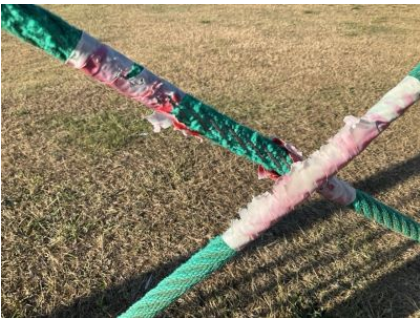
Rope wire exposed. Monitor for broken strands and sharp edges, tape over or replace if found.

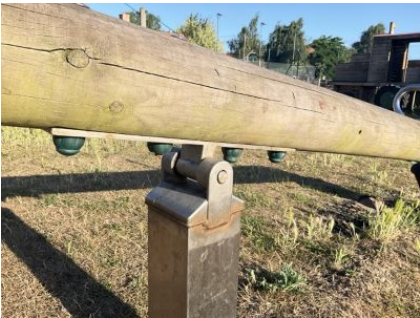
Bolt(s) loose.

Plank bolts loose. Tighten all fittings.

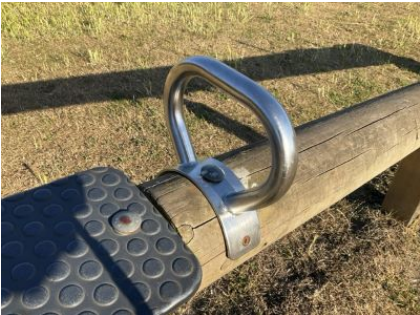
Fixtures loose or missing.

Hand grips loose to the plank.

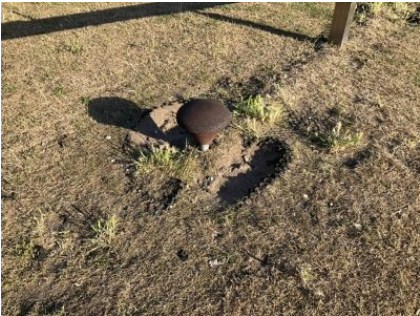
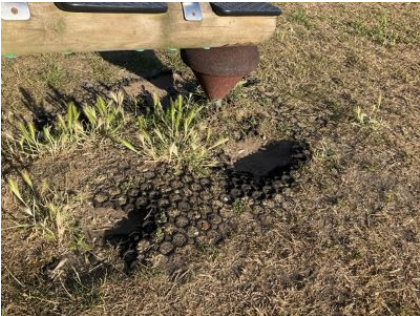
Surface needs repair.

Grass mats are damaged and exposed stones are present. Remove stones and Replace mats.

Replace.

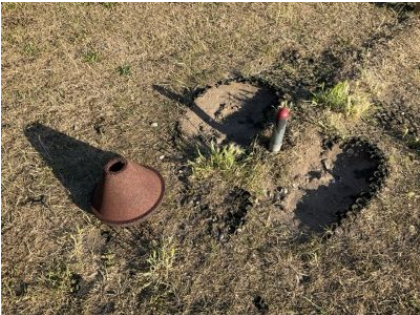
Both rubber dampeners are loose to the metal post. Re-glue and secure.

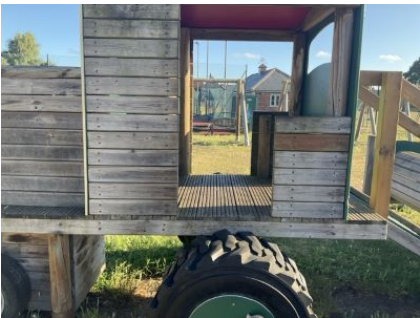
1. Strimmer damage is present on posts, allowing water to enter and timbers to soften. It can also remove the protective envelope around the timber. Prevent further damage and check timbers for decay throughout the year.

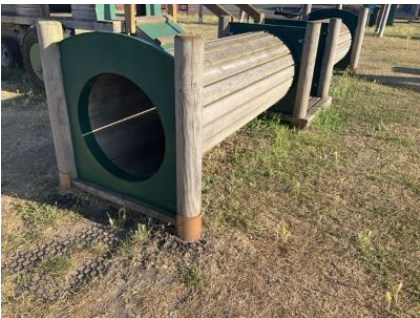
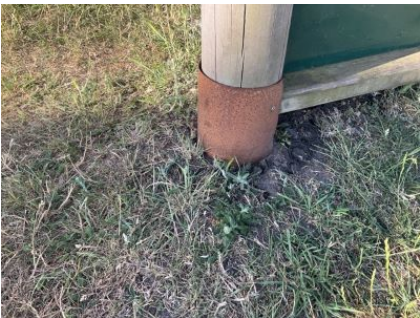
Strimmer damage is present on posts, allowing water to enter and timbers to soften. It can also remove the protective envelope around the timber. Prevent further damage and check timbers for decay throughout the year.

Prevent further damage.

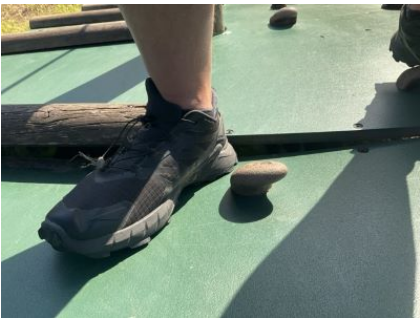
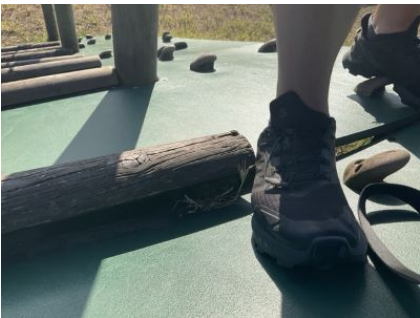
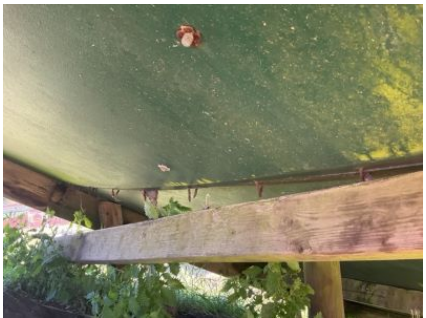
The top green climbing section is loose and dips creating finger entrapments due to the frame below decaying at the ends and detaching. Replace the timber beam and secure as soon as possible. Temporary repairs should be made immediately.

Secure., Replace.

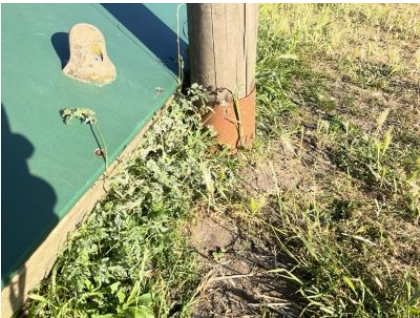
Strimmer damage is present on posts, allowing water to enter and timbers to soften. It can also remove the protective envelope around the timber. Prevent further damage and check timbers for decay throughout the year.

Prevent further damage.
