## BURNHAM MARKET PARISH COUNCIL ANNUAL GENERAL MEETING Minutes

Date: Wednesday 6<sup>th</sup> May 2026 at 6.30pm |

## Burnham Market Play Area

# Safety Inspection Report

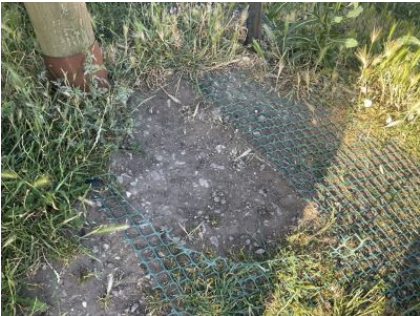
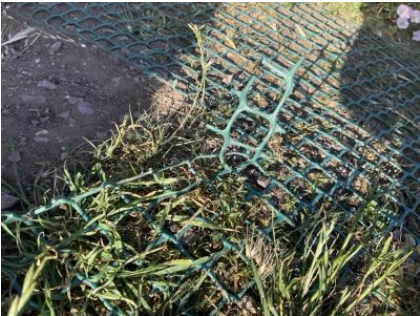
Green mesh has been damaged leaving sharp edges.  
Stones are exposed.

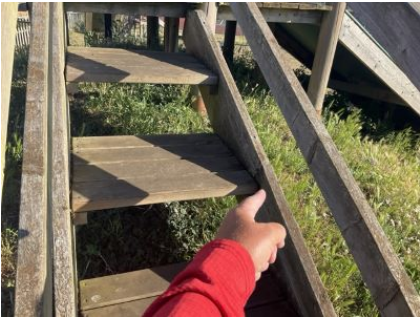
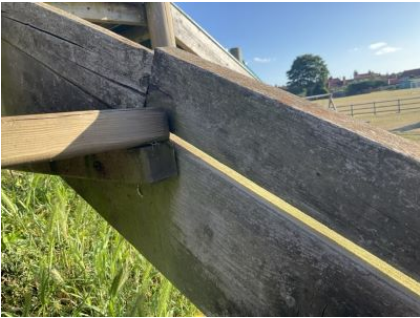
Stairs stringer rail loose.

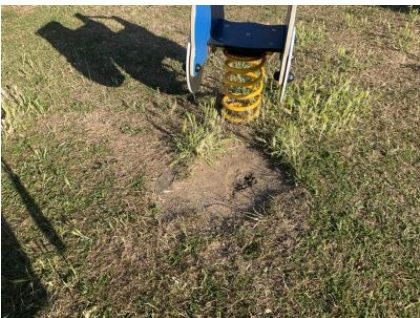
Surface is wearing.

Repair the worn areas.

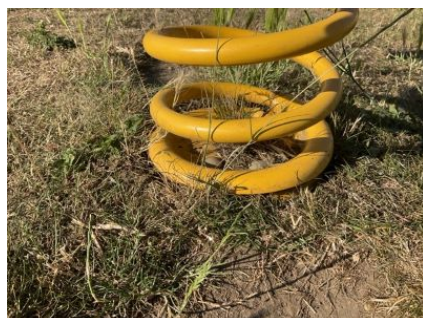
Bolt(s) loose.

Base bolts loose.

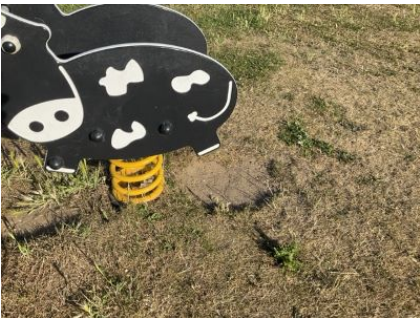
Surface is wearing.

Repair the worn areas.

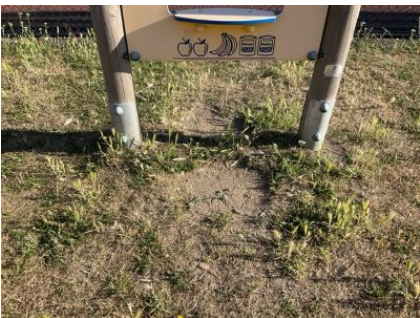
Surface is wearing.

Repair the worn areas.

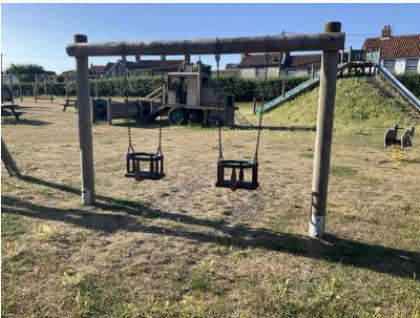
This equipment relies on one post for its stability. Special attention should be paid to maintenance (e.g. by monitoring degradation) and if necessary decommissioning the item before the end of its operating life. This is a requirement of the British Standard.

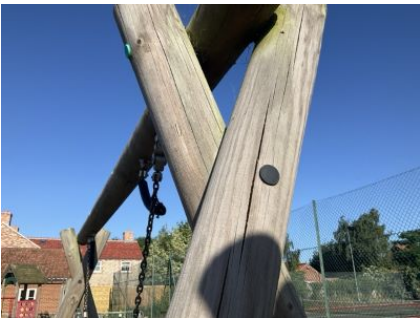
**Finding Photos**

Surface needs repair.

Repair.

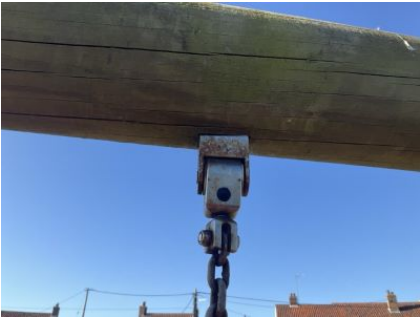
Finding Photos

Swing hangers very loose to the top bar. Swing hanger could fall out over time if not secured correctly. Excessive movement in the top bar will lead to premature wear to both the bolts and top bar itself. Remove and inspect bolt and secure according to the manufacturer’s instructions.

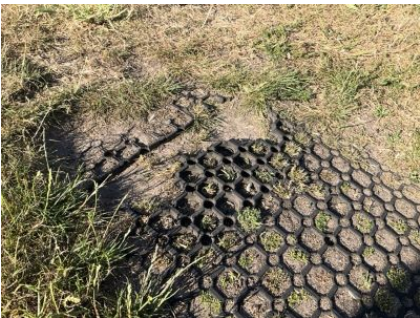
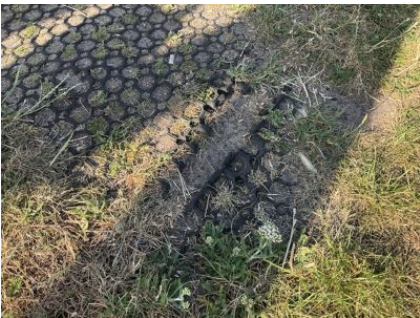
Finding Photos

Surface needs repair.

Grass mats are damaged. Replace.

Repair., Replace.

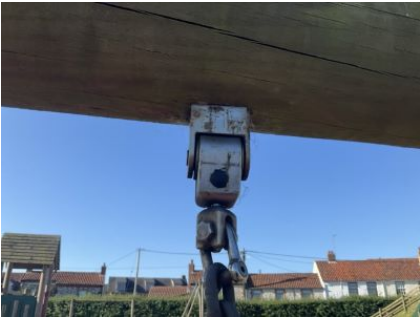
**Finding Photos**

Swing hangers very loose to the top bar. Swing hanger could fall out over time if not secured correctly. Excessive movement in the top bar will lead to premature wear to both the bolts and top bar itself. Remove and inspect bolt and secure according to the manufacturer’s instructions.

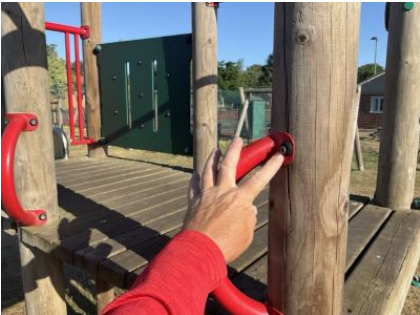
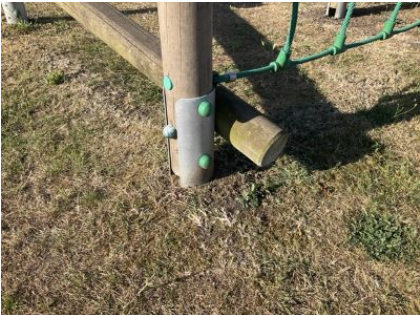
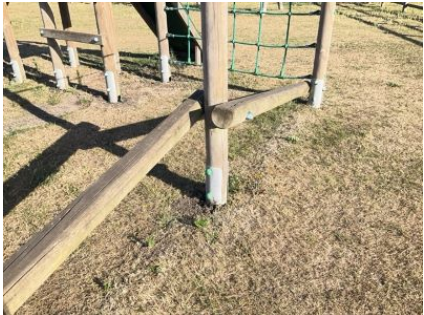
**Finding Photos**

Bolt(s) loose.

Unit is rocking, posts are loose in the metal ground shoes grab handholds working loose. General tightening up of all post ground fittings and grab handholds.

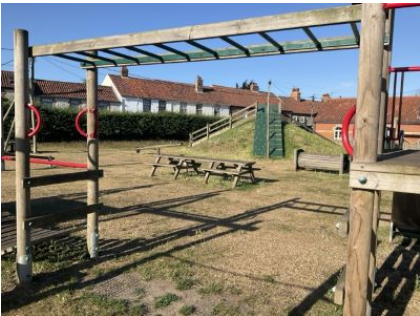
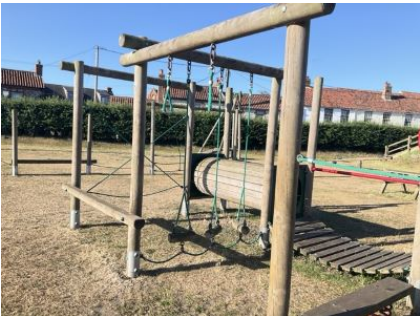
## Finding Photos

Overhead ladders and rings provide significant play value and benefits to children, and with it the risk of falling. Ensuring the surface remains in good condition will help to keep the correct balance between benefits and risk.

The protective surface under all bars and rings must be kept in good condition.

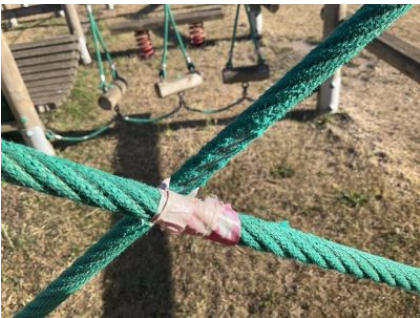
## Finding Photos

Rope wire exposed. Monitor for broken strands and sharp edges, tape over or replace if found.
